## The Village at Rio Paseo Condominium *Goodyear, AZ*

Report #: 40816-0  
Beginning: January 1, 2022  
Expires: December 31, 2022

# RESERVE STUDY Update "With-Site-Visit"

August 19, 2021

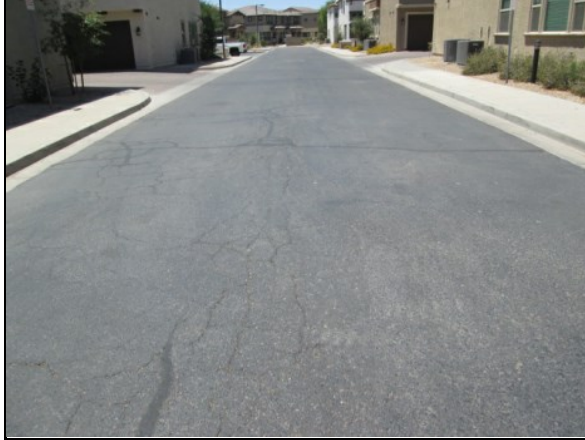
Comments: Observed to be generally intact and smooth. Some cracking and alligating evident in areas. Overall, the asphalt appears to be in fair shape. Life span is based on periodically seal coating and maintaining the surface.

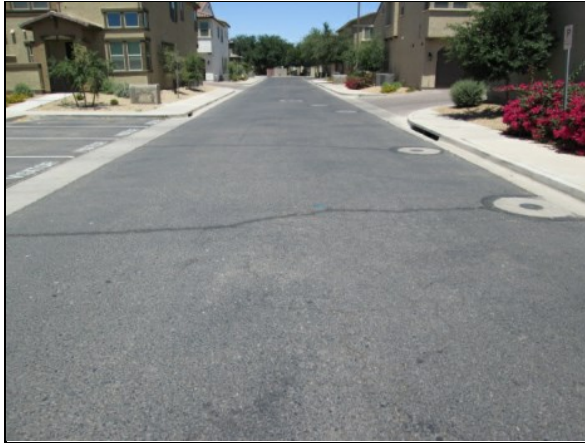
Comments: Seal coat appears to be wearing off. Surface likely wore off faster than normal due to the heavy traffic constructing the remaining (39) unit buildings during 2017-2020. Seal coat asphalt surfaces periodically to prevent premature cracking and deterioration. This component funds to periodically seal the asphalt with HA5.
