Title of Action: Gallery Condominium Association vs. K. Hovnanian at Gallery, LLC

We represent the Gallery Condominium Association ("Association") regarding the defective original construction of The Gallery condominium project located in Scottsdale, Arizona. The purpose of this letter is to provide you with formal notice of the defective work and the Association's claim pursuant to the Homeowners' Association Dwelling Actions (A.R.S. § 33-2002, et seq.), the Purchaser Dwelling Act (A.R.S. § 12-1361, et seq.), and the Association's governing documents.

The Association has retained a forensic expert, SBSA, Inc. ("SBSA") to investigate the defective construction of the common elements at The Gallery. The following defects and deficiencies in the common elements at The Gallery have been identified by SBSA:

These defective conditions are described in detail in the attached Notice of Claim Summary report dated July 2, 2019¹. The SBSA report includes photographs of the defective conditions, which were observed project-wide. The defects impair the structural integrity, functionality or appearance of the dwelling and will continue to do so in the future if not repaired or replaced.

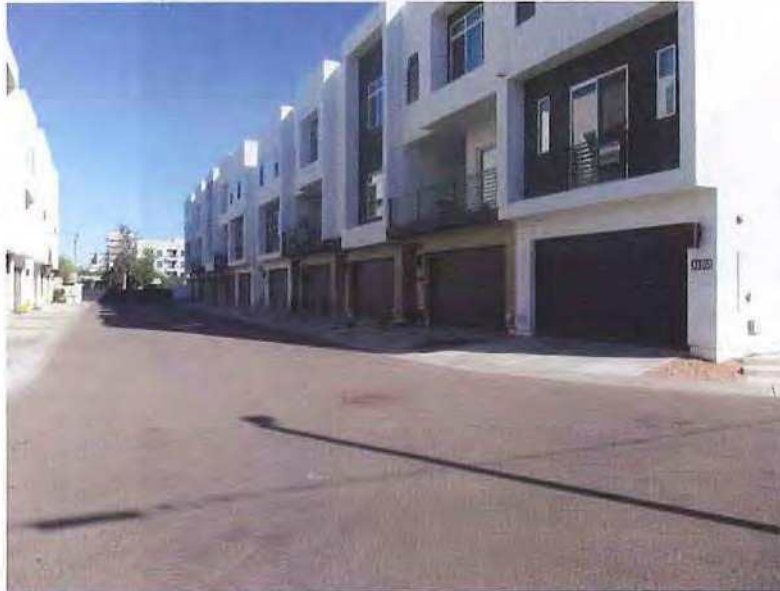
A complete LFRS is required by the Building Codes. This system must be created from the foundation to the roof to provide a complete load path. The following outlines SBSA's findings on the as-built systems. No plans have been provided for review at this time. A full review of the original design is required to determine what the intent was for the original LFRS.

December 19, 2018, Photo 14, OBS1, JBF, overview of the elevation showing limited panel size available for LFRS.

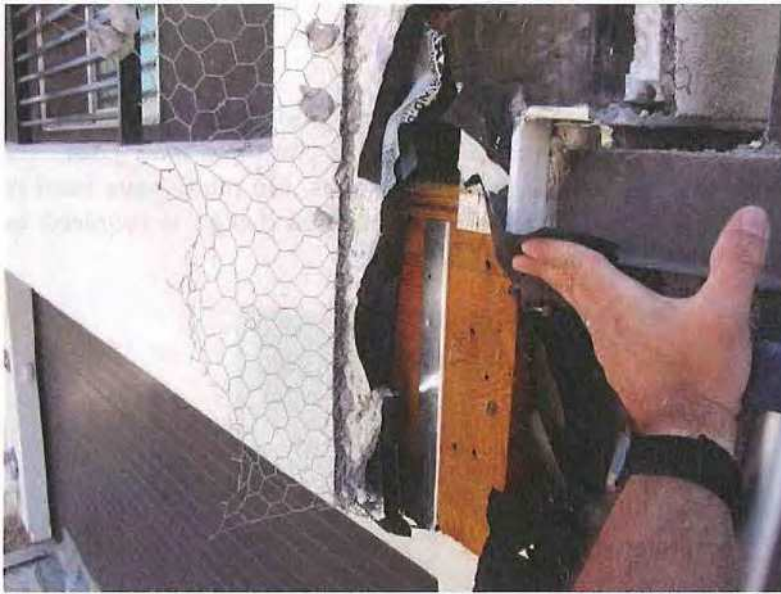
May 13, 2019, Disc IT1, Photograph 50, JBF, west elevation of Building D - Unit 3113, open stud framing with no exterior sheathing.

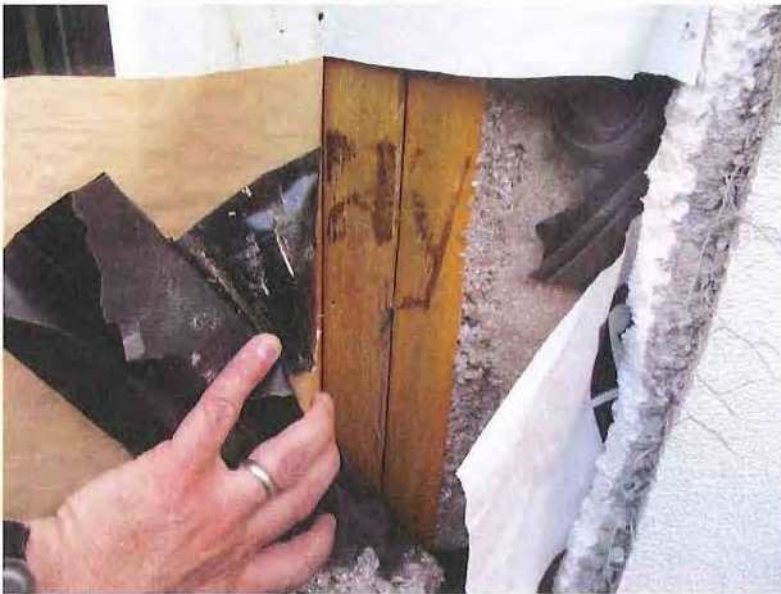
May 13, 2019, Disc IT1, Photograph 156, JBF, south elevation of Building C - Unit 3117, open stud framing with no exterior sheathing.

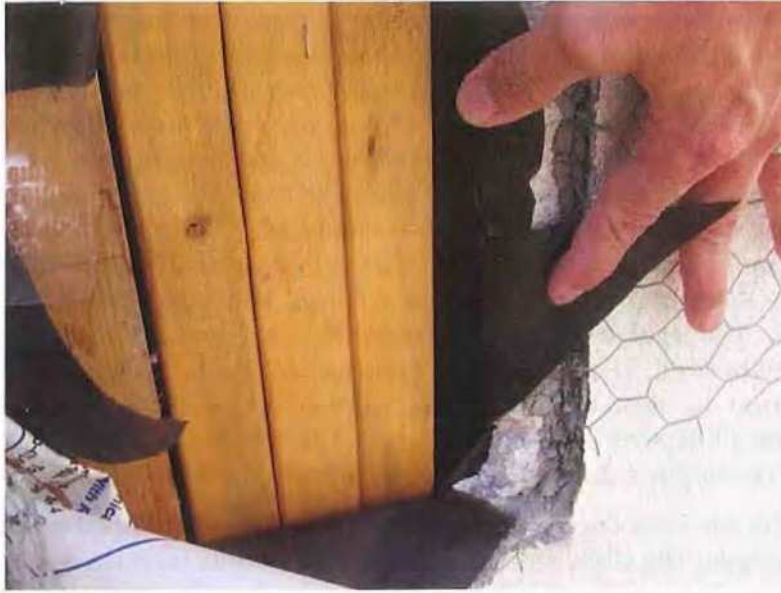
May 14, 2019, Disc IT3, Photograph 26, JBF, north elevation of Building A - Unit 3124, open stud framing with no exterior sheathing.

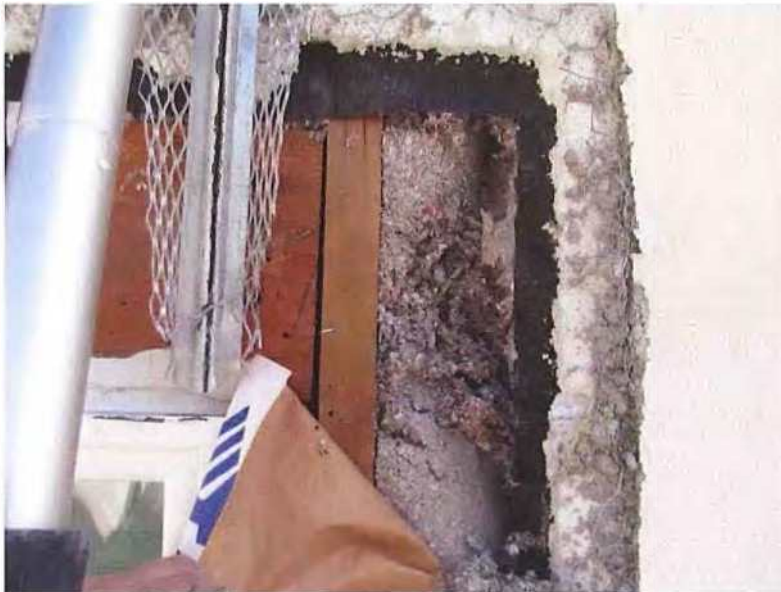
May 14, 2019, Disc IT3, Photograph 52, JBF, south elevation of Building B - Unit 3104, open stud framing with no exterior sheathing.

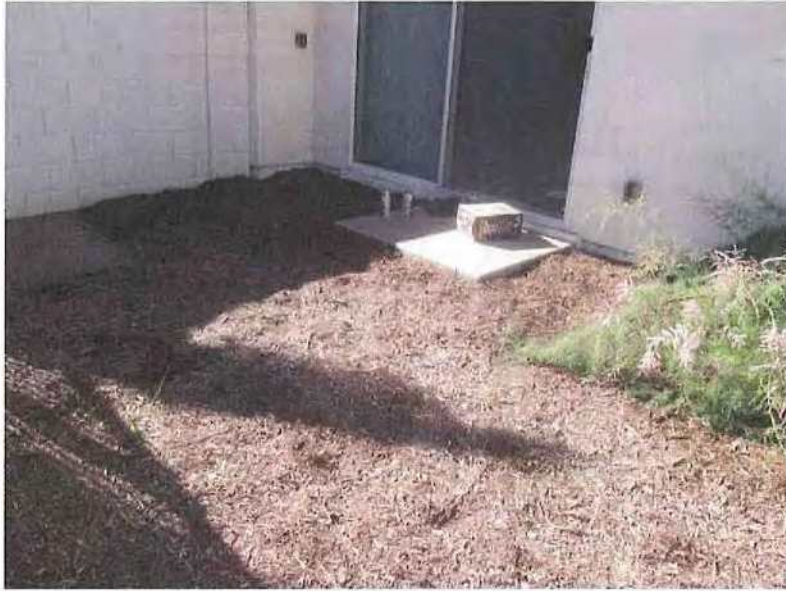
According to the Building Code, a minimum 5-percent slope and a 6-inch clearance must be provided in the protective zone (10-feet defined by the code) or an alternative drainage system must be provided. A full review of the original design is required to determine the intent of the original civil design.

December 19, 2018, Disc OBS1, Photograph 80, JBF, east elevation of Building D - Unit 3111, poor slope of grade away from foundation.

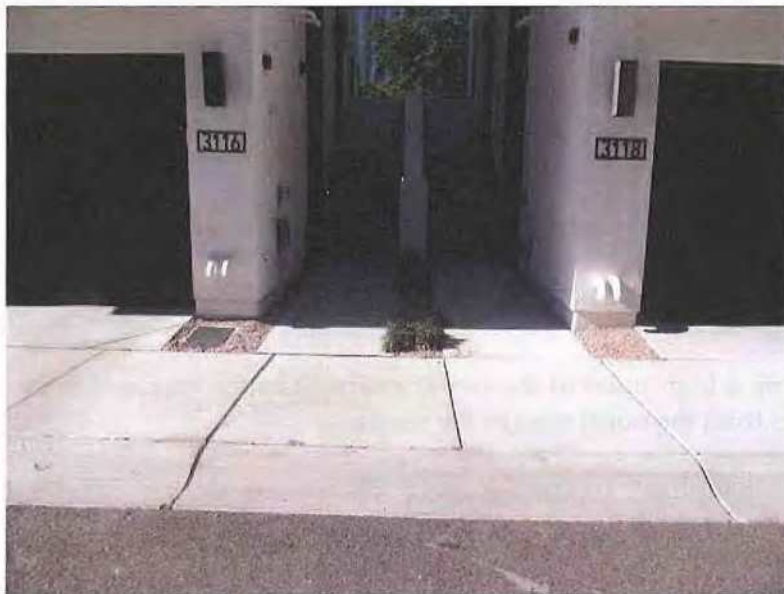
December 19, 2018, Disc OBS1, Photograph 156, JBF, west elevation between Buildings C and D, poor slope of grade between buildings.

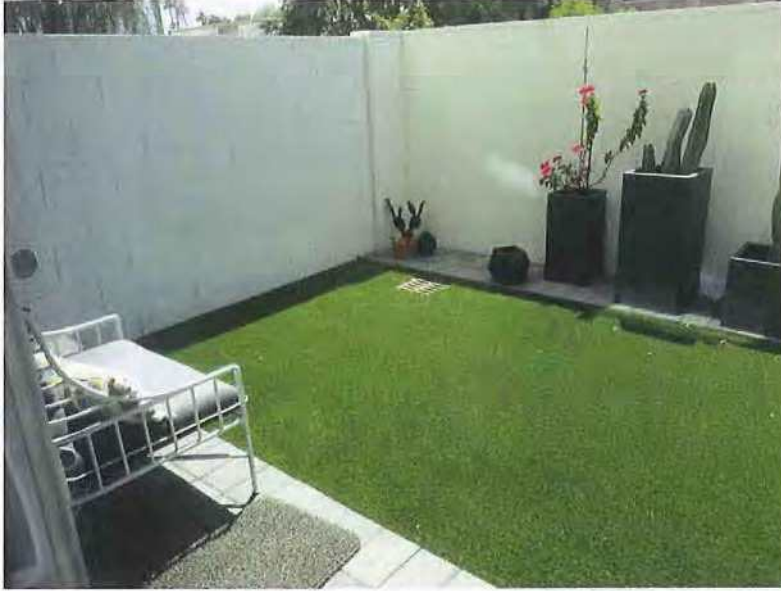
May 13, 2019, Disc IT2, Photograph 120, ELF, Building B - Unit 3110, incorporation of drainage systems should have been considered in the design and the construction to take the roof drainage, rear lot drainage, and street and curb drainage to the detention ponds.

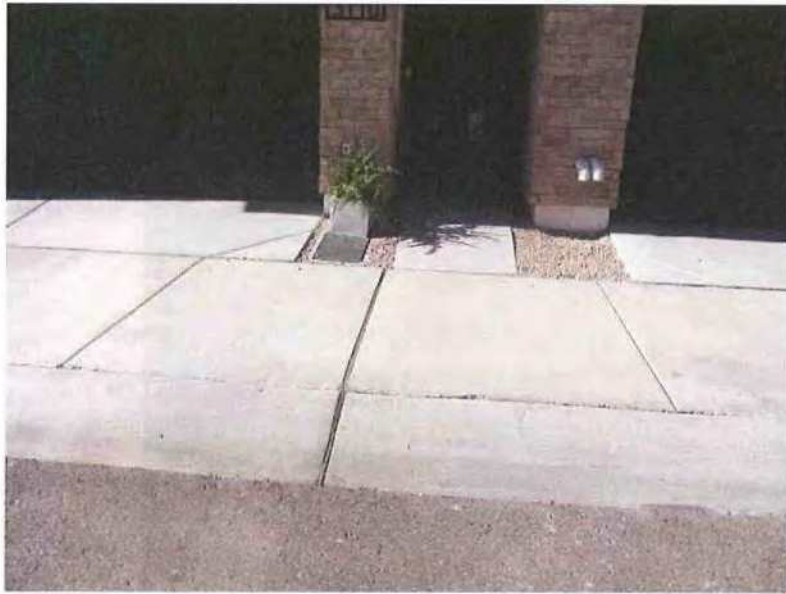
The drainage should be unimpeded to the points of discharge. On this site, the condensate flows and the drainage that strikes the building are directed into small landscape strips along the entries and garages. The water will migrate below the walks, curbs, and asphalt areas.

December 19, 2018, Disc OBS1, Photograph 154, JBF, east elevation of Building B, drainage adjacent to foundation bound by concrete flatwork.

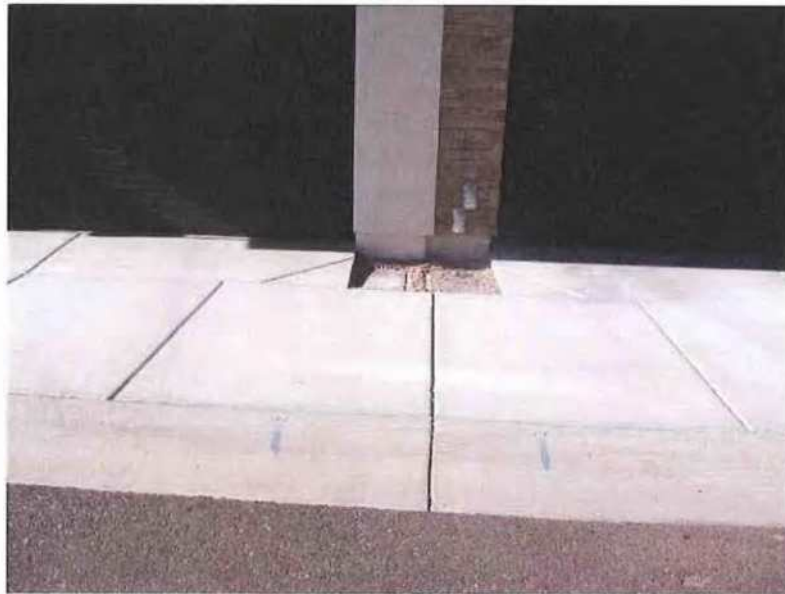
December 19, 2018, Disc OBS1, Photograph 157, JBF, east elevation of Building A, condensate from high efficiency units drain water adjacent to foundation bound by concrete flatwork into the electrical vault.

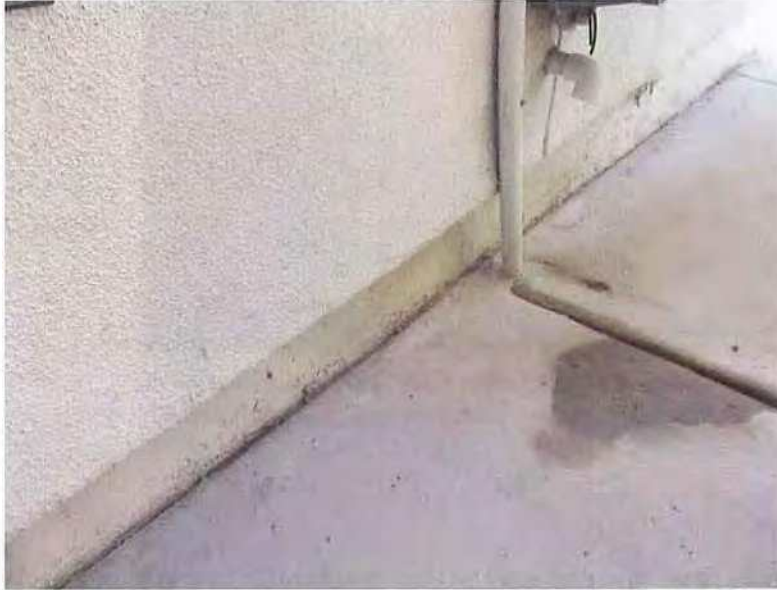
The construction should allow the non-foundation elements to move independent of the structurally supported system, including allowance for any MEP systems that penetrate the slabs while being connected to the building system.

December 19, 2018, Disc OBS1, Photograph 136, JBF, south elevation of Building A - Unit 3118, no isolation joint between concrete flatwork and structural foundation.

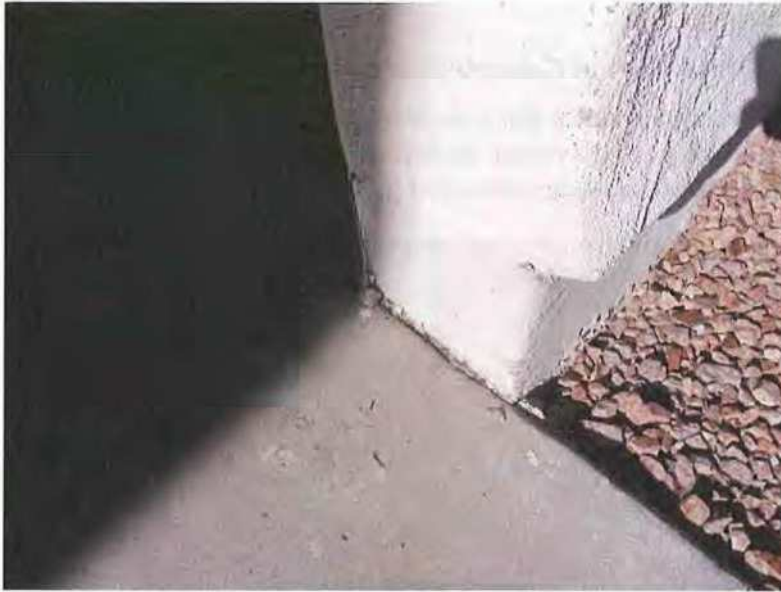
December 19, 2018, Disc OBS1, Photograph 137, JBF, east elevation of Building B - Unit 3116, no isolation joint between concrete flatwork and structural foundation.

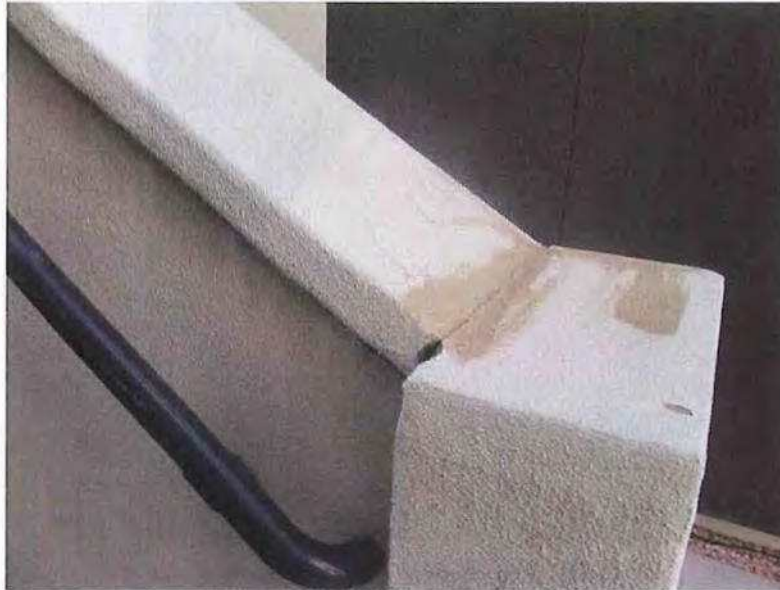
December 19, 2018, Disc OBS1, Photograph 45, JBF, east stairs between Buildings C and D, cracking and separation of stair wall indicative of differential movement.

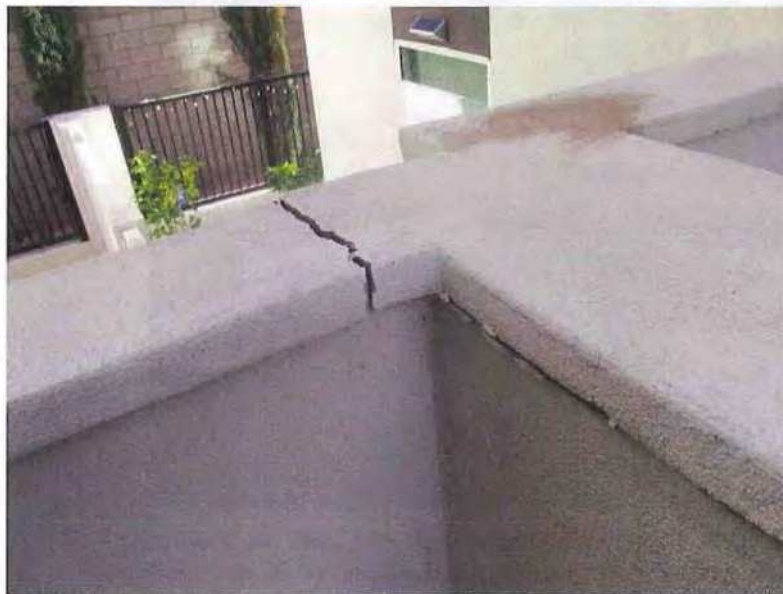
December 19, 2018, Disc OBS1, Photograph 47, JBF, east stairs between Buildings C and D, cracking and separation of stair wall indicative of differential movement.

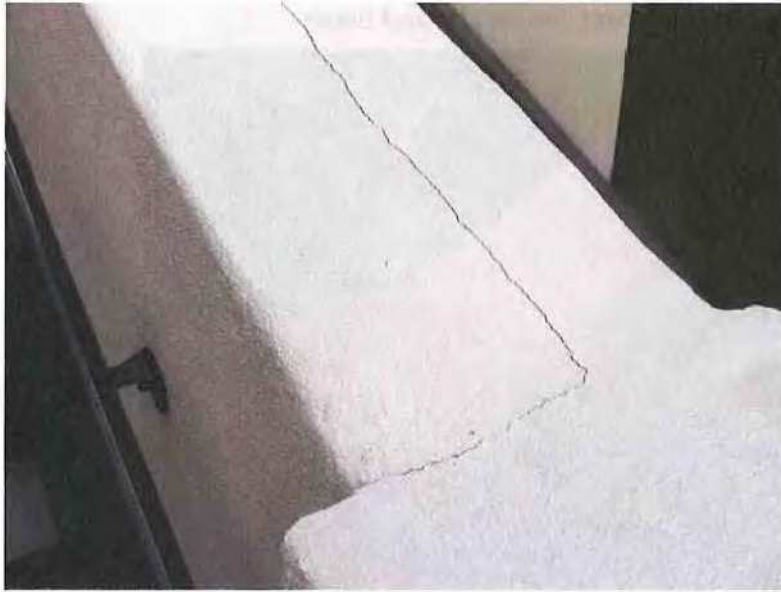
December 19, 2018, Disc OBS1, Photograph 132, JBF, west stairs between Buildings A and B, cracking and separation of stair wall.

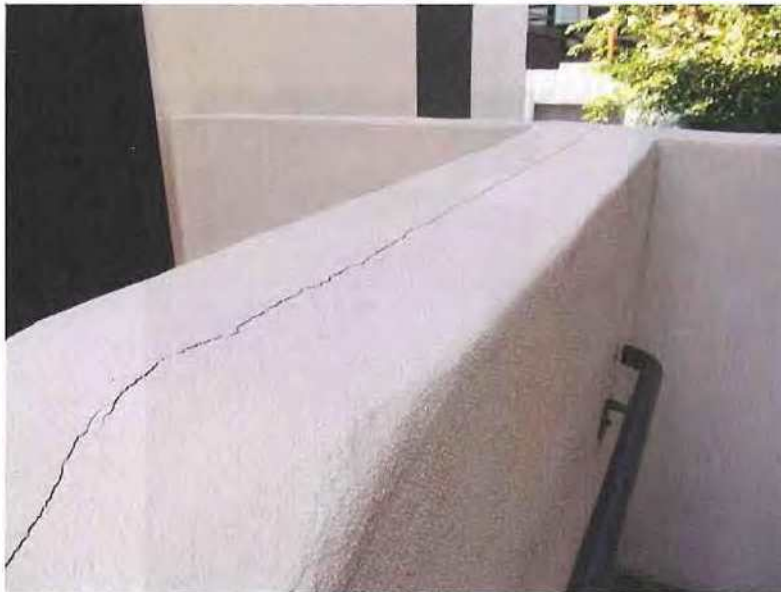
December 19, 2018, Disc OBS1, Photograph 134, JBF, west stairs between Buildings A and B, cracking and separation of stair wall indicative of differential movement.

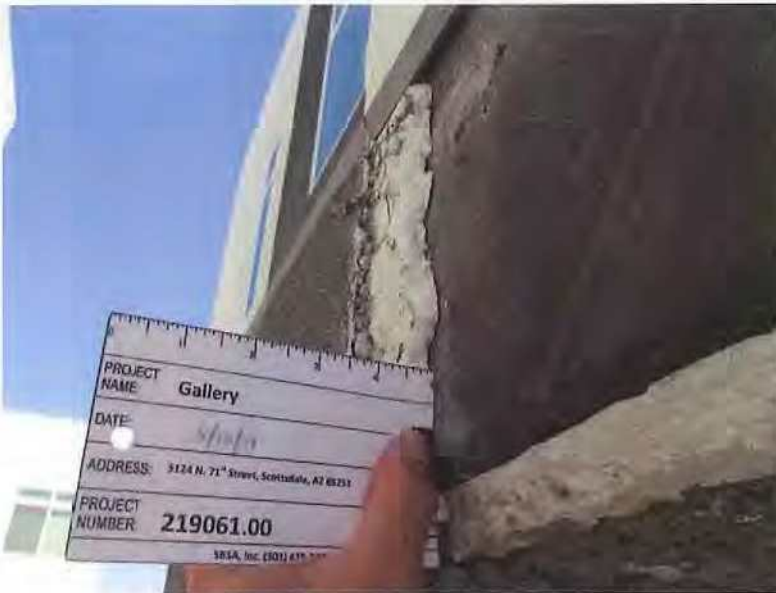
OR APPROVED EQUAL." SBSA code review is based on the Amerimix Fiber Base Coat Stucco system as referenced in ICC-ES Evaluation Report ESR-3529. Based on the preliminary intrusive testing performed, the stucco was generally 1/2-inch thick and was installed over 1-inch expanded polystyrene (EPS) insulation board where open framing was used and over 1/2-inch EPS insulation board where a solid substrate was present. One layer of GMCraft 10 Grade D building paper was present behind the EPS insulation regardless of the substrate:

May 13, 2019, Disc ITL, Photograph 127, JBF, north elevation of Building B – Unit 3116, 1/2-inch thick stucco over 1/2-inch EPS insulation over GMCraft 10 paper over solid wood framing at face and 1-inch EPS at bottom where open framing is present.

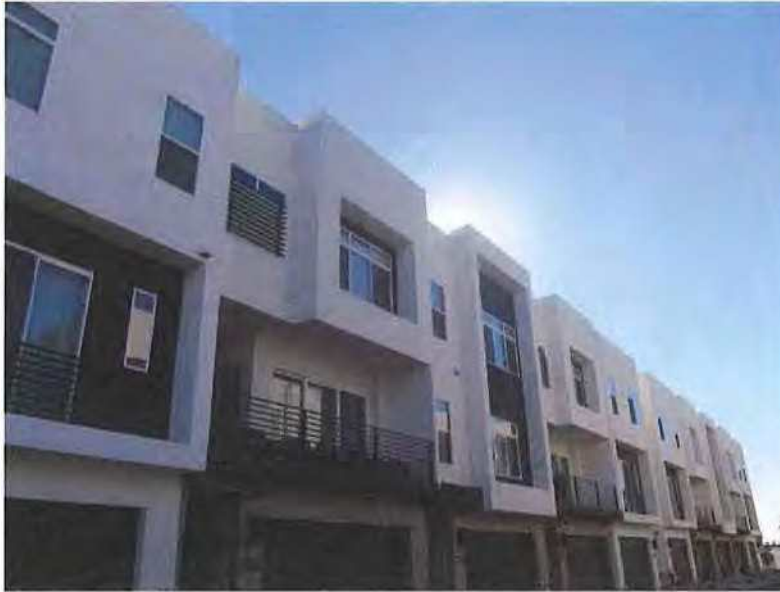
During curing, control joints aid in capturing hydration cracking. After the curing, the joints provide for movement provisions, which are particularly necessary with post-tension slab design for edge and center lift characteristics and their impact on the veneers.

December 19, 2018, Disc OBS1, Photograph 5, JBF, west elevation of Buildings C and D, no control/movement joints provided.

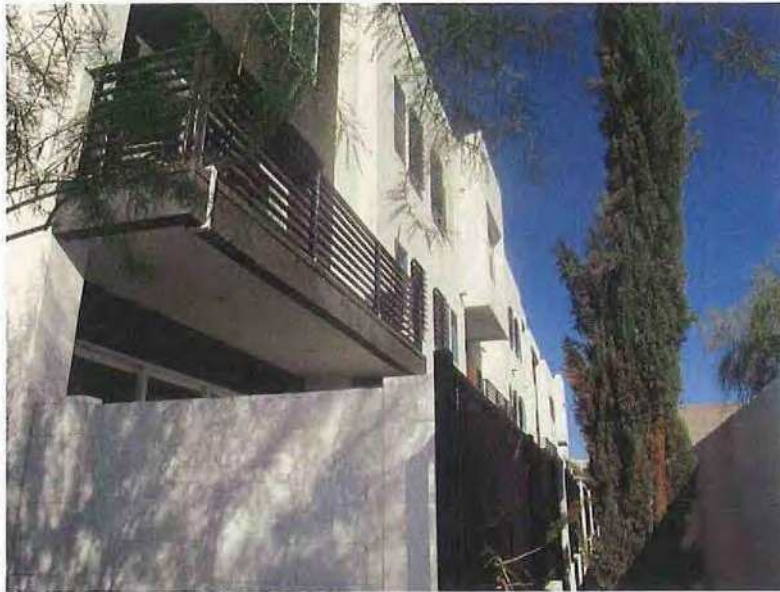
December 19, 2018, Disc OBS1, Photograph 13, JBF, east elevation of Buildings C and D, no control/movement joints provided.

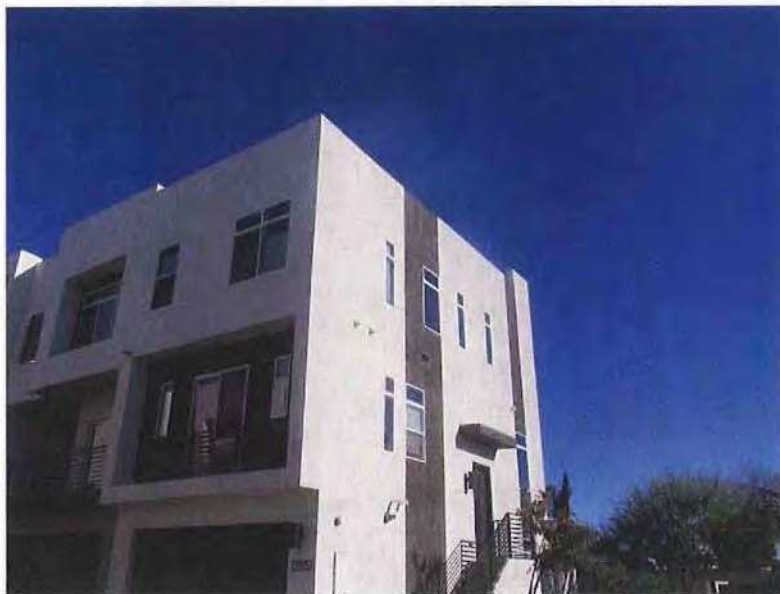
December 19, 2018, Disc OBS1, Photograph 5, JBF, south elevation of Building D, vertical control joint only provided at corners of windows. This was common of north and south elevations at all buildings.

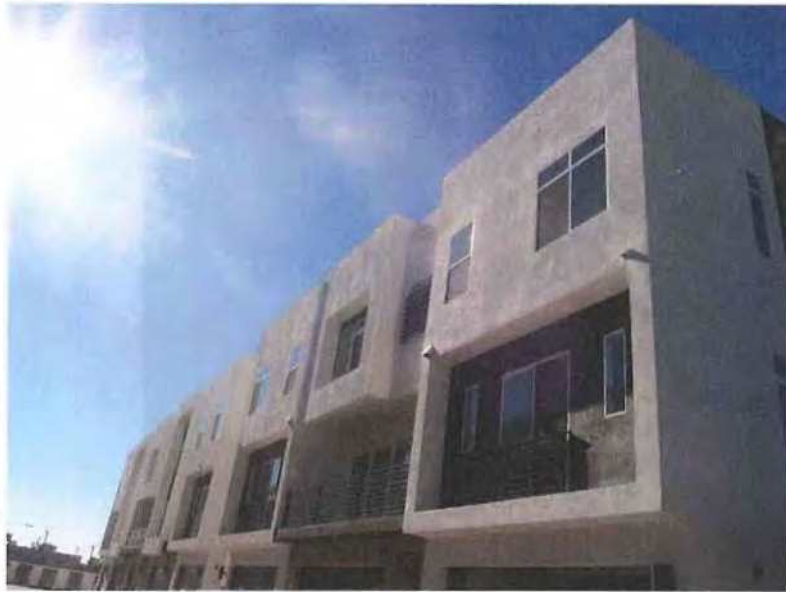
December 19, 2018, Disc OBS1, Photograph 110, JBF, east elevation of Buildings A and B, no control/movement joints provided.

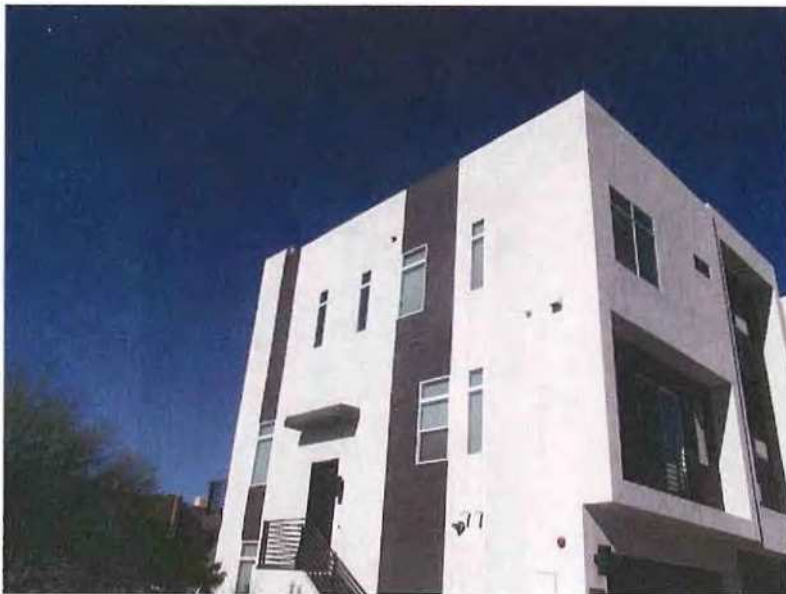
December 19, 2018, Disc OBS1, Photograph 115, JBF, east elevation of Buildings A and B, no control/movement joints provided.

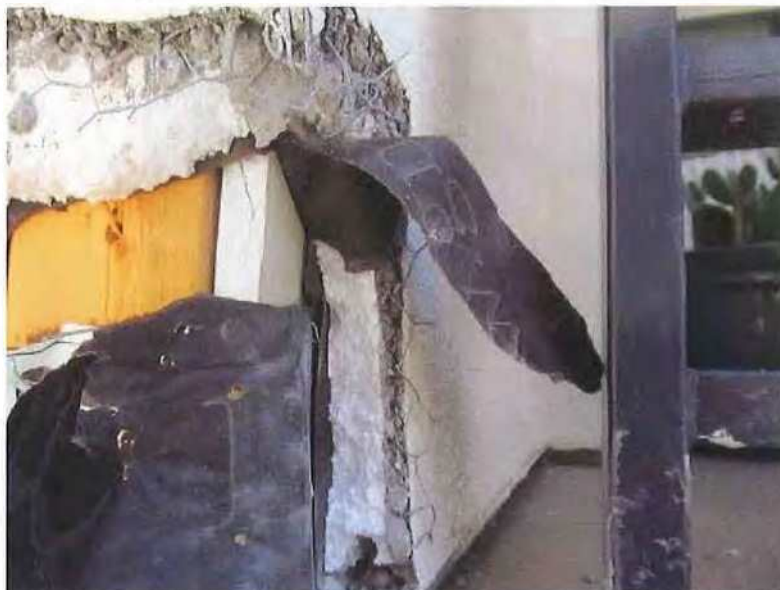
May 13, 2019, Disc IT1, Photograph 53, JBF, west elevation of Building D - Unit 3113, 1/2-inch thick EPS insulation installed over gypsum sheathing does not incorporate vertical grooves and was not installed over two layers of Grade D paper, Tyvek StuccoWrap, or Tyvek DrainWrap. Thus, it is non-compliant with ESR-3529.

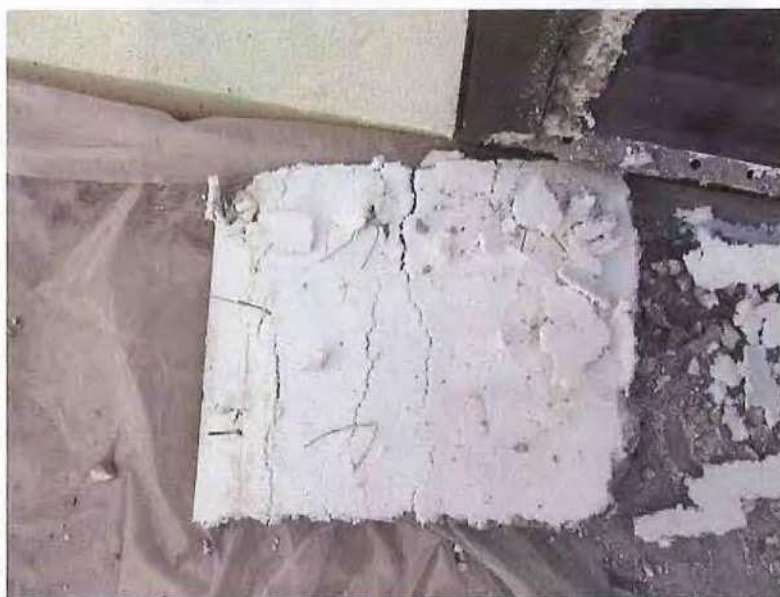
May 13, 2019, Disc IT1, Photograph 116, JBF, south elevation of Building B, 1/2-inch thick EPS insulation installed over OSB sheathing does not incorporate vertical grooves and was not installed over two layers of Grade D paper, Tyvek StuccoWrap, or Tyvek DrainWrap. Thus, it is non-compliant with ESR-3529.

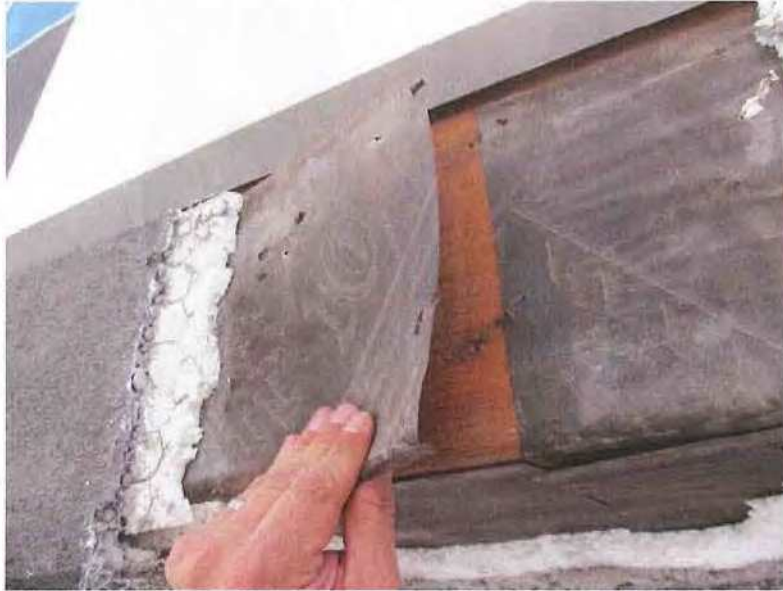
May 13, 2019, Disc IT1, Photograph 128, JBF, north elevation of Building B - Unit 3116, one layer of GMCraft 10 paper does not provide minimum water-resistance rating of 60-minutes in accordance with ESR-3529.

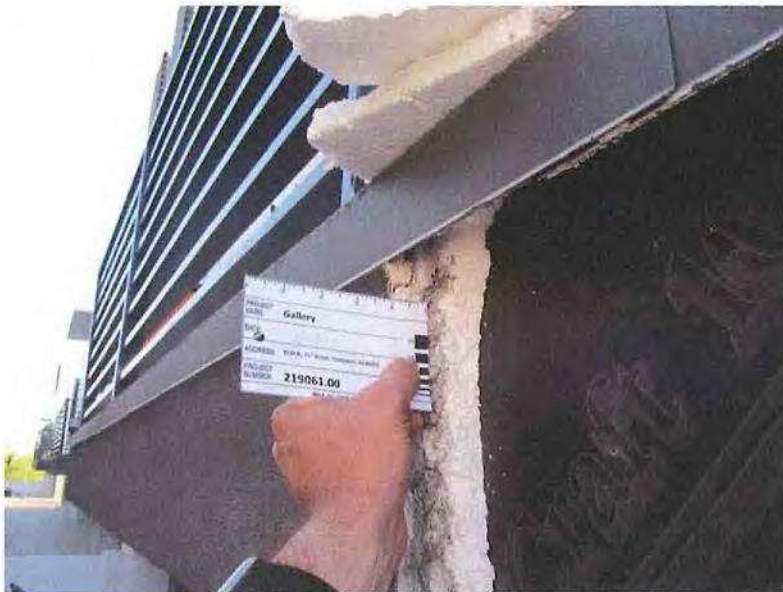
May 13, 2019, Disc IT1, Photograph 176, JBF, east elevation of Building C - Unit 3127, one layer of GMCraft 10 paper does not provide minimum water-resistance rating of 60-minutes in accordance with ESR-3529.

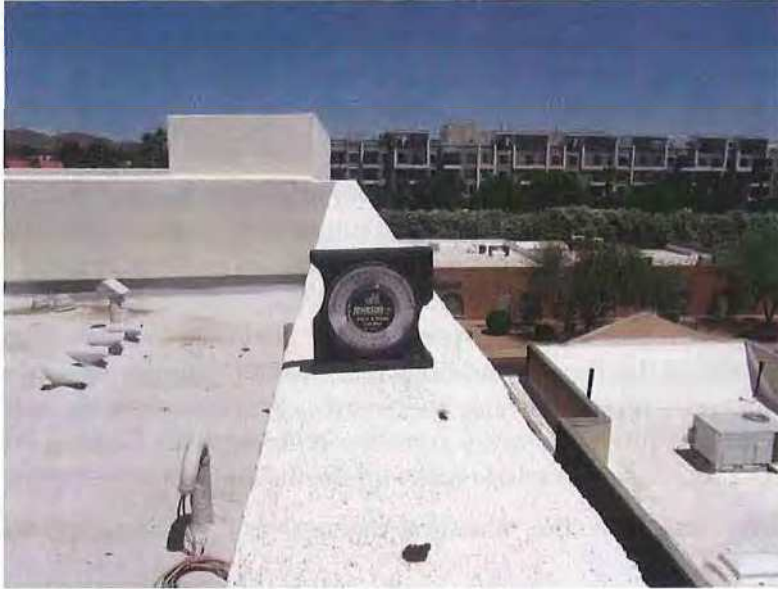
May 13, 2019, Disc IT1, Photograph 33, JBF, Building C - Unit 3125, stucco does not slope at parapet cap.

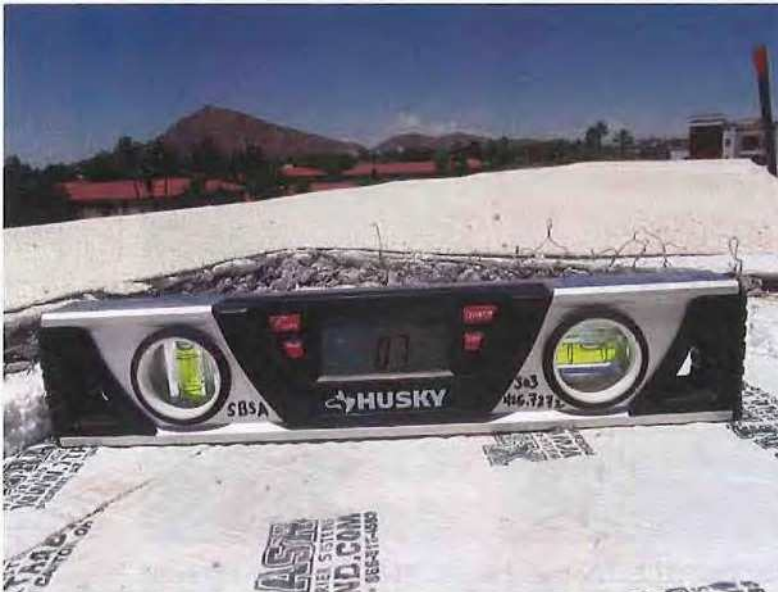
May 13, 2019, Disc IT1, Photograph 98, JBF, Building C - Unit 3125, stucco does not slope at parapet cap.

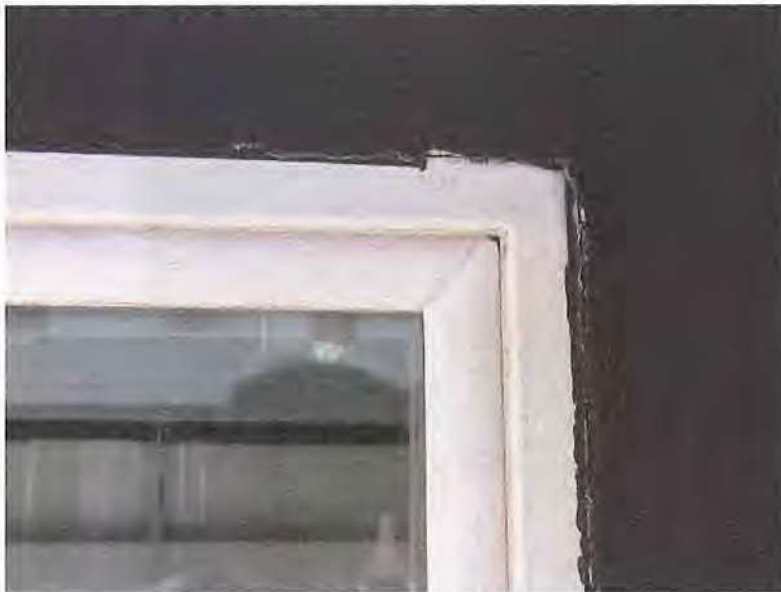
May 13, 2019, Disc IT2, Photograph 33, ELF, west elevation of Building D - Unit 3115, no expansion joints provided between stucco and window. Cracking is present at this interface.

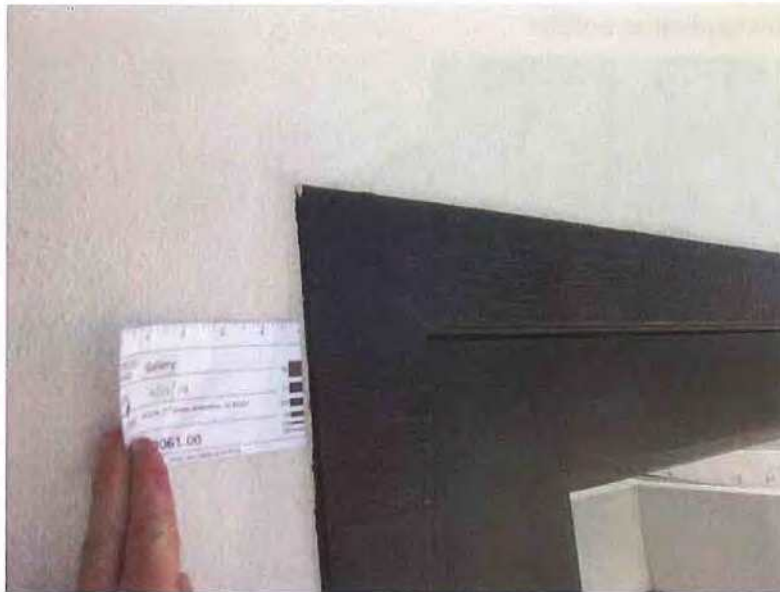
May 13, 2019, Disc IT2, Photograph 50, ELF, Building A - Unit 3122, no expansion joints provided between stucco and wood trim.

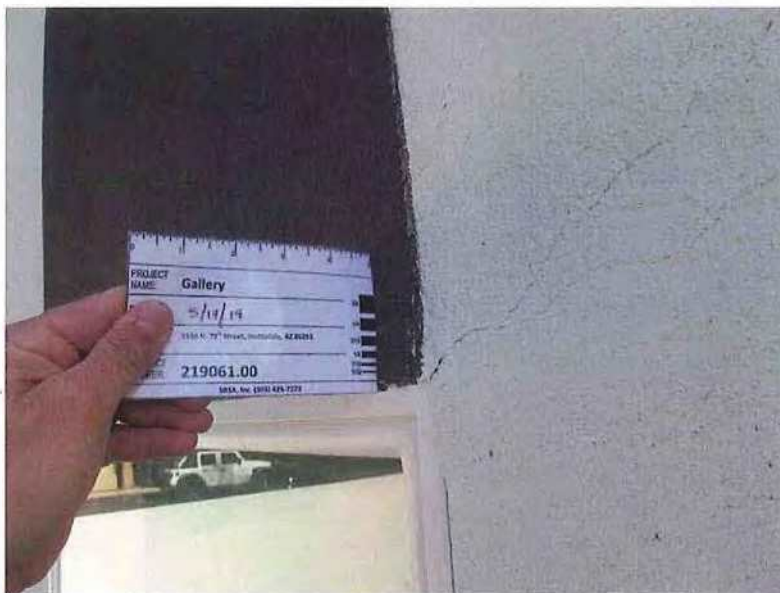
May 14, 2019, Disc IT3, Photograph 12, JBF, south elevation of Building B - Unit 3104, no expansion joints provided between stucco and window. A diagonal stucco crack is present at this location.

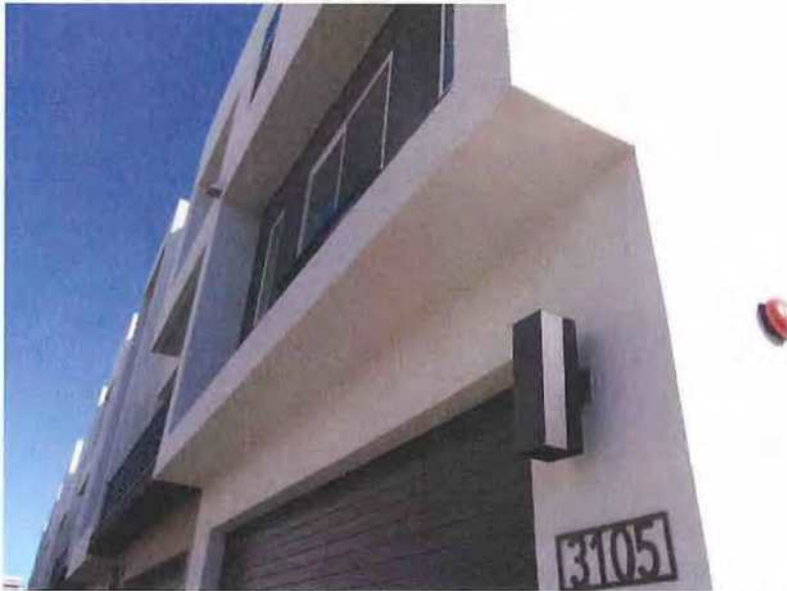
December 19, 2018, Disc OBS1, Photograph 18, JBF, west elevation of Building D - Unit 3105, no weep mechanism at base of stucco at soffit.

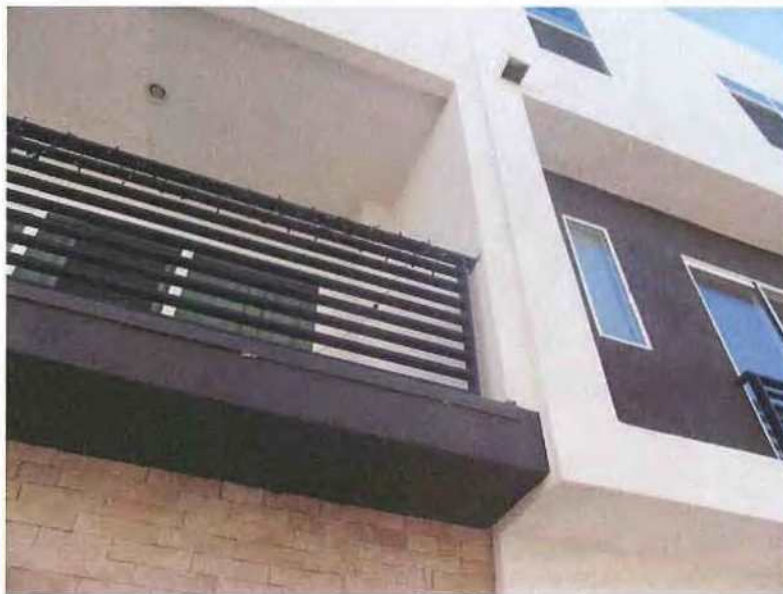
December 19, 2018, Disc OBS1, Photograph 24, JBF, west elevation of Building D - Units 3111 & 3113, no weep mechanism at base of stucco at soffits.

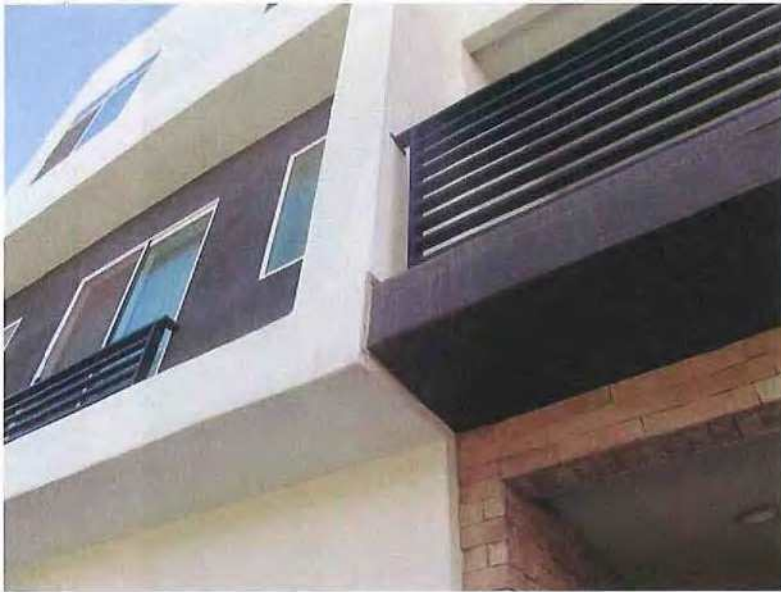
December 19, 2018, Disc OBS1, Photograph 61, JBF, west elevation of Building C - Units 3125 & 3127, no weep mechanism at base of stucco at soffits.

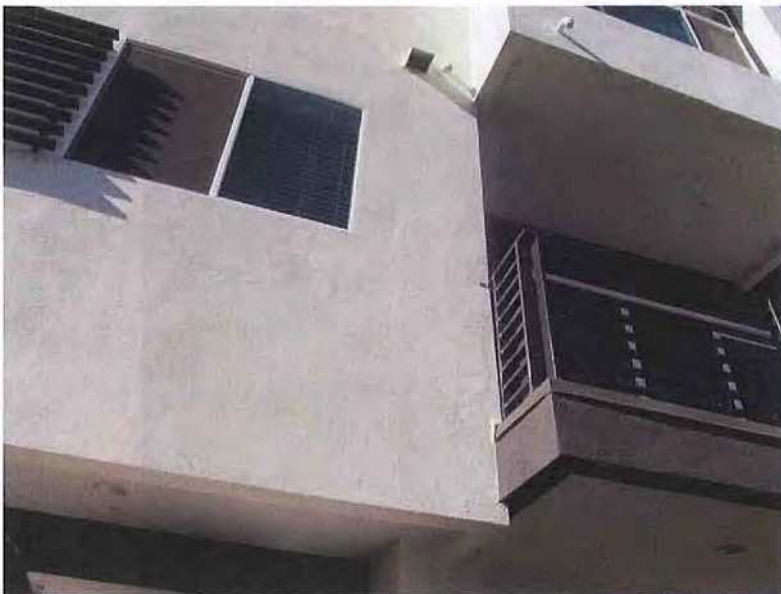
December 19, 2018, Disc OBS1, Photograph 82, JBF, east elevation of Building D - Units 3109 & 3111, no weep mechanism at base of stucco at soffits.

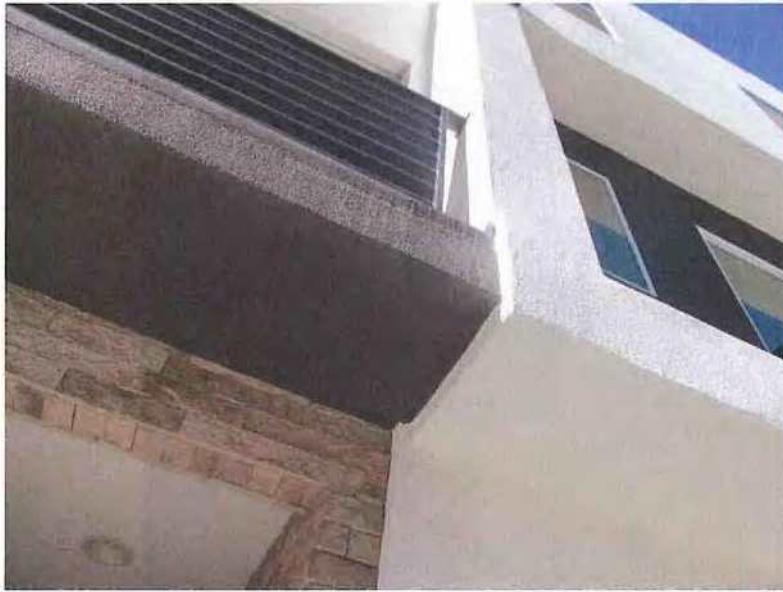
December 19, 2018, Disc OBS1, Photograph 129, JBF, east elevation of Building A - Units 3122 & 3124, no weep mechanism at base of stucco at soffits.

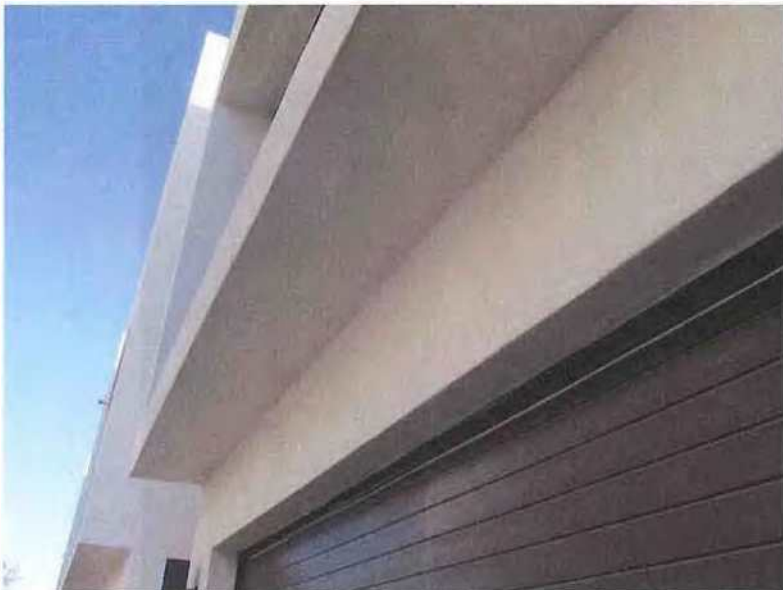
December 19, 2018, Disc OBS1, Photograph 40, JBF, west elevation of Building D - Unit 3115, no flashing or weep mechanism provided at top of garage door opening

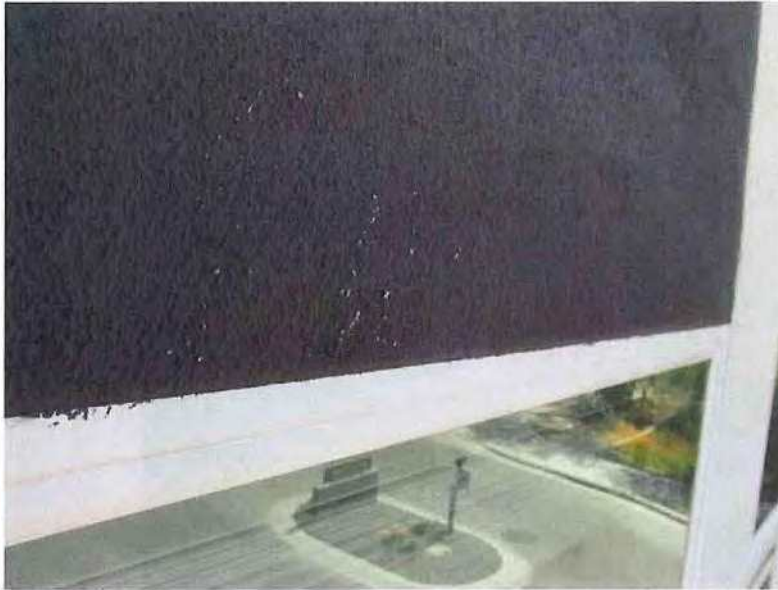
May 13, 2019, Disc IT1, Photograph 142, JBF, north elevation of Building C - Unit 3127, no sheet metal flashing at head of window opening.

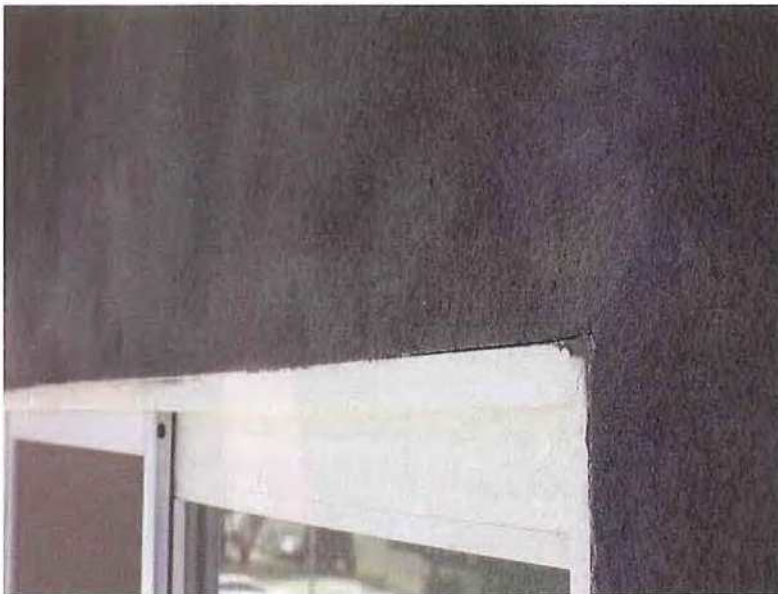
May 13, 2019, Disc IT2, Photograph 34, ELF, west elevation of Building D - Unit 3115, no sheet metal flashing at head of window opening.

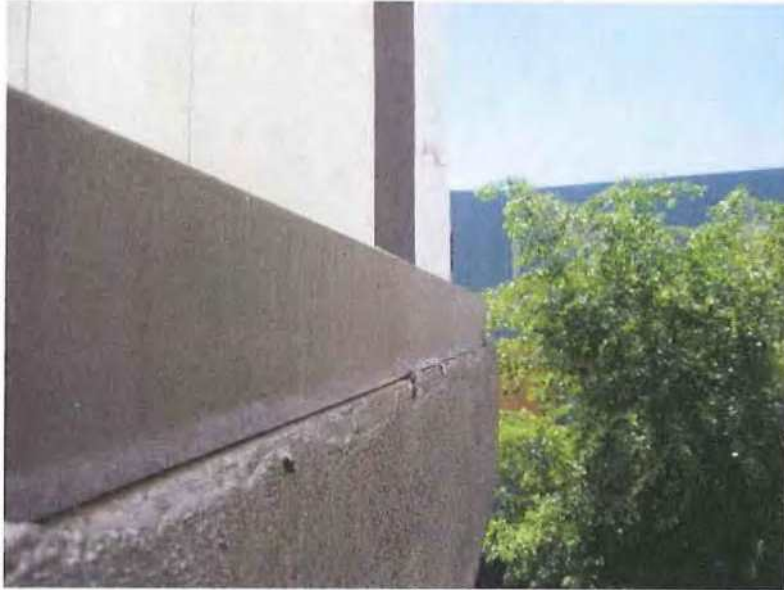
May 13, 2019, Disc IT1, Photograph 110, JBF, north elevation of Building B - Unit 3116, metal flashing at leading edge of roof is inset from stucco.

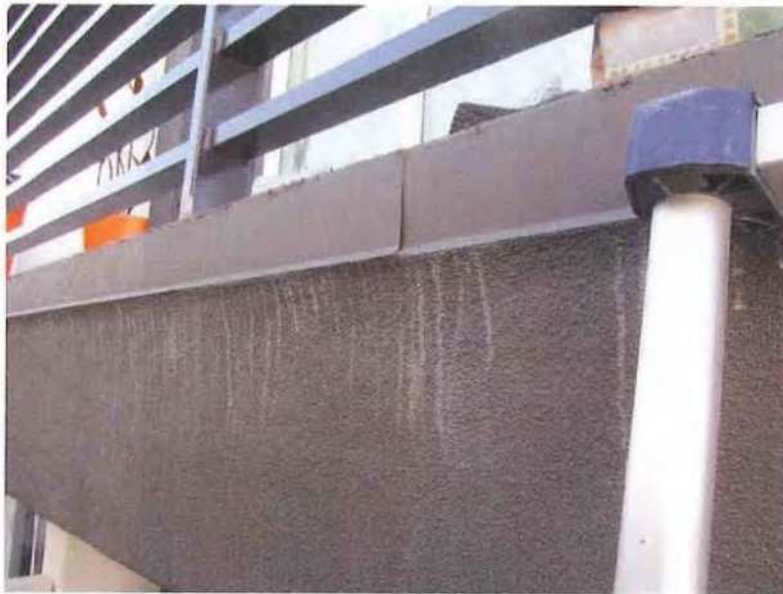
May 13, 2019, Disc IT1, Photograph 145, JBF, east elevation of Building C - Unit 3127, metal flashing at leading edge of balcony is inset from stucco. Stucco built up beyond flashing at this location.

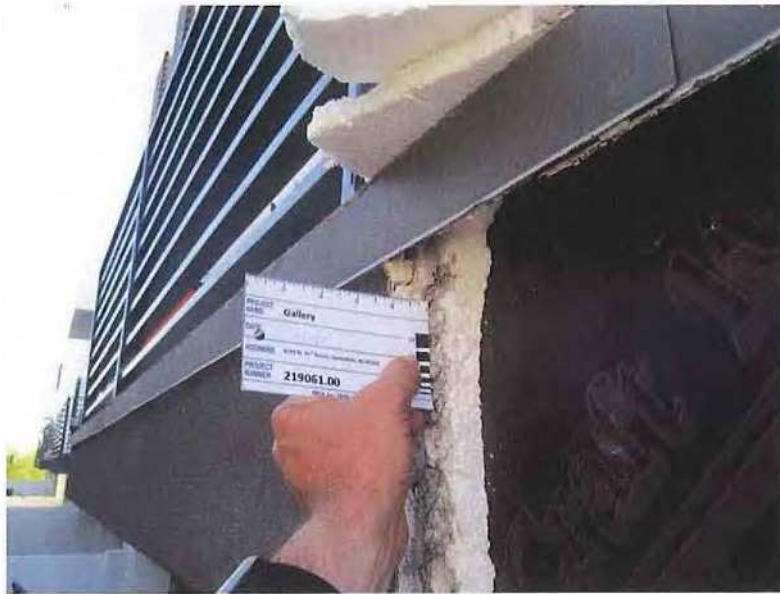
May 13, 2019, Disc IT1, Photograph 176, JBF, east elevation of Building C - Unit 3127, metal flashing at leading edge of balcony is inset from stucco. Stucco built up to approximately 1-inch thick beyond flashing at this location.

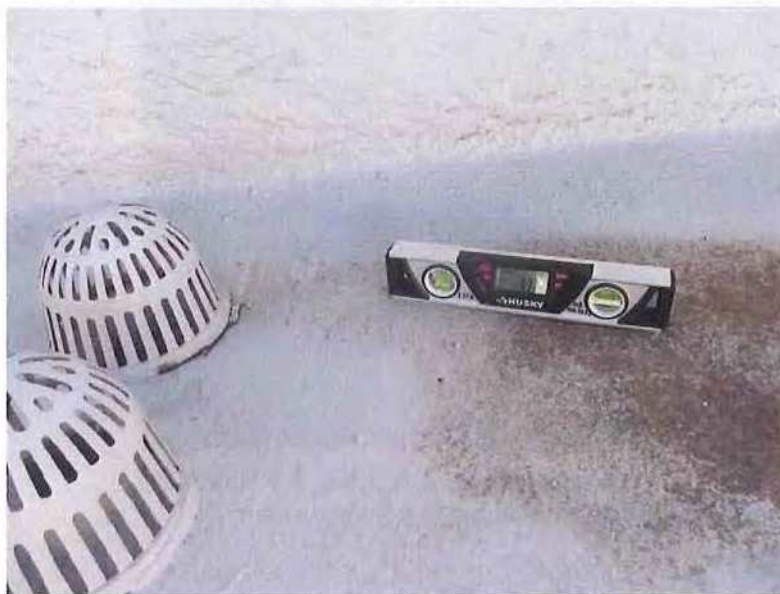
December 19, 2018, Disc OBS1, Photograph 176, JBF, Building A - Unit 3124, roof slope measured to be 1.7-percent away from drain and evidence of water ponding is present.
