Title of Action: Gallery Condominium Association vs. K. Hovnanian at Gallery, LLC

We represent the Gallery Condominium Association ("Association") regarding the defective original construction of The Gallery condominium project located in Scottsdale, Arizona. The purpose of this letter is to provide you with formal notice of the defective work and the Association's claim pursuant to the Homeowners' Association Dwelling Actions (A.R.S. § 33-2002, et seq.), the Purchaser Dwelling Act (A.R.S. § 12-1361, et seq.), and the Association's governing documents.

The Association has retained a forensic expert, SBSA, Inc. ("SBSA") to investigate the defective construction of the common elements at The Gallery. The following defects and deficiencies in the common elements at The Gallery have been identified by SBSA:

These defective conditions are described in detail in the attached Notice of Claim Summary report dated July 2, 2019¹. The SBSA report includes photographs of the defective conditions, which were observed project-wide. The defects impair the structural integrity, functionality or appearance of the dwelling and will continue to do so in the future if not repaired or replaced.

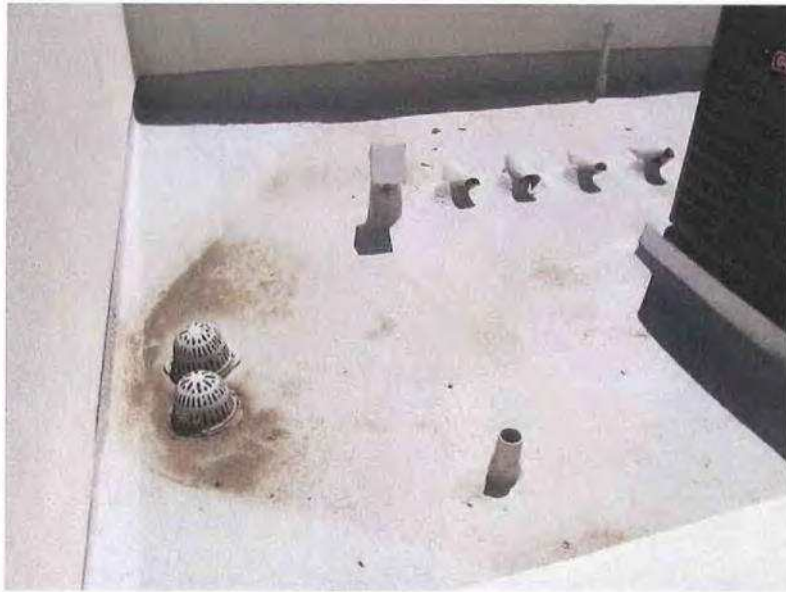
May 13, 2019, Disc IT1, Photograph 29, JBF, Building C - Unit 3125, insufficient slope of roof at drain resulting in ponding water.

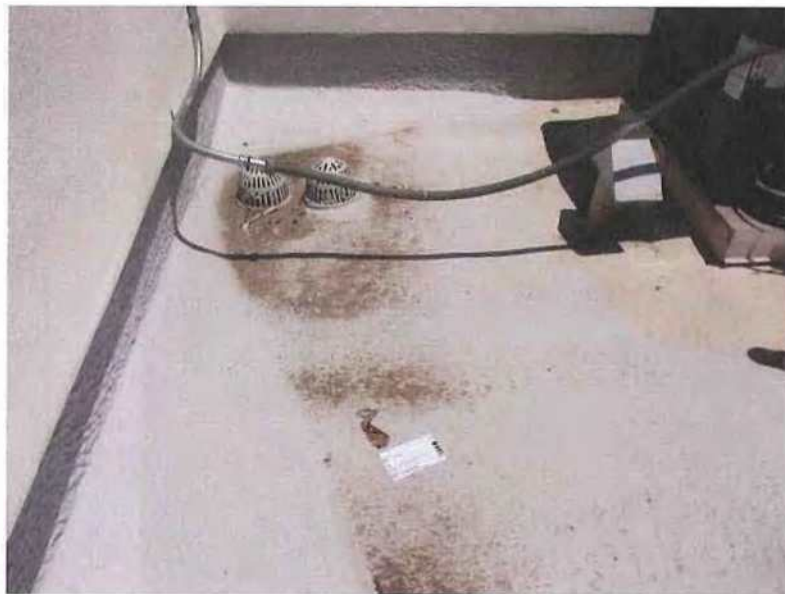
May 13, 2019, Disc IT2, Photograph 79, ELF, Building A - Unit 3122, insufficient slope of roof at drain resulting in ponding water.

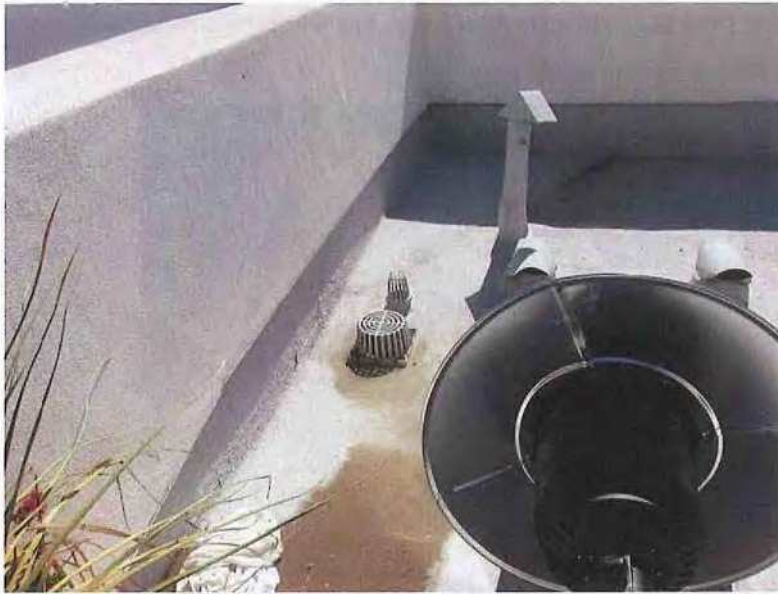
May 14, 2019, Disc IT4, Photograph 58, ELF, Building D - Unit 3113, insufficient slope of roof at drain resulting in ponding water.

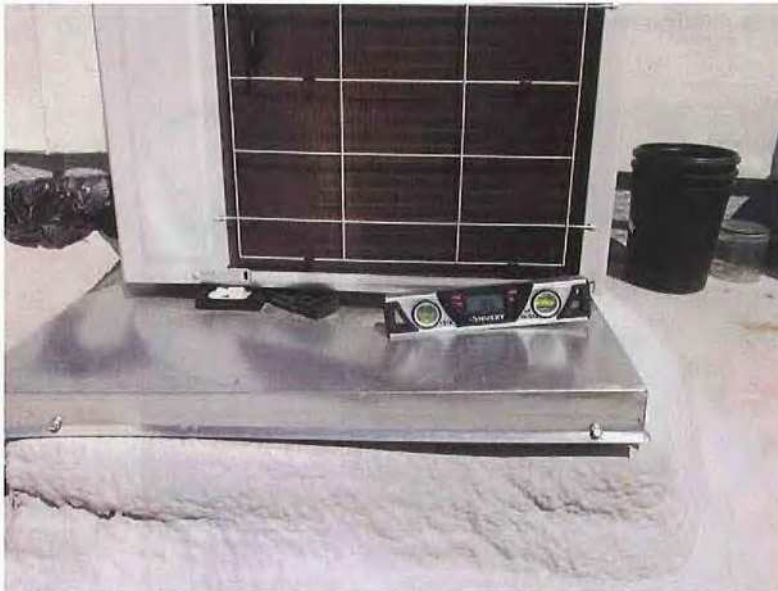
May 13, 2019, Disc IT2, Photograph 146, ELF, Building B - Unit 3110, roof built-up and flashing provided to accommodate additional air conditioner after original construction. Surface is uneven and inadequate for support of air conditioner unit.

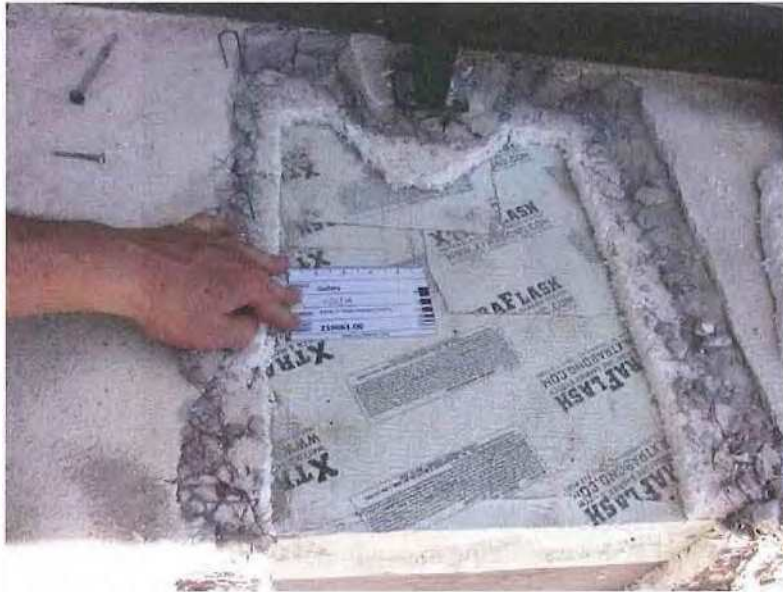
May 13, 2019, Disc IT2, Photograph 21, ELF, west elevation of Building D – Unit 3115, XtraFlash membrane under stucco. Stain through holes in membrane.

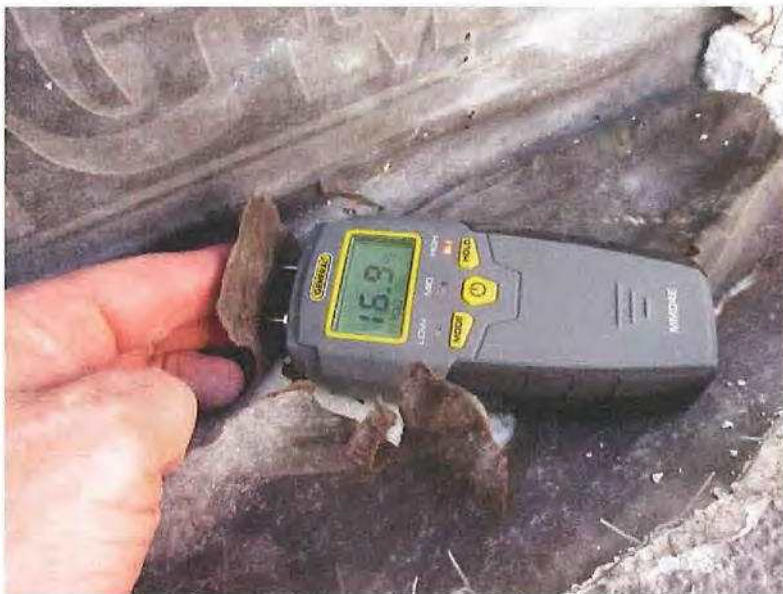
May 14, 2019, Disc IT4, Photograph 13, ELF, west elevation of Building C – Unit 3123, high moisture content in building paper below stucco over self-adhered membrane.

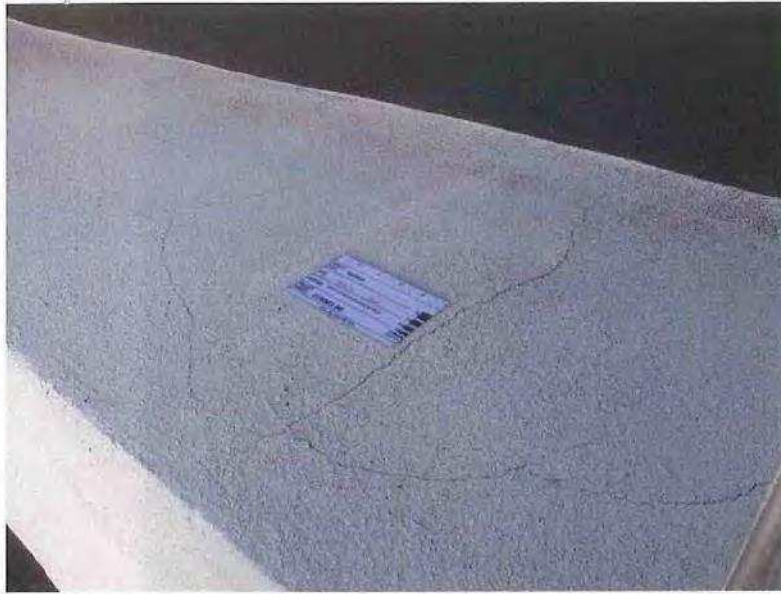
May 14, 2019, Disc IT4, Photograph 26, ELF, west elevation of Building C - Unit 3125, cracking of stucco on window shelf indicative of water entrapment.

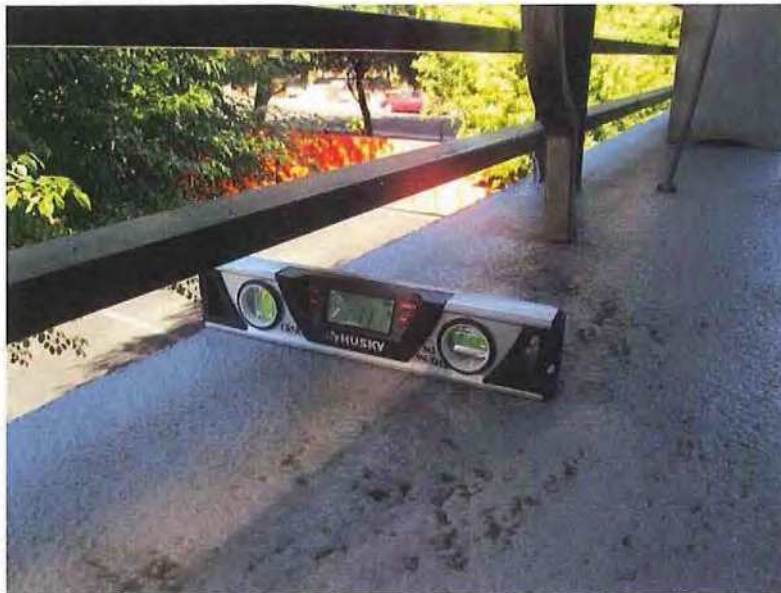
December 19, 2018, Disc OBS1, Photograph 163, JBF, Building A - Unit 3124, balcony slope measured to be 1.1-percent away from leading edge and evidence of water ponding is present.

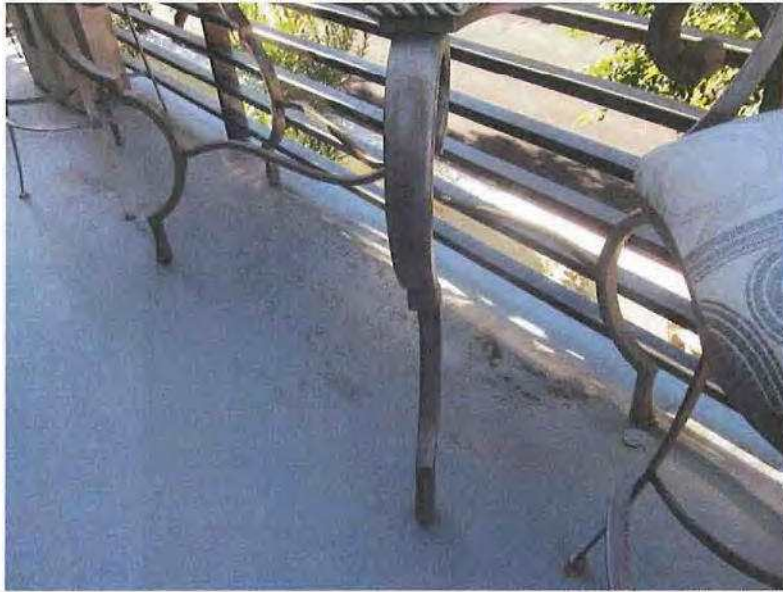
December 19, 2018, Disc OBS1, Photograph 167, JBF, Building A - Unit 3124, evidence of water ponding is present at leading edge of balcony.
