Exhibit A

Project Number: 219061.00 (030)
Project Name: Gallery
Location: 3104-3127 North 71st Street
Scottsdale, Arizona 85251

Subject: Construction and Design Compliance Report

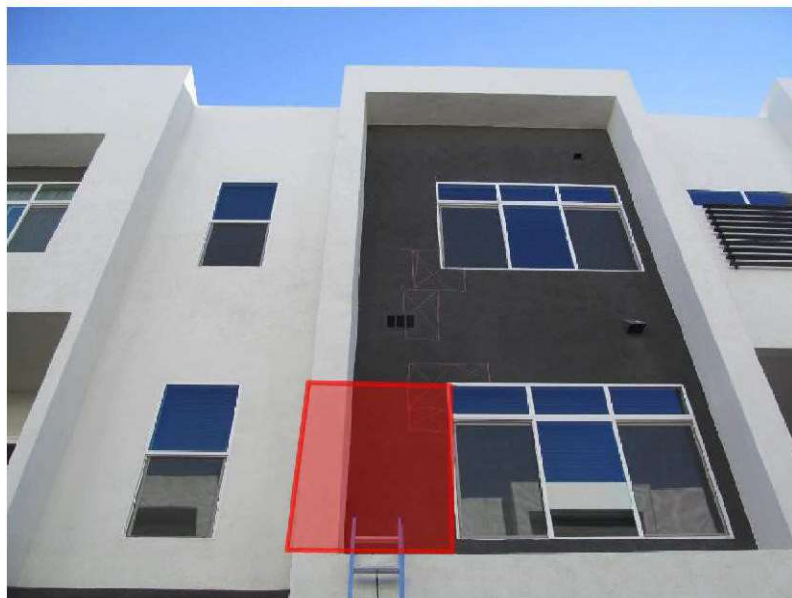
As constructed, the cladding was installed over open stud framing without the required exterior sheathing at the second floor level between the triple panel slider window in the great room and the pop-out wall. Fasteners in the CS16 strap connecting the exterior sheathing below the triple panel window were missing and the steel strap had buckled. The buckled steel strap and the missing exterior wood sheathing failed to comply with the braced/shear wall plan specified on the structural drawings. The non-compliant condition more likely than not reduces the structural integrity of the LFRS, as intended by the Structural Engineer of Record (EOR) and requires repairs.

March 10, 2021, Disc IT8, Photograph 41, SSR, Building D – Unit 3111, overall view of building elevation with non-compliant LFRS. Red box outlines the approximate area within which the exterior sheathing was identified to be missing.

- Where exterior sheathing is identified as missing, install new 3/8-inch minimum-rated sheathing using specified nails spaced to provide minimum shear resistance of 306-plf per the braced/ shear wall schedule.

- Where existing strap is identified as installed incorrectly, remove and replace with new strap per the holddown schedule. Install according to the manufacturer's installation requirements.

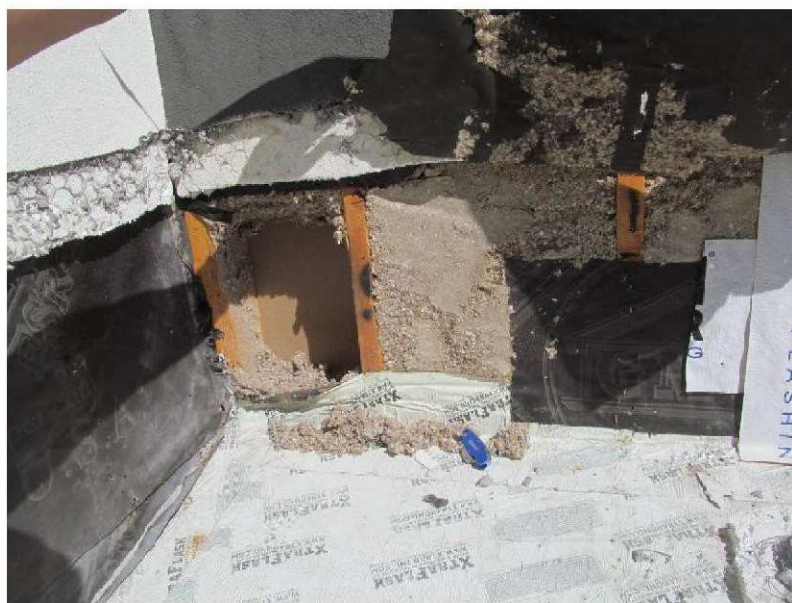
March 10, 2021, Disc IT8, Photograph 237, SSR, Building D – Unit 3111, missing OSB sheathing at existing stud framing.

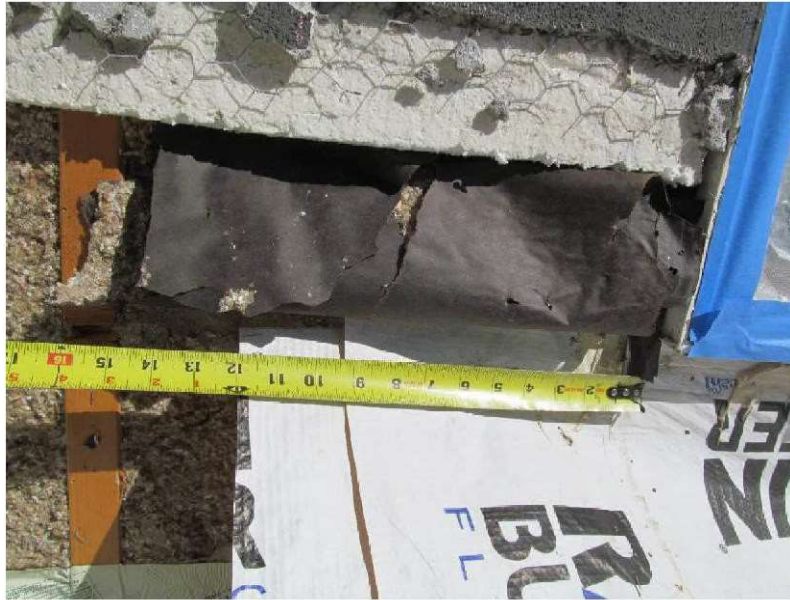
March 10, 2021, Disc IT8, Photograph 248, SSR, Building D - Unit 3111, missing OSB sheathing at existing stud framing.

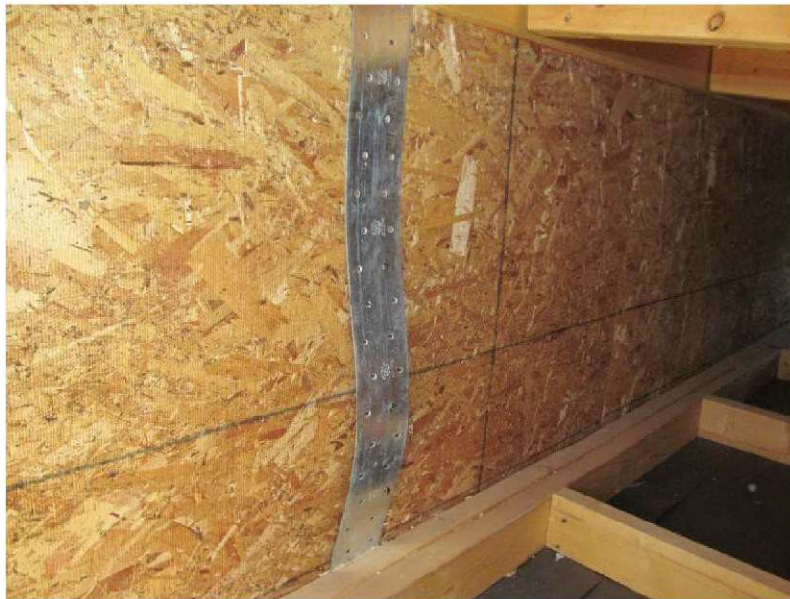
March 10, 2021, Disc IT8, Photograph 278, SSR, Building D - Unit 3111, CS-16 metal strap is disengaged and buckled.

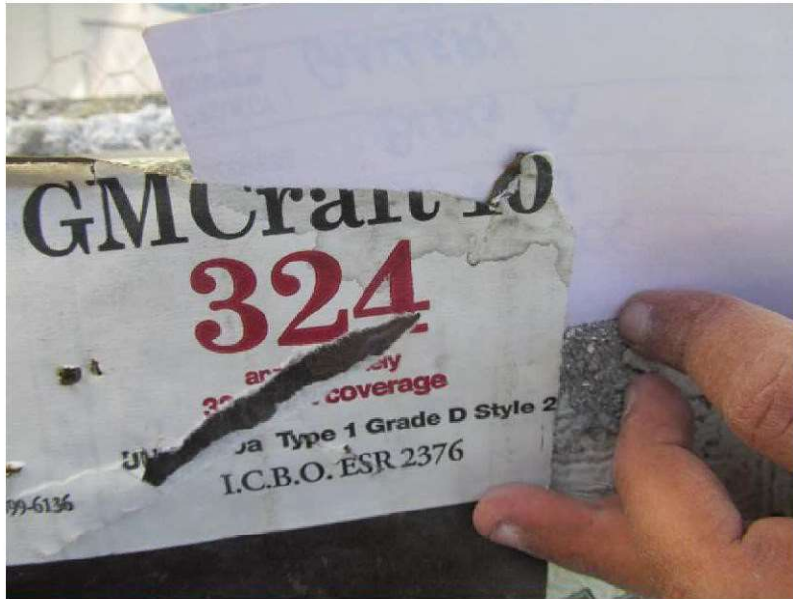
March 9, 2021, Disc IT6, Photograph 314, SSR, Building A, one layer of WRB with 10-minute water resistance. Label references ESR 2376.

- Repair contractor to estimate using between two layers of Grade D kraft building paper or one layer of Grade D kraft paper with minimum water-resistance rating of 60-minutes or using Tyvek products such as StuccoWrap or DrainWrap as specified in Section 3.2.4 and Section 3.2.10 of ESR-3529.

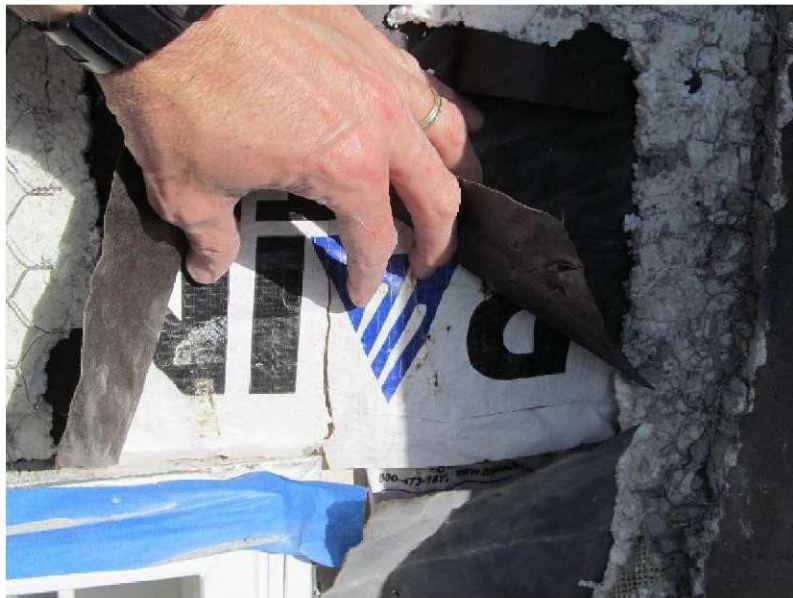
March 9, 2021, Disc IT5, Photograph 178, JIF, Building B, one layer of WRB over sheathing.

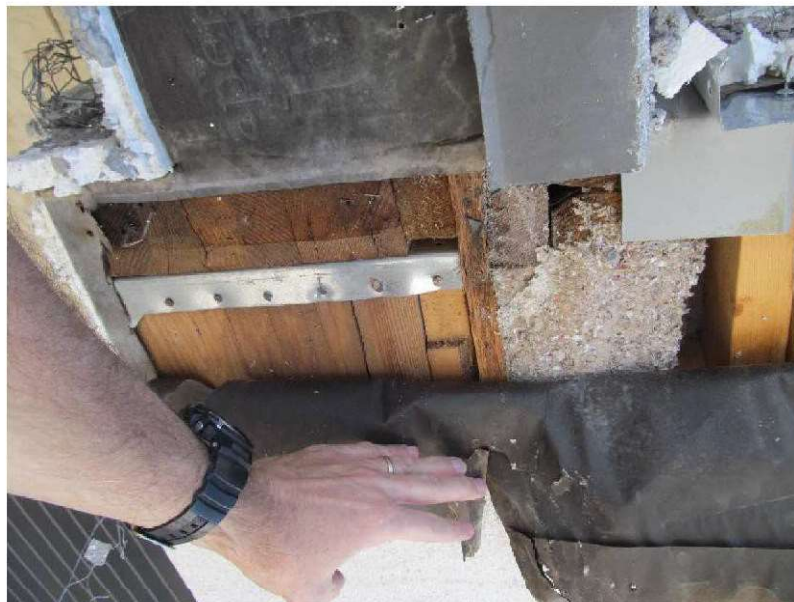
March 9, 2021, Disc IT5, Photograph 72, JFF, Building B, one layer of WRB over framing.

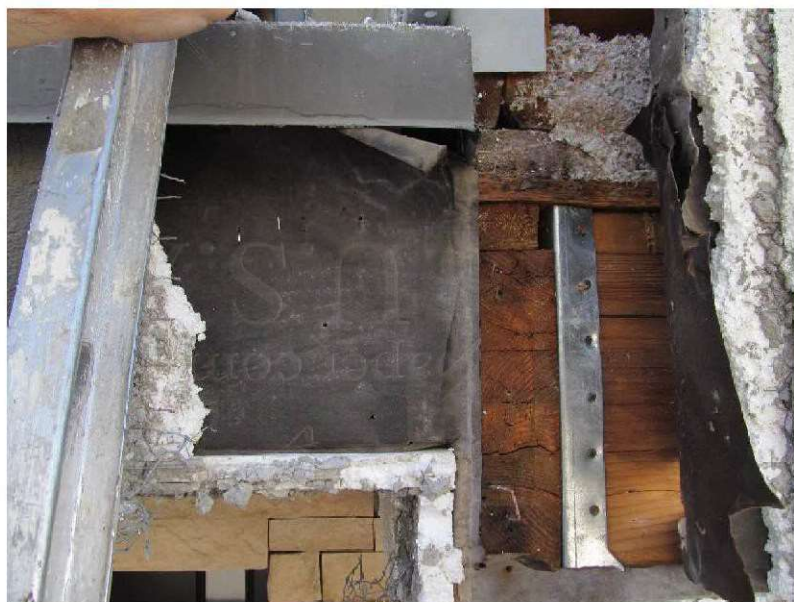
Haphazardly installed and closely spaced staple and fastener holes facilitate the water intrusion, causing damage and increasing future additional damage. Full-length rusted fasteners and stains on framing indicate damage due to water intrusion where the non-compliant WRB was installed behind stucco. Failure of the moisture-management system along with the combination of other construction defects as discussed in this report will continue to direct water onto moisture-sensitive building components.

March 9, 2021, Disc IT5, Photograph 75, JFF, Building B, damaged framing due to water intrusion.

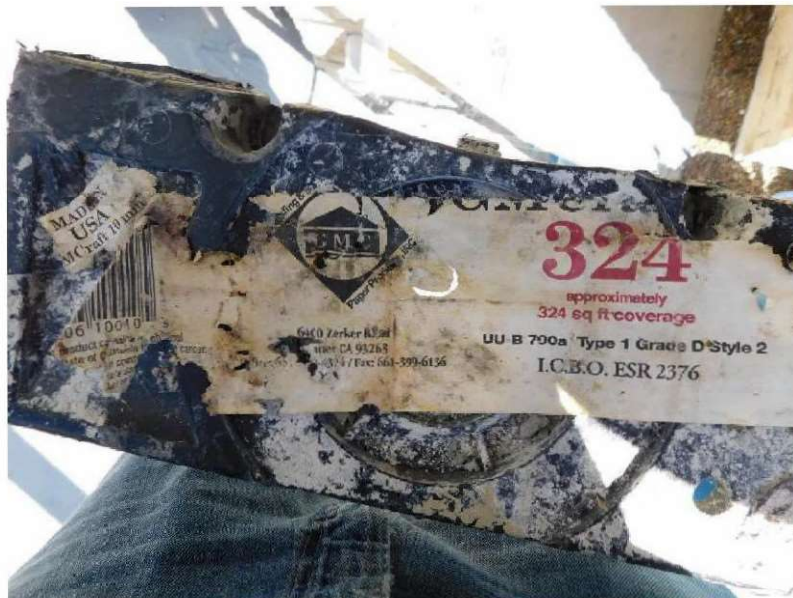
March 10, 2021, Disc IT9, Photograph 124, SSR, Building C, manufacturer's label shows the building paper is Type 1, Grade D, Style 2 building paper with 10-minute water resistance and references ESR 2376.

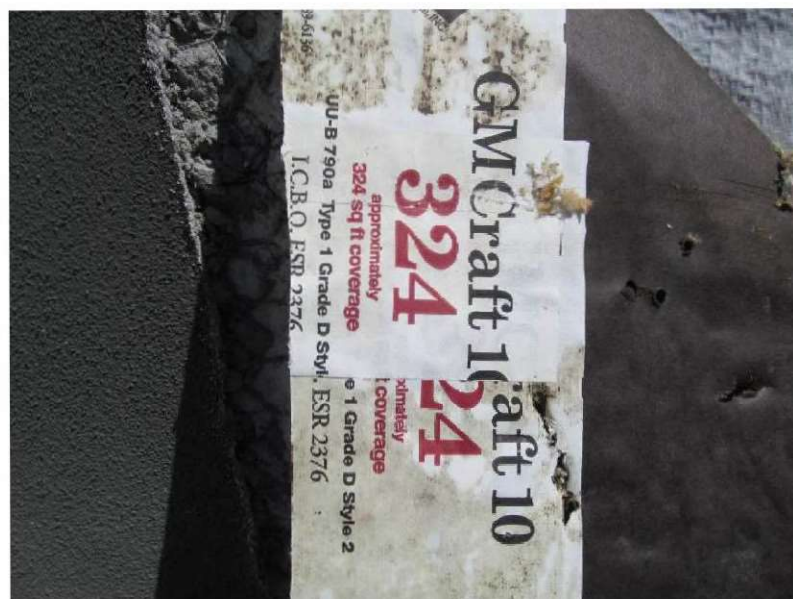
March 10, 2021, Disc IT8, Photograph 216, SSR, Building D, manufacturer's label shows the building paper is Type 1, Grade D, Style 2 building paper with 10-minute water resistance and references ESR 2376.

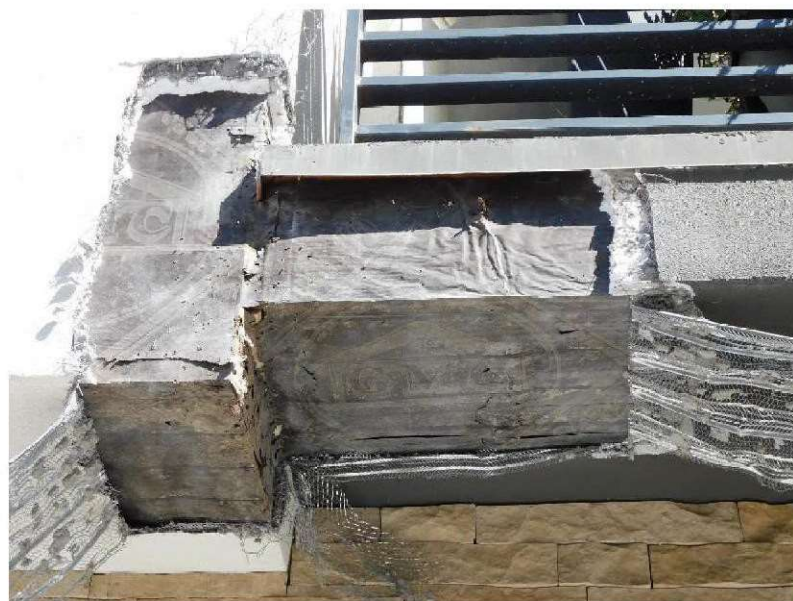
March 10, 2021, Disc IT8, Photograph 101, PER, Building C, deteriorated WRB over framing.

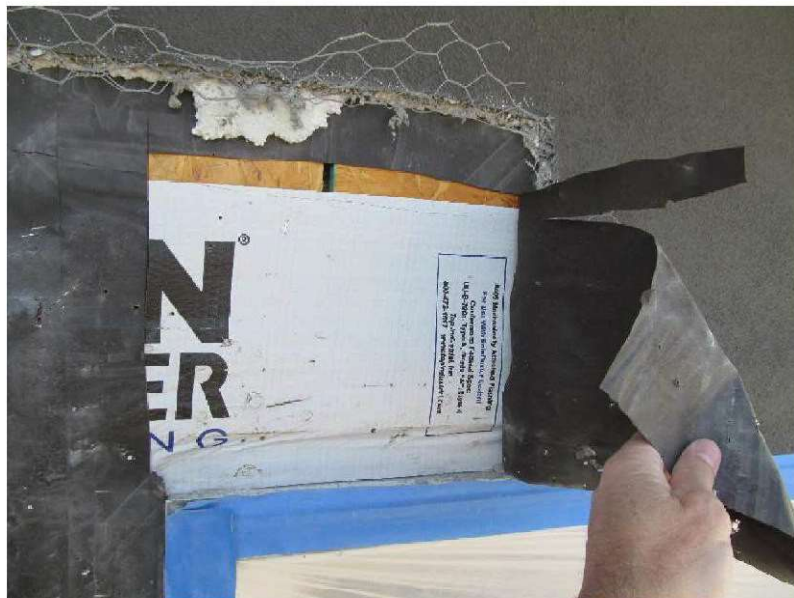
March 10, 2021, Disc IT7, Photograph 136, JJF, Building D, one layer of WRB over sheathing.

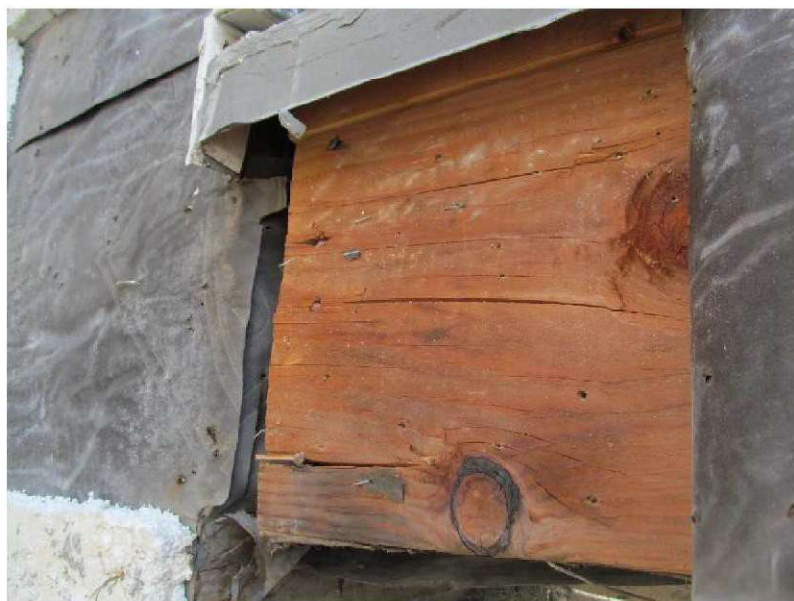
March 10, 2021, Disc IT8, Photograph 114, SSR, Building D, one layer of WRB over framing with visible stains.

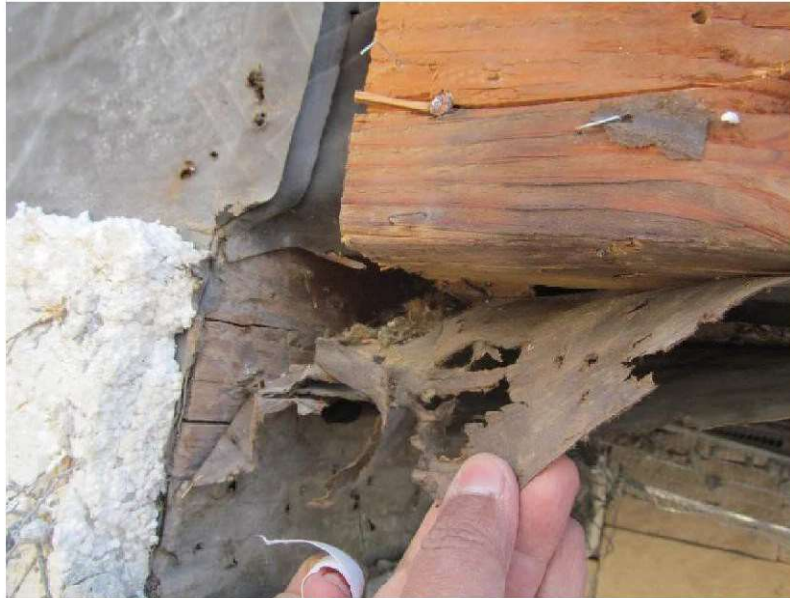
March 10, 2021, Disc IT8, Photograph 120, SSR, Building D, deteriorated WRB over framing with visible stains.

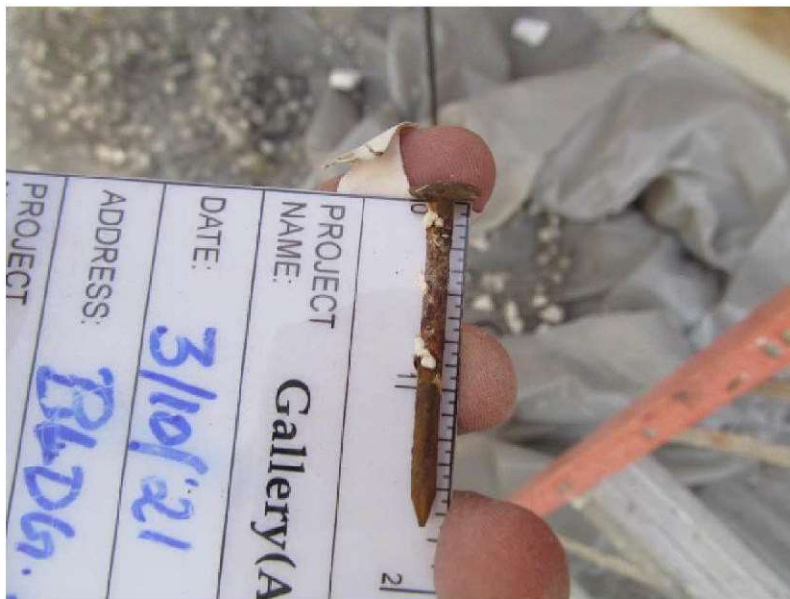
March 10, 2021, Disc IT8, Photograph 172, SSR, Building D, full-depth rusted fasteners.

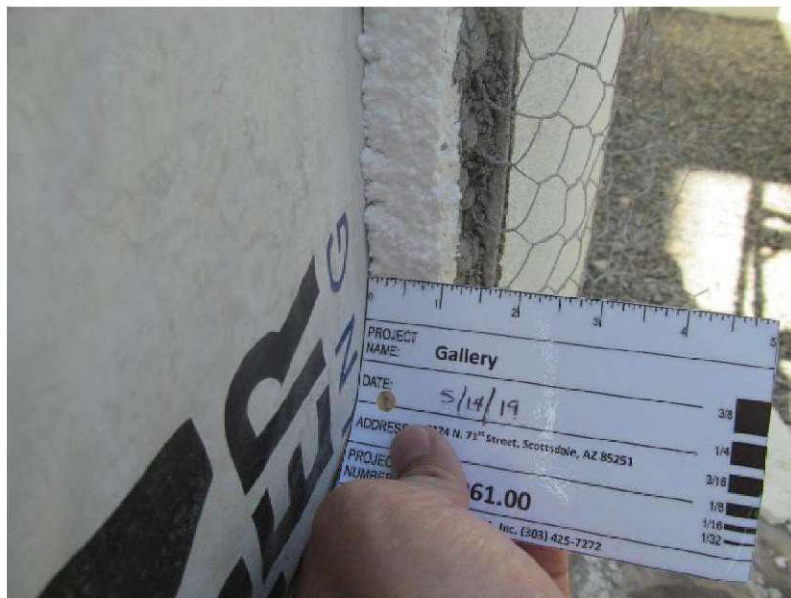
May 14, 2019, Disc IT3, Photograph 18, JBF, Building A, EPS foam board installed tight to WRB and vertical grooves generally missing at the inner face.

- As an alternative to EPS foam boards with vertical grooves, flat-faced EPS foam boards may be installed over the solid substrates provided the WRB recommended in Section 3.2.4 of ESR-3529 is used.

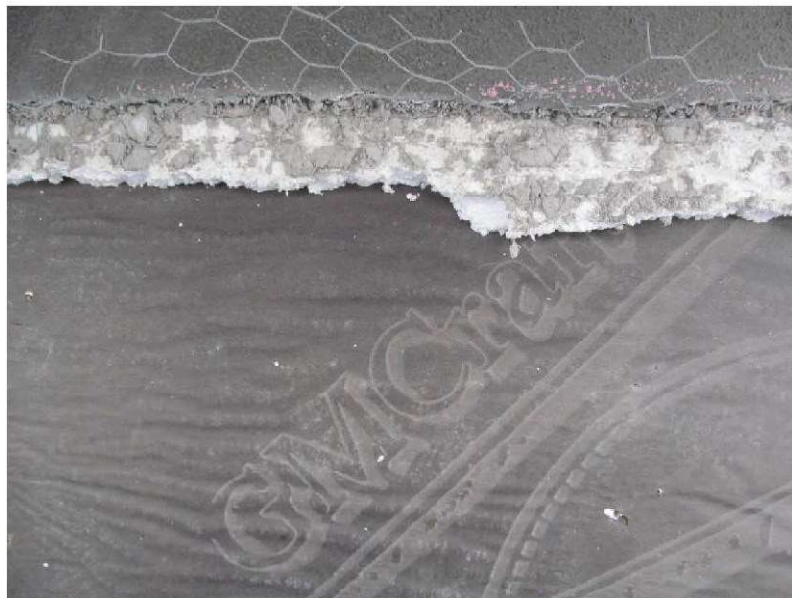
March 9, 2021, Disc IT6, Photograph 271, SSR, Building A, EPS foam board installed tight to GMCraft WRB and vertical grooves generally missing at the inner face.

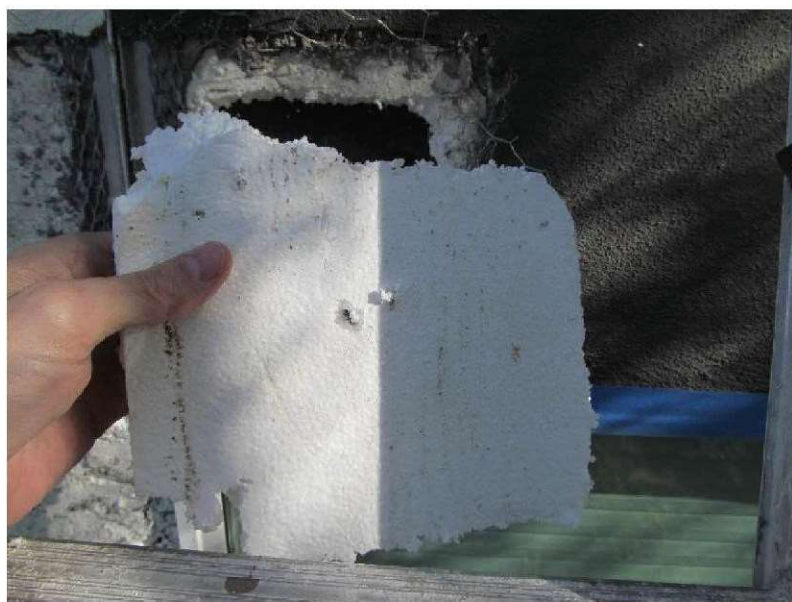
March 10, 2021, Disc IT7, Photograph 20, JJF, Building B, EPS foam board installed over WRB with vertical grooves generally missing at the back face.

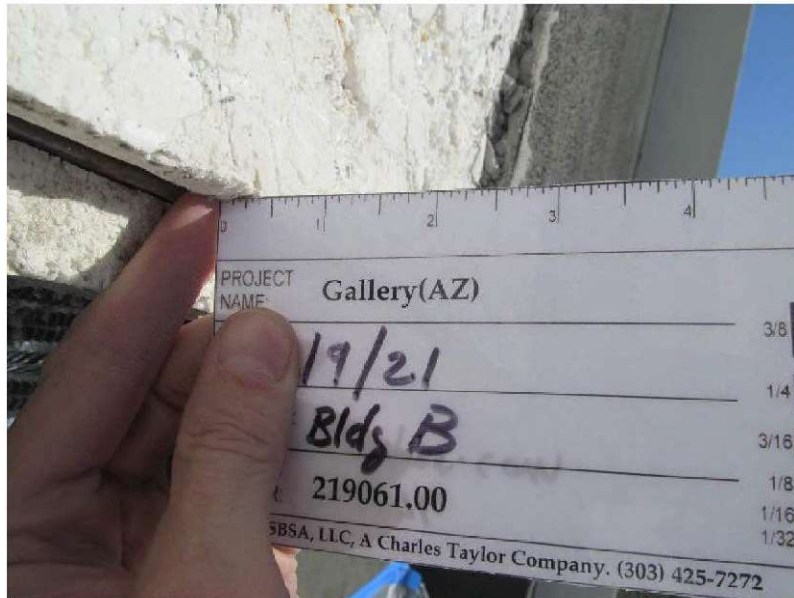
March 9, 2021, Disc IT5, Photograph 155, JFF, Building B, 3/8-inch-thick EPS foam board installed over WRB with vertical grooves generally missing at the back face.

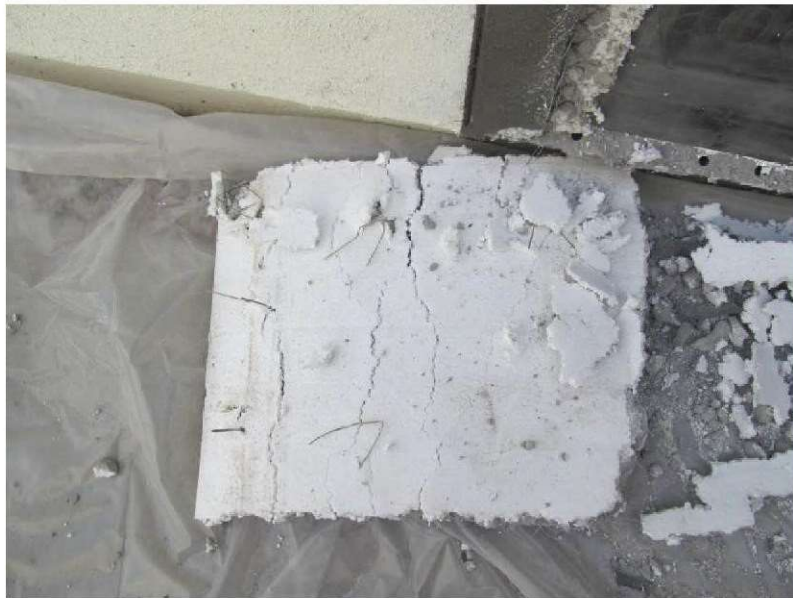
May 13, 2019, Disc IT1, Photograph 116, JBF, Building B, 1/2-inch-thick EPS insulation installed over OSB sheathing does not incorporate vertical grooves.

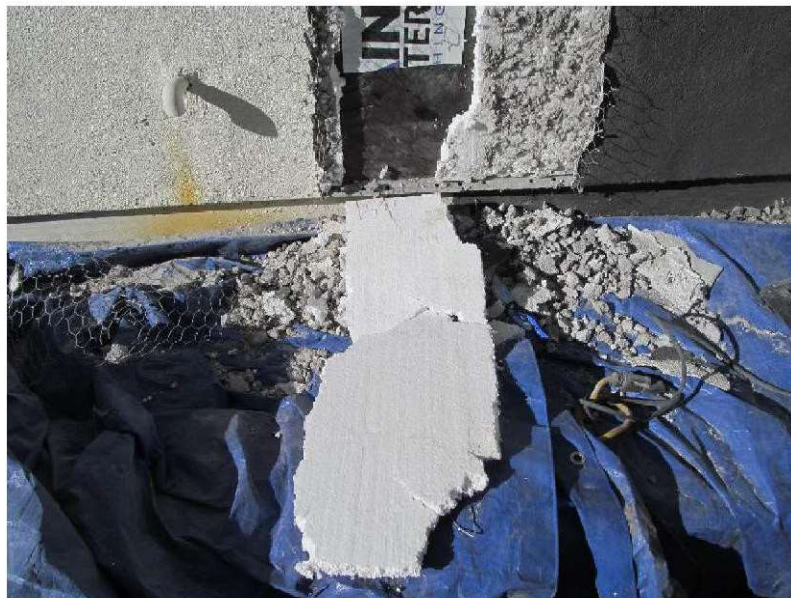
March 10, 2021, Disc IT7, Photograph 279, JJF, Building C, EPS foam board installed over WRB with vertical grooves generally missing at the back face.

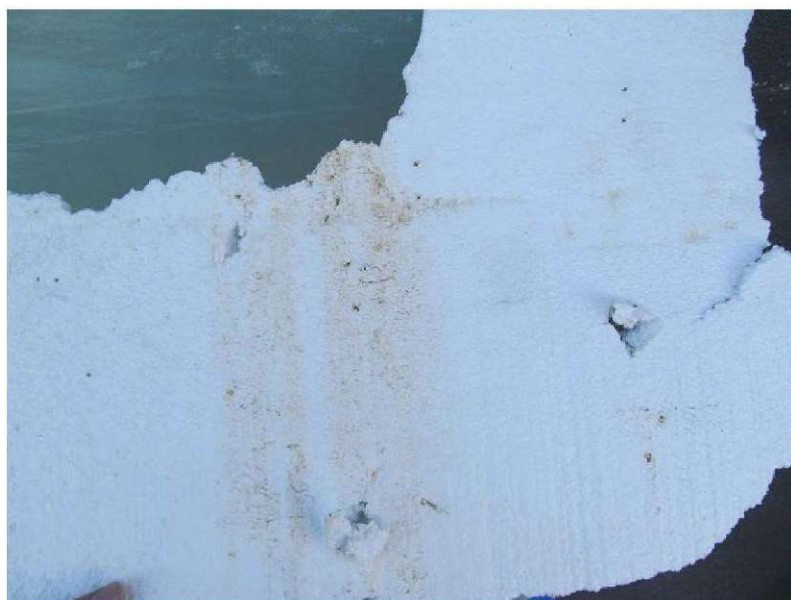
March 10, 2021, Disc IT7, Photograph 210, JJF, Building C, EPS foam board installed tight to WRB and vertical grooves generally missing at the back face.

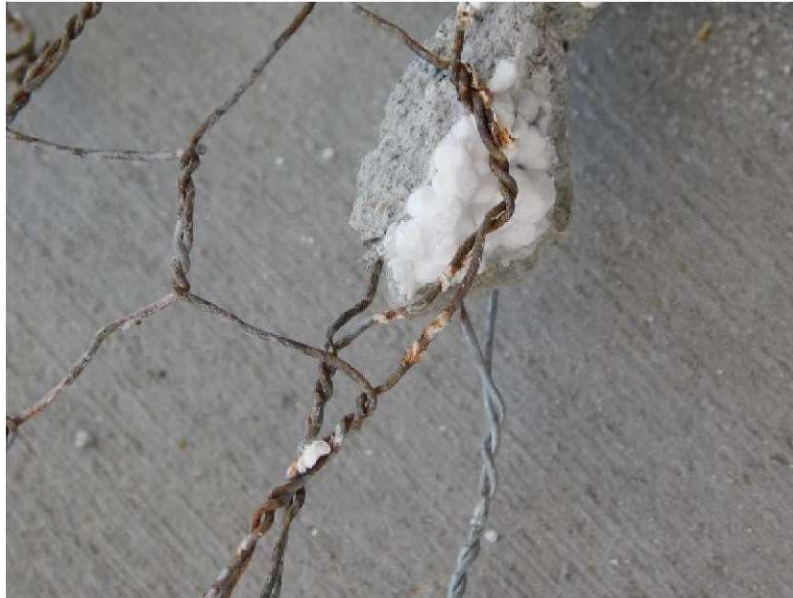
March 10, 2021, Disc IT9, Photograph 92, PER, Building C, rusted lath

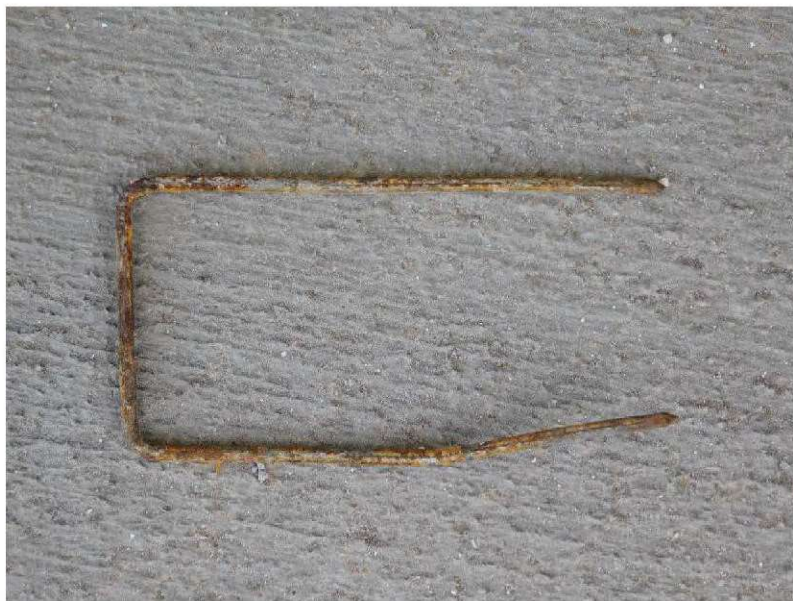
March 10, 2021, Disc IT9, Photograph 90, PER, Building C, rusted staples

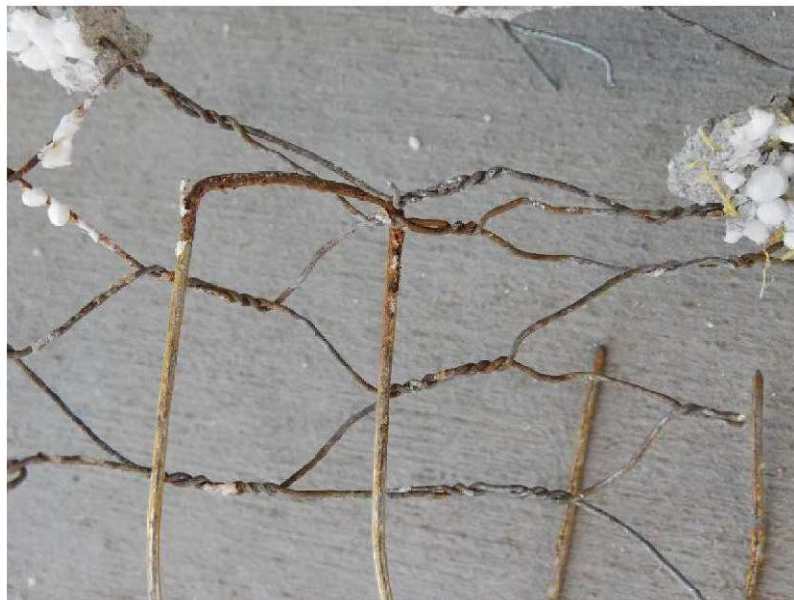
March 10, 2021, Disc IT9, Photograph 87, PER, Building C, rusted staples and lath

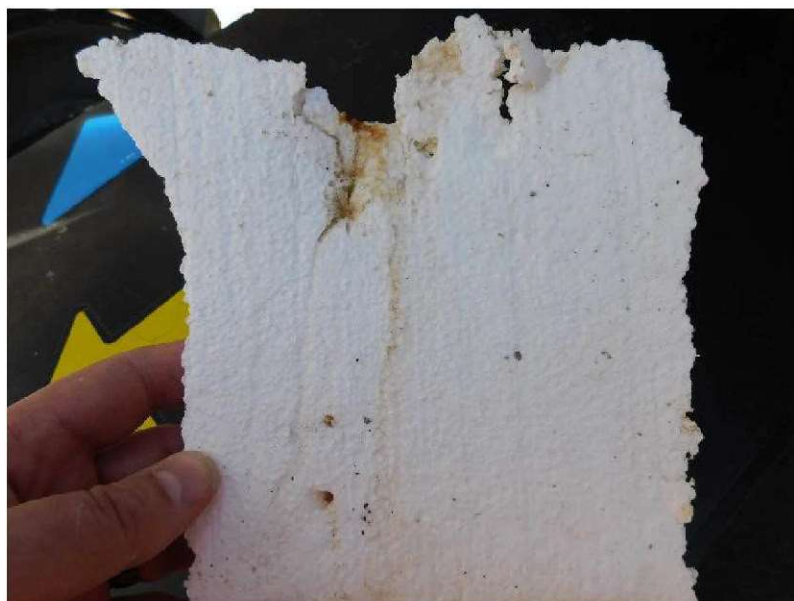
March 10, 2021, Disc IT9, Photograph 95, PER, Building C, EPS foam board installed tight to WRB and vertical grooves generally missing at the back face. Note corrosion from the nails on the EPS foam board.

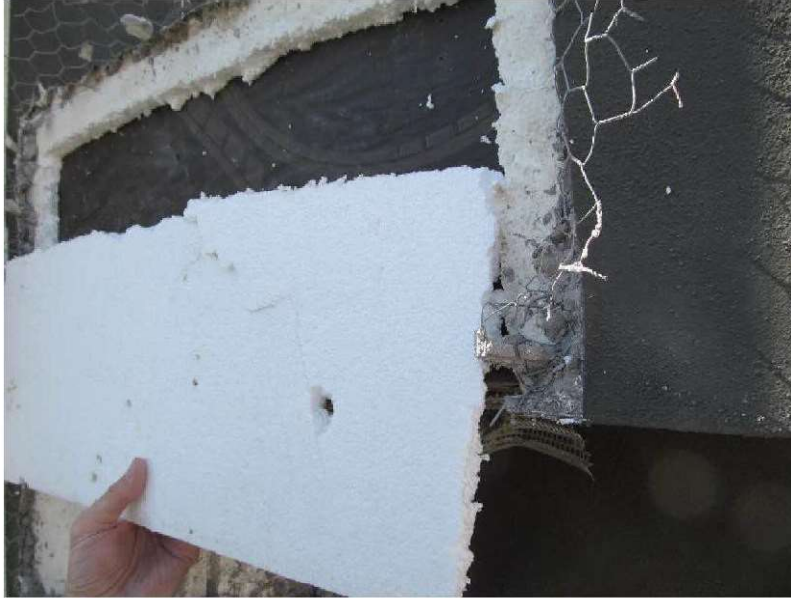
March 10, 2021, Disc IT7, Photograph 117, JJE, Building D, EPS foam board installed over WRB with vertical grooves generally missing at the back face.

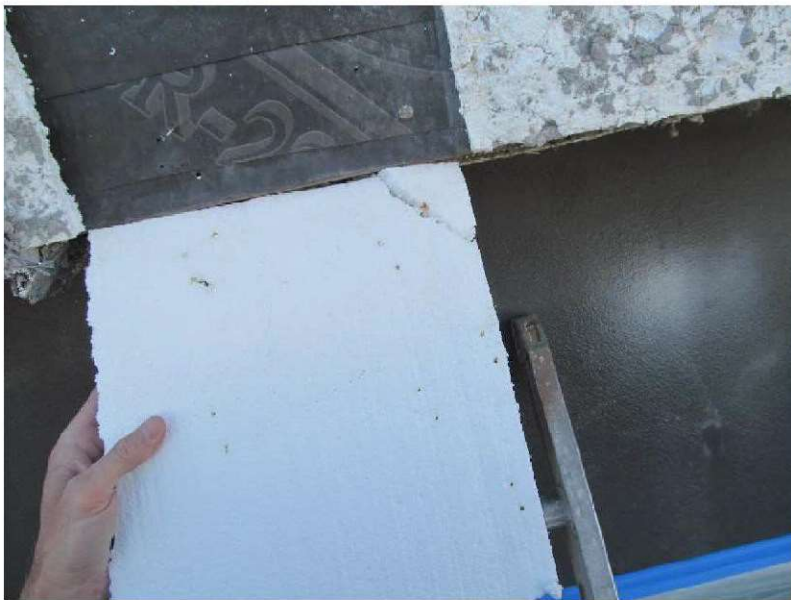
March 10, 2021, Disc IT7, Photograph 226, JJE, Building D, EPS foam board installed over WRB with vertical grooves generally missing at the back face.
