RE: JSH File No: **17412-00067**  
File Type: Residential  
Property: Gallery Condominiums Subdivision  
Address: 7107 East Earll Drive  
Scottsdale, AZ 85251  
BSC File No: 220080S

Per Jones, Skelton & Hochuli, P.L.C.'s (JSH) request, Evan J. Marshall, SE of BSC Forensic Services, LLC (BSC), formerly of Envista Forensics, LLC (Envista), performed on-site inspections at the referenced property on March 9-11, 2021. Reportedly, subsequent to construction completion, water infiltration through various locations of the roof and exterior wall cladding caused water damage to interior finish surfaces of several units of the buildings.

- Whether the wood framing construction work performed by LeBlanc Construction was the cause of the reported water penetration.
- Whether there was missing wood construction at the balcony edges as reported on pages 8-9 of the MCC Defect Issue Report dated January 31, 2022.
- Whether missing shear wall components can be extrapolated to entire project.

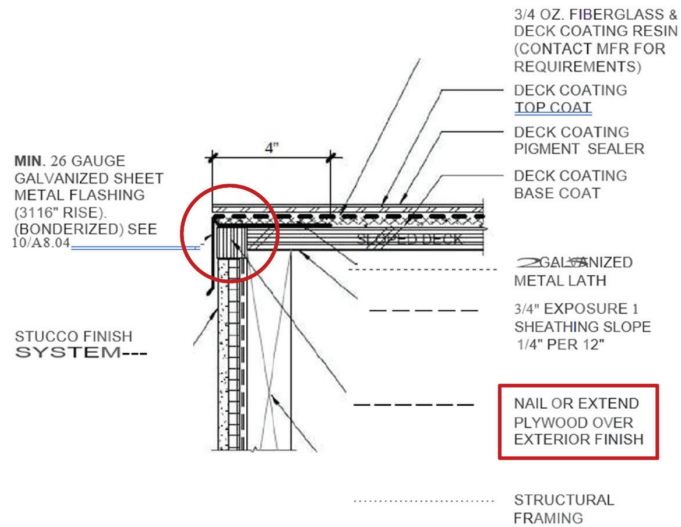
Detail 5/AS.04

The MC Defect Issue Report dated January 31, 2022, identified non-compliant metal drip edge flashing at some of the deck (i.e. balcony) edges wherein stucco did not extend up and behind the metal flashing. The report included an architectural detail at the balcony edge identifying the location of wood along the edge of the balcony.

Figure 14. Taken from the MC Defect Issue Report dated January 31, 2022, of an architectural detail at the deck (i.e. balcony) edge.

- In detail 5/AS.04 Deck Perimeter Flashing (above), Note the wood block at the end of the deck 9 (circled). This block serves three purposes:
  1. A stop for the stucco
  2. A spacer for the sheet metal
  3. A nailer for the sheet metal.
- MC did not observe a clear photograph of this component of the assembly in the plaintiff photographs to confirm the block was installed.
- If the blocks were installed, then they were not sized properly, and the client has no responsibility for this issue.
- If the blocks were not installed, the responsibility falls on the framer, stucco installer, general contractor, and the client.

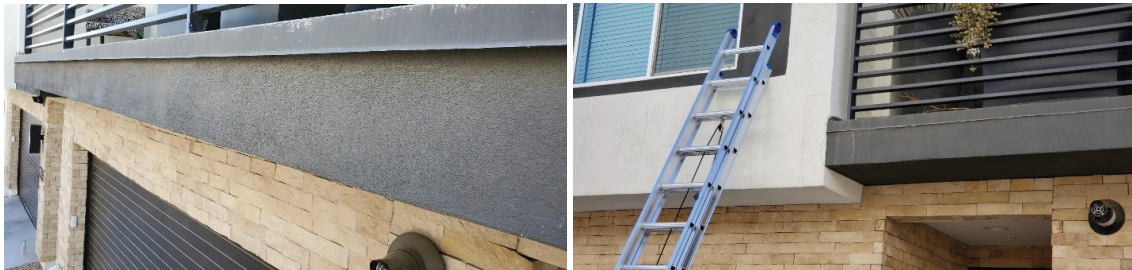
Figure 15. Taken by BSC of balcony condition with stucco installed behind the flashing (left), and stucco installed up against the bottom edge of the flashing (right).

It should be noted that MC indicated that they did not confirm whether this block was installed, or presumably whether the plywood extended to the balcony edge, which was also an acceptable installation method per the architectural detail. MC also indicated that, if they wood blocks were installed, they were not sized correctly. However, as just noted, MC did not confirm whether the wood blocks or plywood were installed correctly. As such, their opinion on the cause of the misplaced flashings had not been substantiated and, as such, was speculative and unsupported by fact-evidence. Additionally, BSC observed locations where the plywood sheathing extended to the back side of flashing/drip edge.

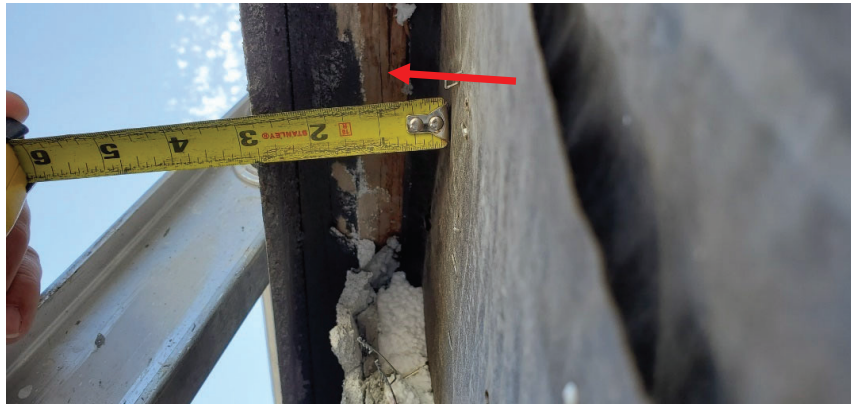
*Figure 17. Photograph taken by BSC of the deck (i.e. terrace or balcony) plywood sheathing (arrow) extending to the backside of the metal drip edge.*

Furthermore, the lack of a wood block at, or plywood extension to, this edge would not preclude installing the flashing correctly, as the flashing fasteners were installed through the top of the flashing and away (inward) from the edge. Any evidence of improper flashing installation would be a defect attributable to the flashing installer, and not the wood framing installer (LeBlanc).

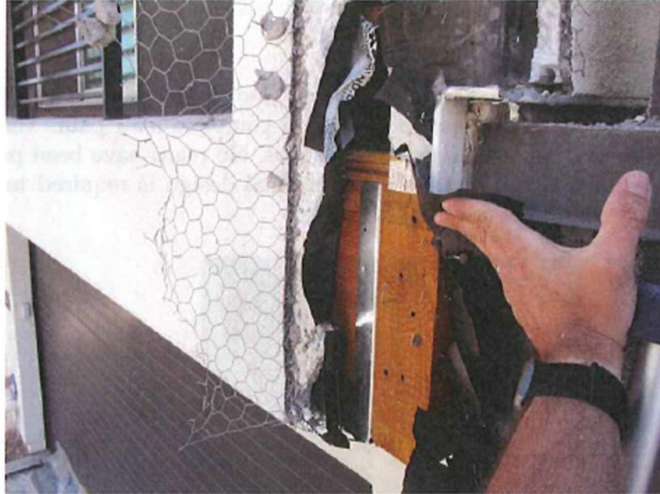
May 13, 2019, Disc IT1, Photograph 50, JBF, west elevation of Building D - Unit 3113, open stud framing with no exterior sheathing.

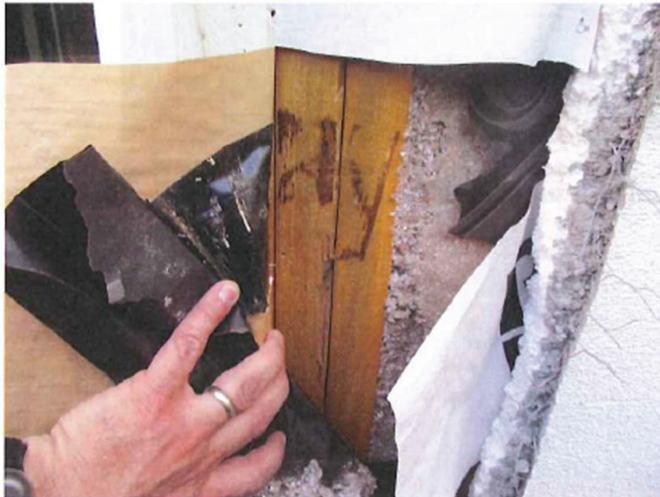
May 13, 2019, Disc IT1, Photograph 156, JBF, south elevation of Building C - Unit 3117, open stud framing with no exterior sheathing.

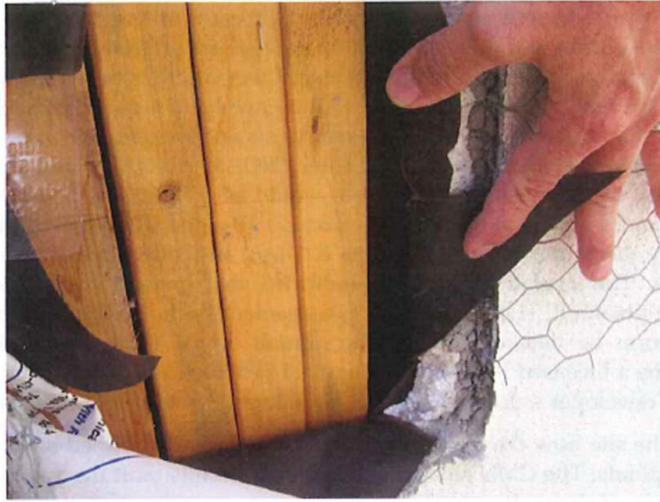
May 14, 2019, Disc IT3, Photograph 26, JBF, north elevation of Building A - Unit 3124, open stud framing with no exterior sheathing.

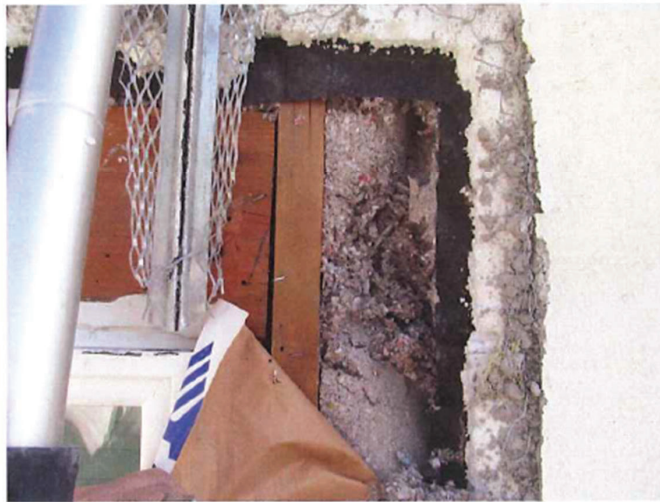
May 14, 2019, Disc IT3, Photograph 52, JBF, south elevation of Building B - Unit 3104, open stud framing with no exterior sheathing.
