BSC File No. 220080S

February 14, 2022

The Condominium Buildings and Property Photographs

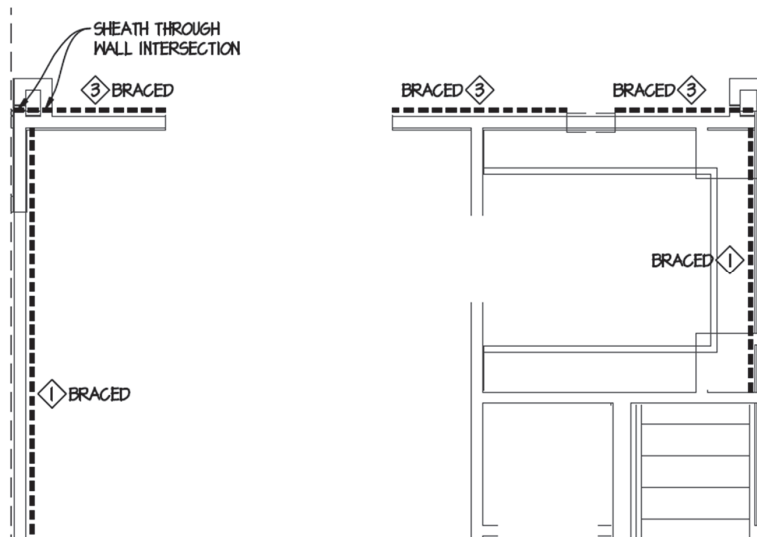
Figure 20. Taken from structural drawings of typical wall sheathing (i.e. shear wall) locations.

While missing wood sheathing was reported at several locations, there was no correlation to locations of shear wall panels as specified by the engineer. For example, a preceding *Figure* taken from the structural drawings depicts wood shear wall panels that extend behind the wood-framed bump-outs in the walls, but which do not wrap completely around the bump-outs. Additionally, wood wall sheathing and metal straps were observed at Unit 3118 and others, indicating that the missing wall panels were not pervasive. As such, BSC's inspection confirmed that not all of the wood wall sheathing was missing, and that extrapolation of any missing shear wall components to the entire project was unsupported by fact-evidence.

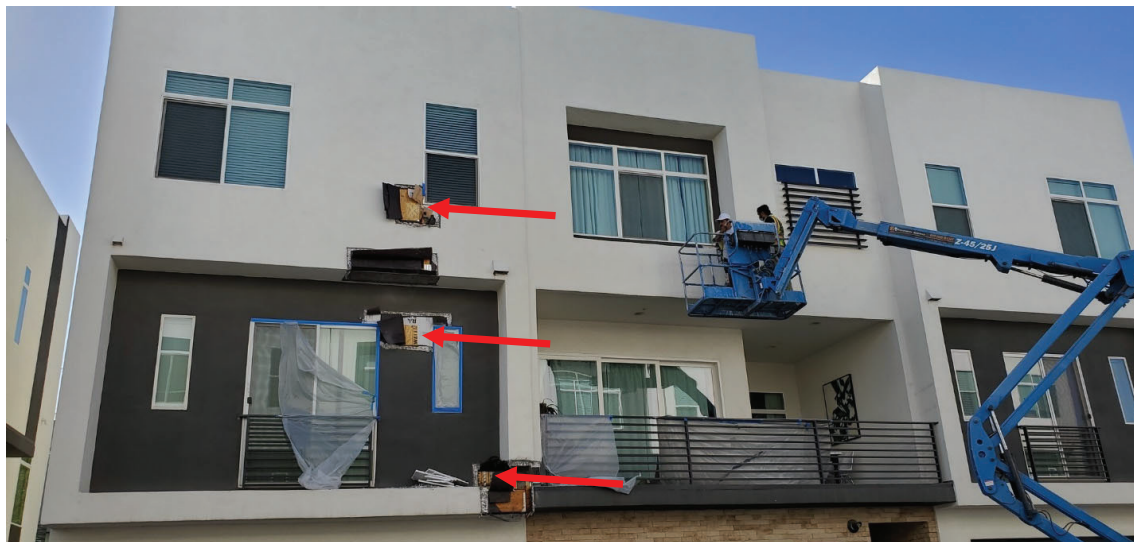
Figure 21. Taken by BSC of wood wall sheathing (i.e. shear walls) at front of Unit 3118 (arrows).

Repairs to any known missing or incorrectly installed exterior shear wall components would consist of removal the stucco and water-resistive barrier (WRB; i.e. building paper) at the specified location, and installation of the missing shear wall components. After the installation, the wall's portion of removed exterior cladding can be replaced using standard architectural methods.

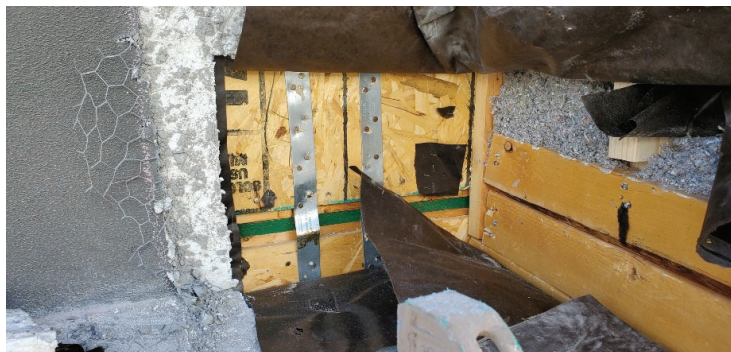
Figure 22. Taken by BSC of wood wall sheathing (i.e. shear wall) at front of Unit 3118.

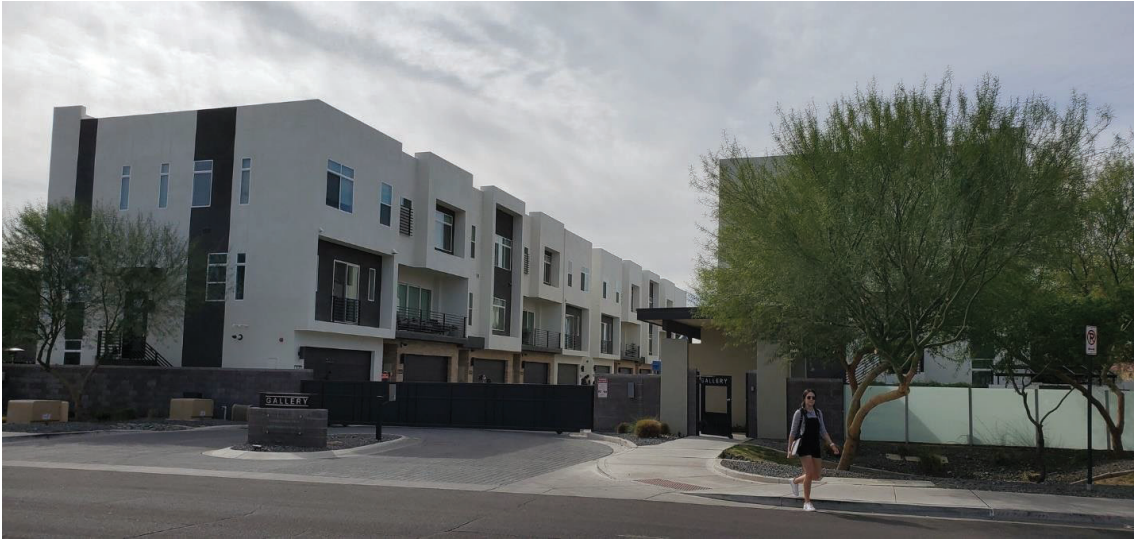
Front (north-facing) end of property.

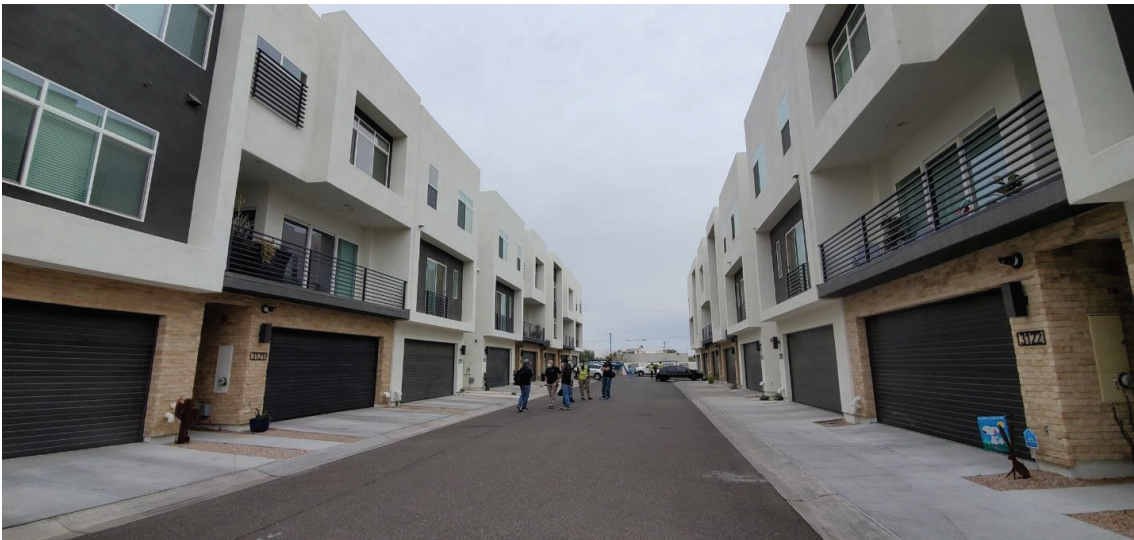
Front elevation of the four buildings (two building in foreground, two buildings in background).

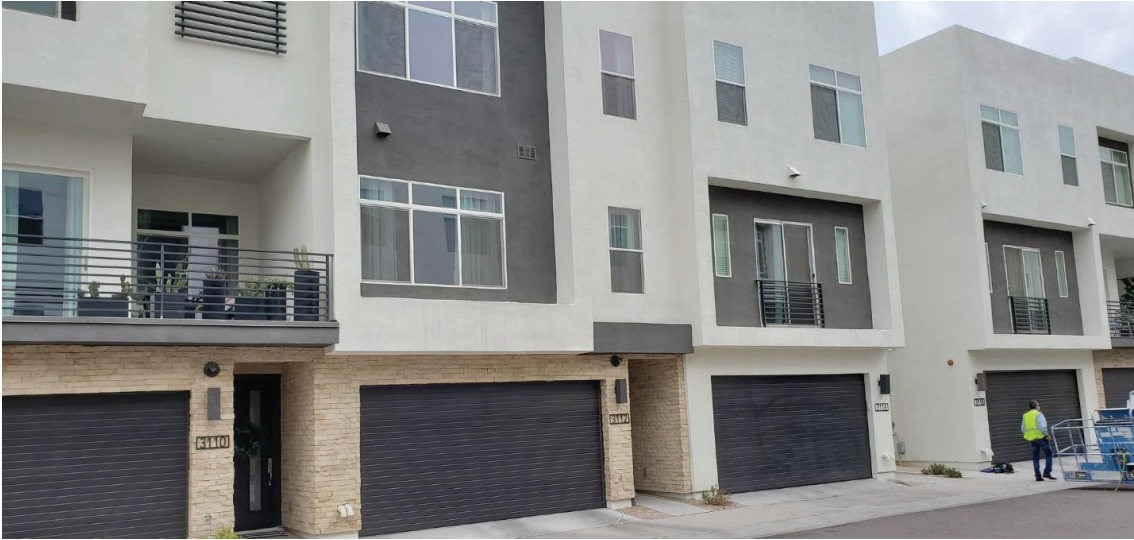
Front elevation typical buildings and units.

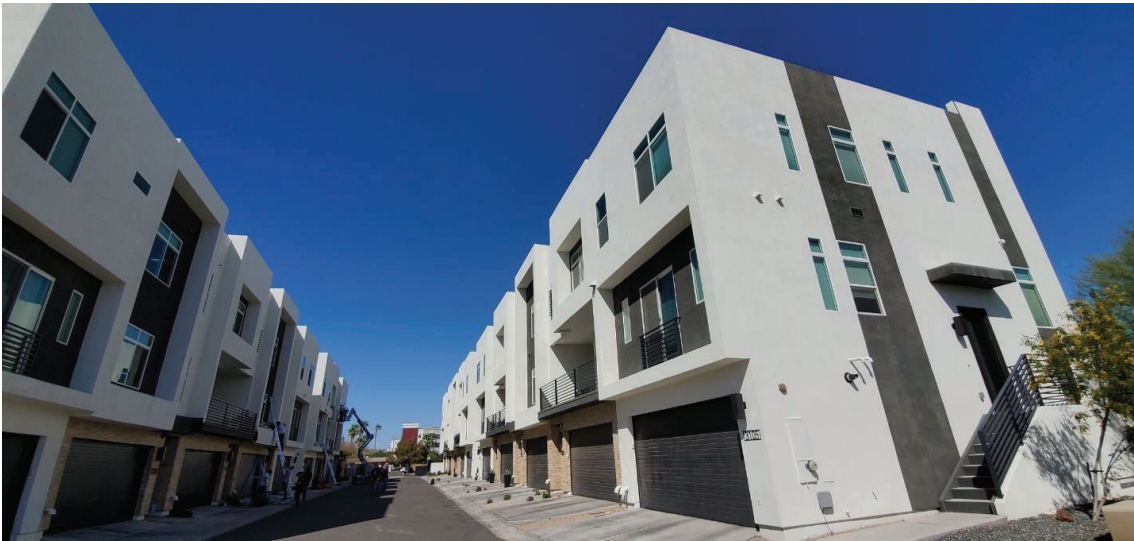
End elevations of buildings.

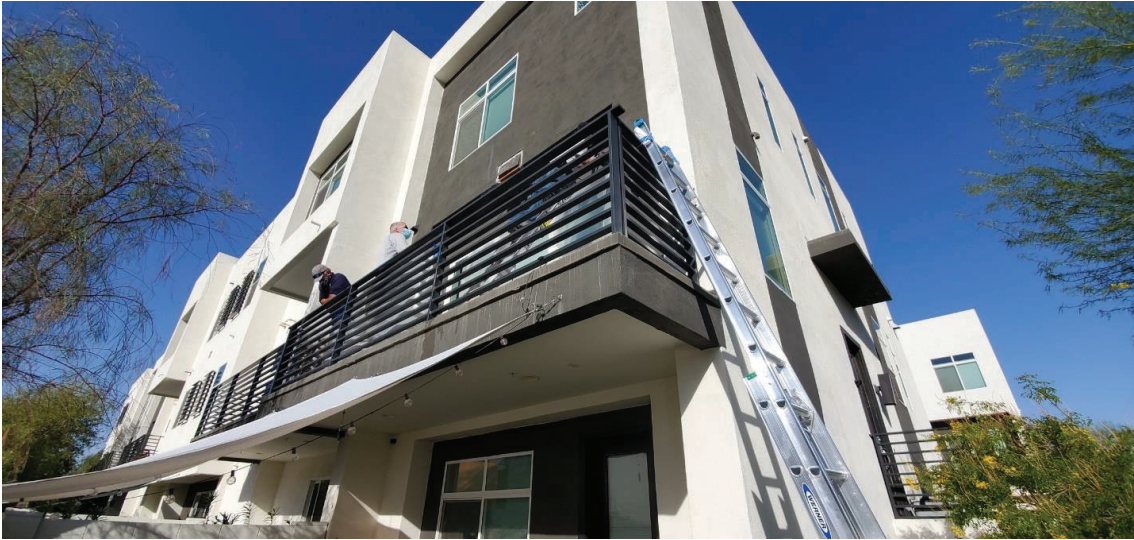
Back elevation of typical building.

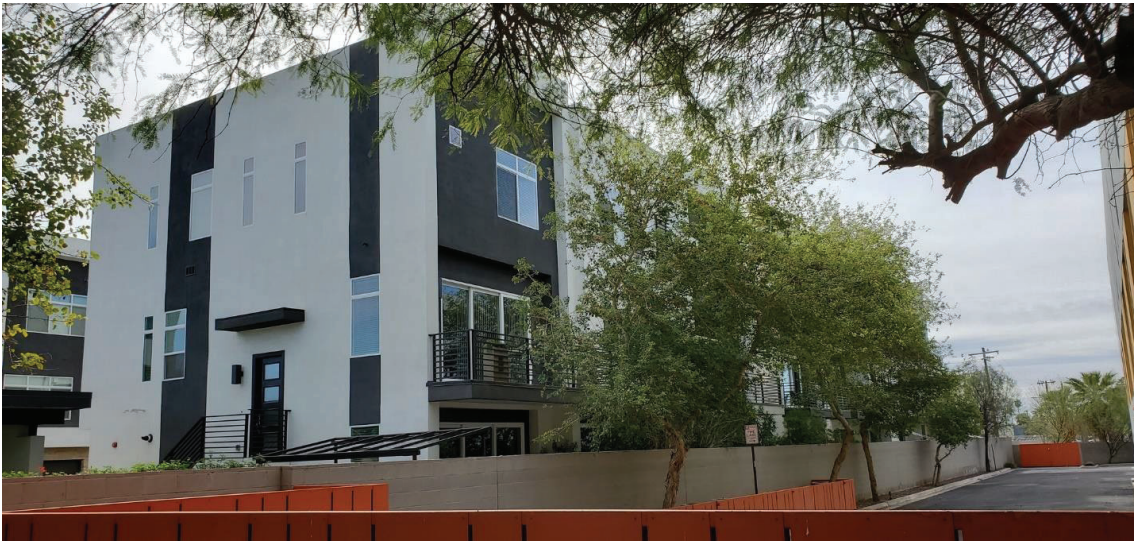
Back elevation of typical building.

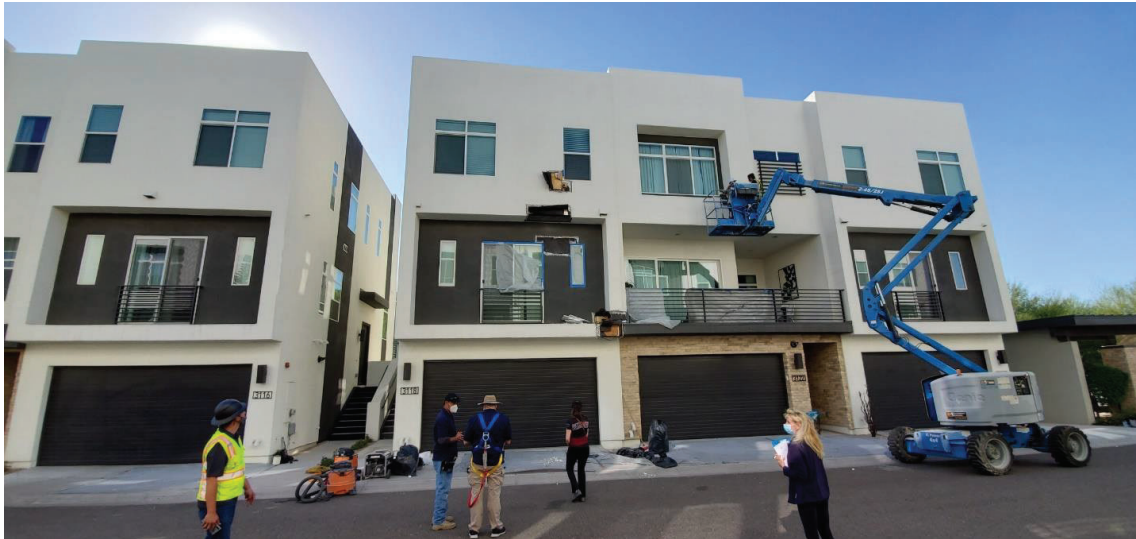
Typical view of destructive investigation work in-progress.

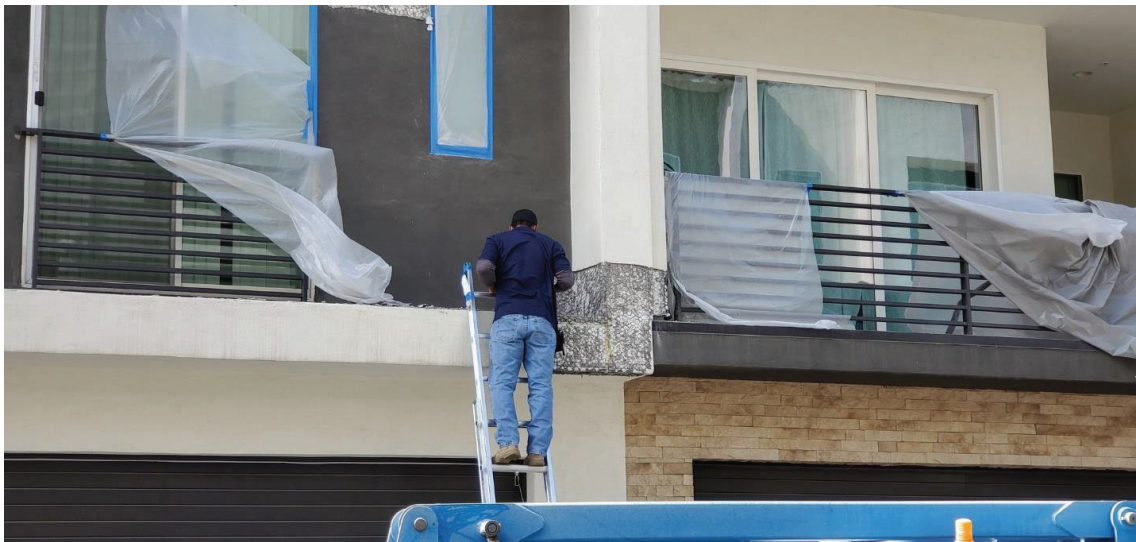
Typical view of destructive investigation work through the stucco cladding.

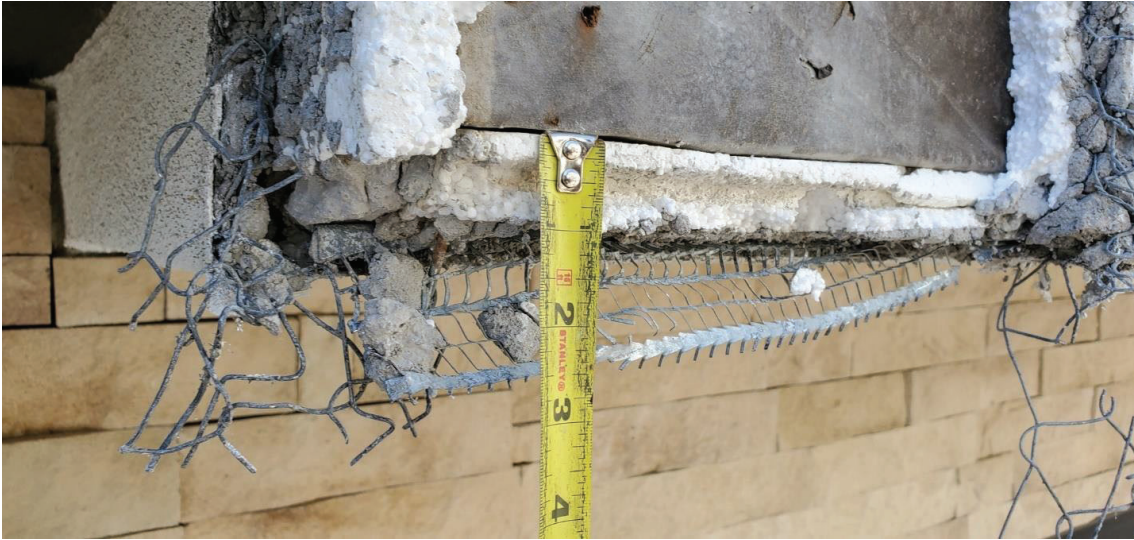
Typical view of destructive investigation work through the stucco cladding.

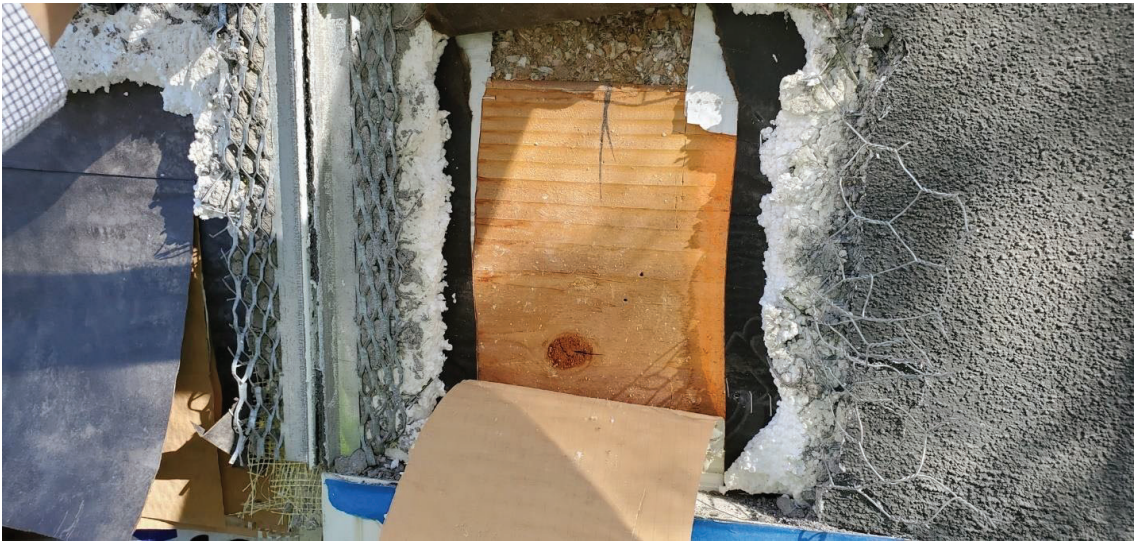
Typical view of destructive investigation work through the stucco cladding and water-resistant barrier (i.e. building paper).
