# EXHIBIT 2

BSC File No. 220080S

JSH File No. 17412-00067

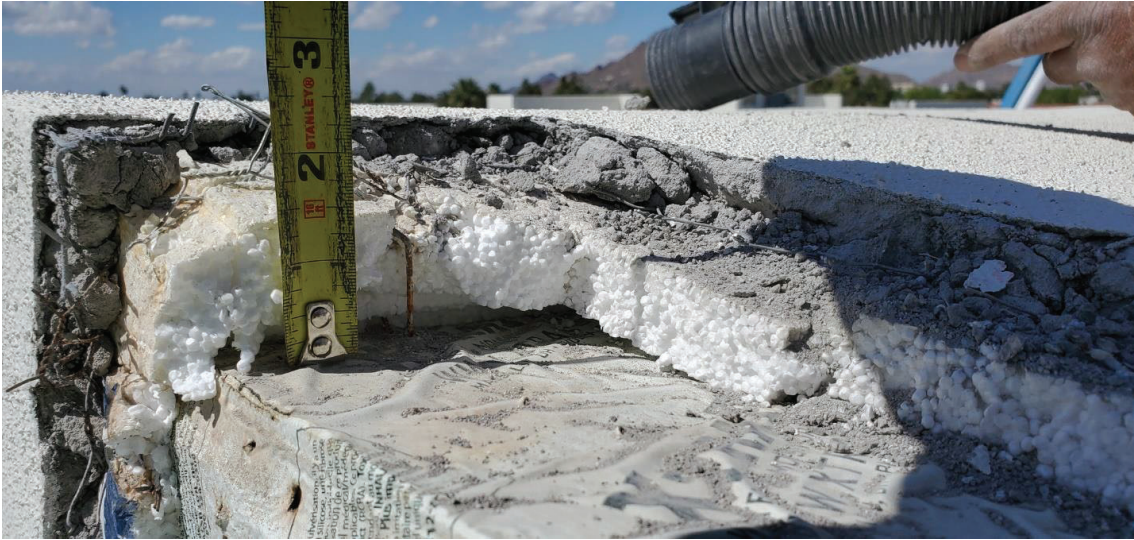
Typical view of destructive investigation work through the stucco cladding and foam insulation at roof parapet.

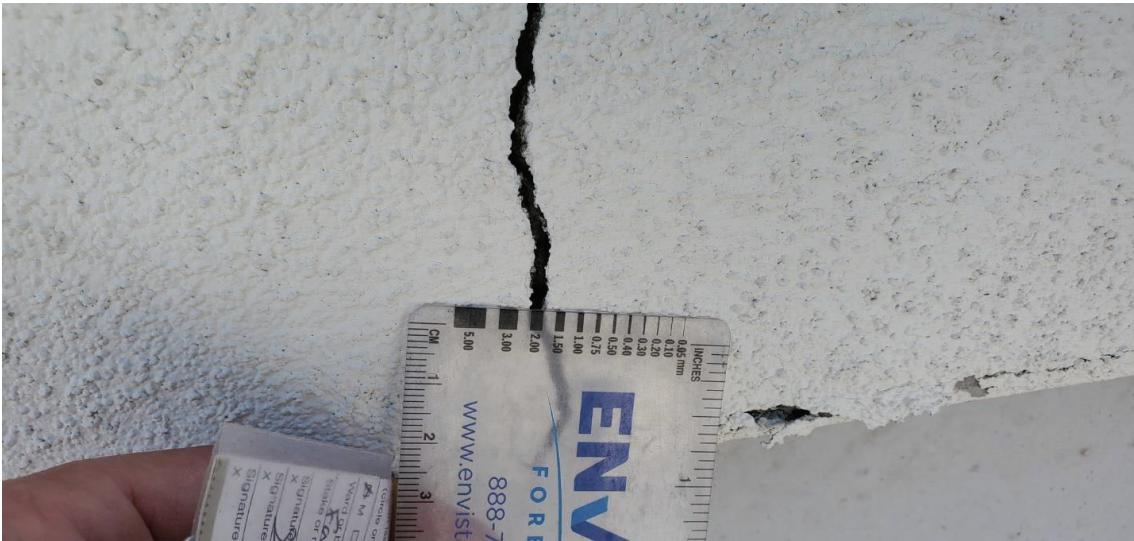
Typical view of crack in stucco.

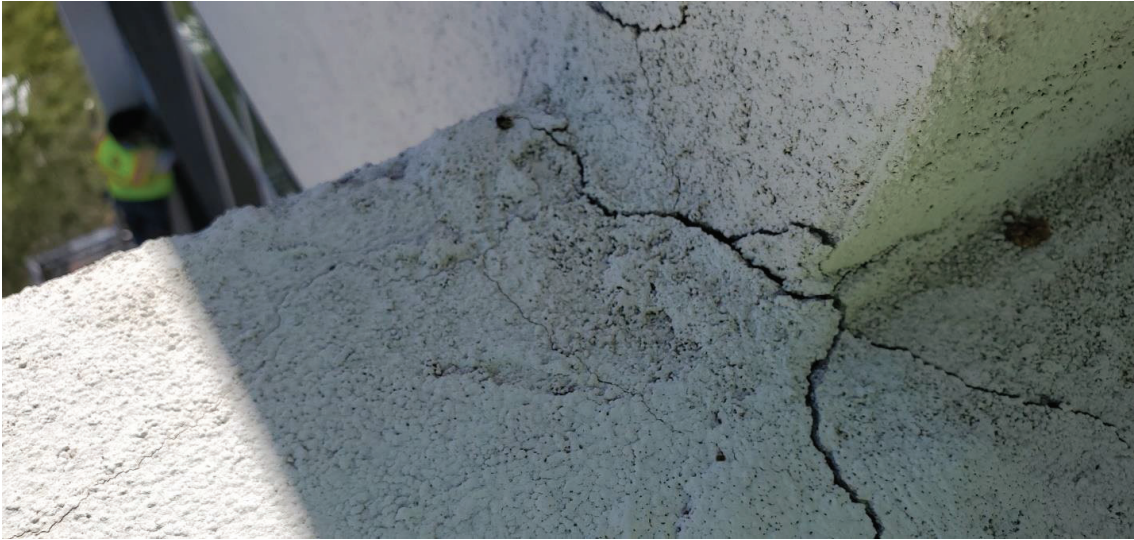
Typical view of cracks in stucco.

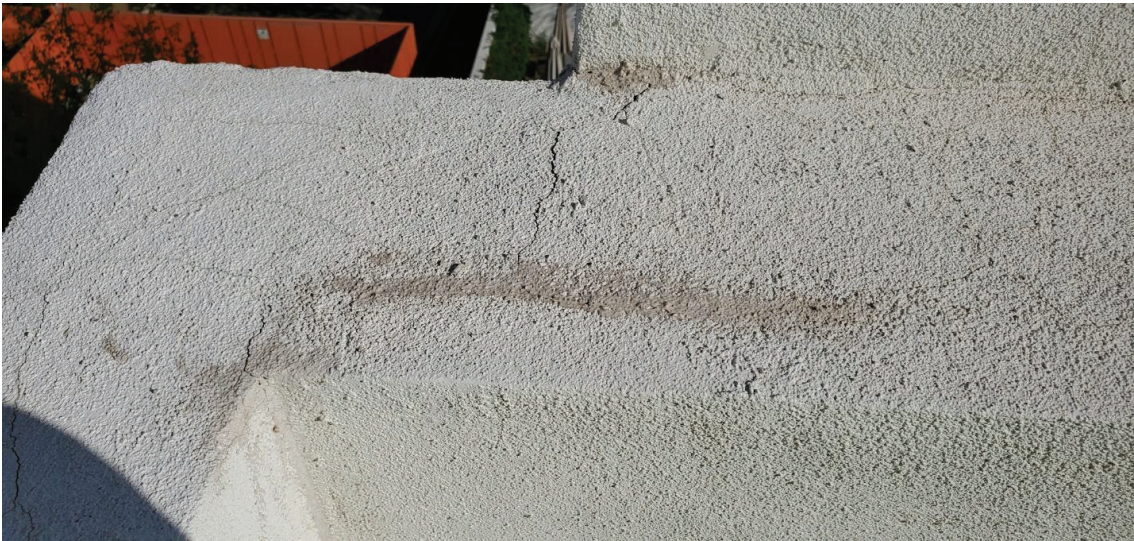
Typical view of cracks in stucco.

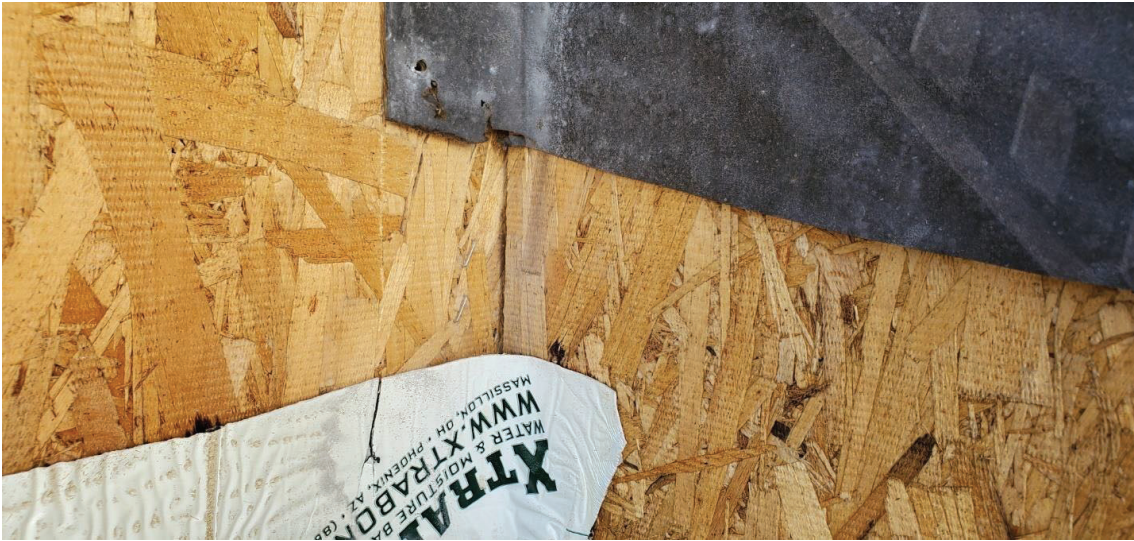
View of exterior wood panels behind deconstructed stucco cladding and building paper.

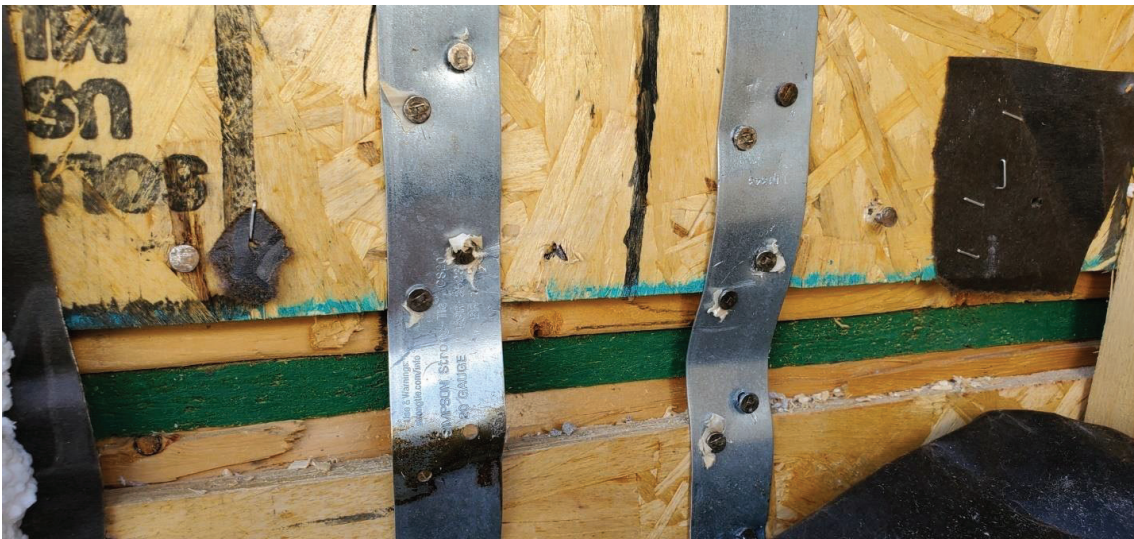
View of exterior wood panels and metal straps behind deconstructed stucco cladding and building paper.

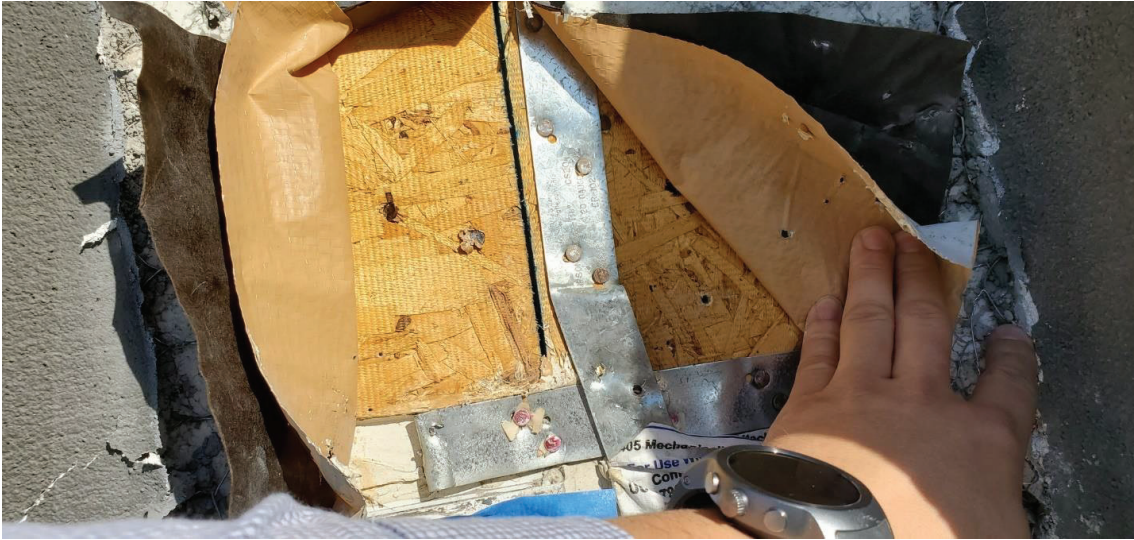
View of exterior wood panels and metal straps behind deconstructed stucco cladding and building paper.

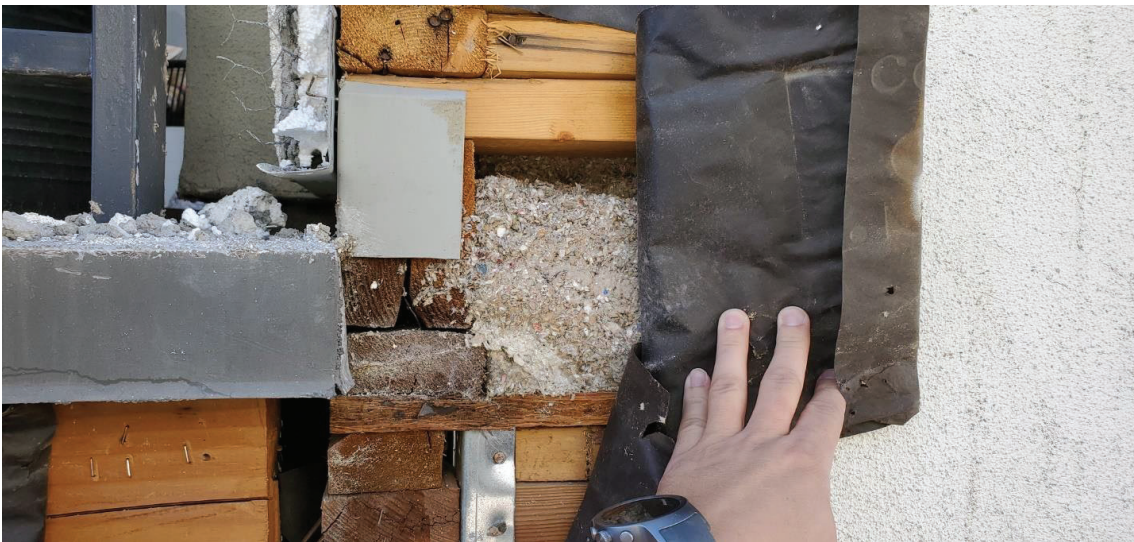
View of typical wood framing near balcony.

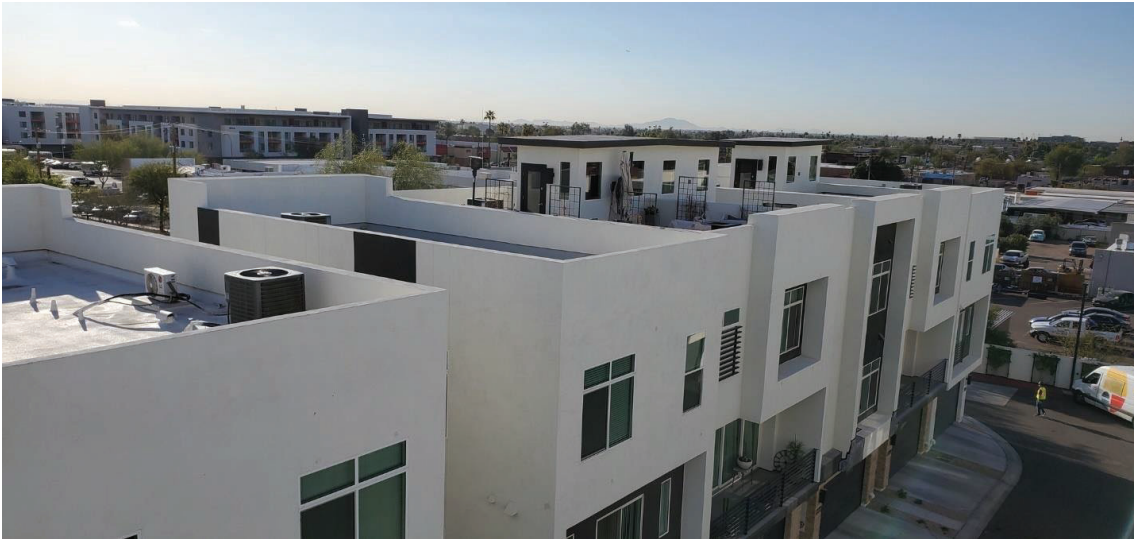
View of rooflines of typical buildings.

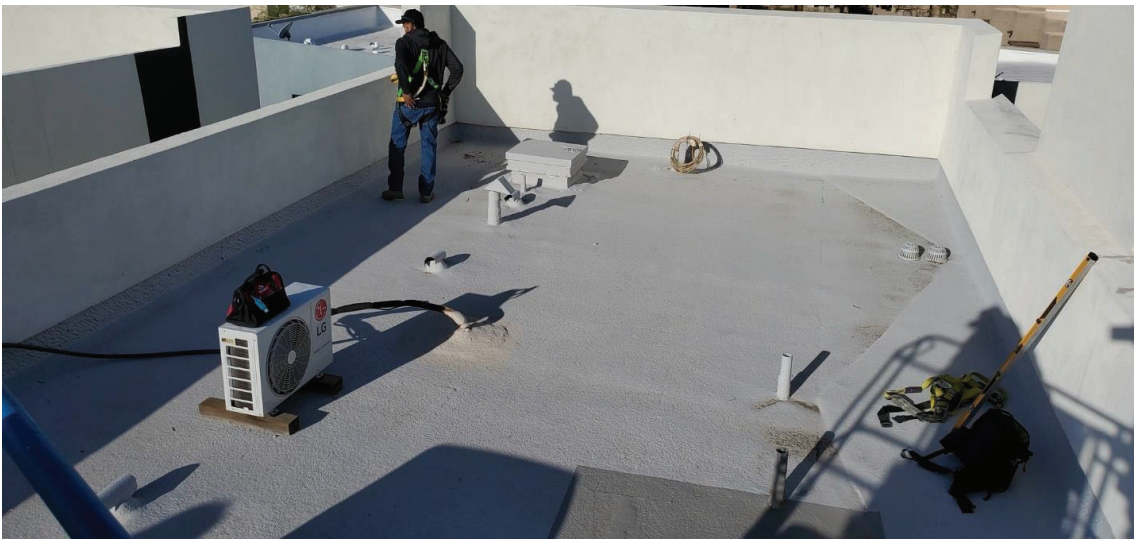
View of typical roof condition and slope.

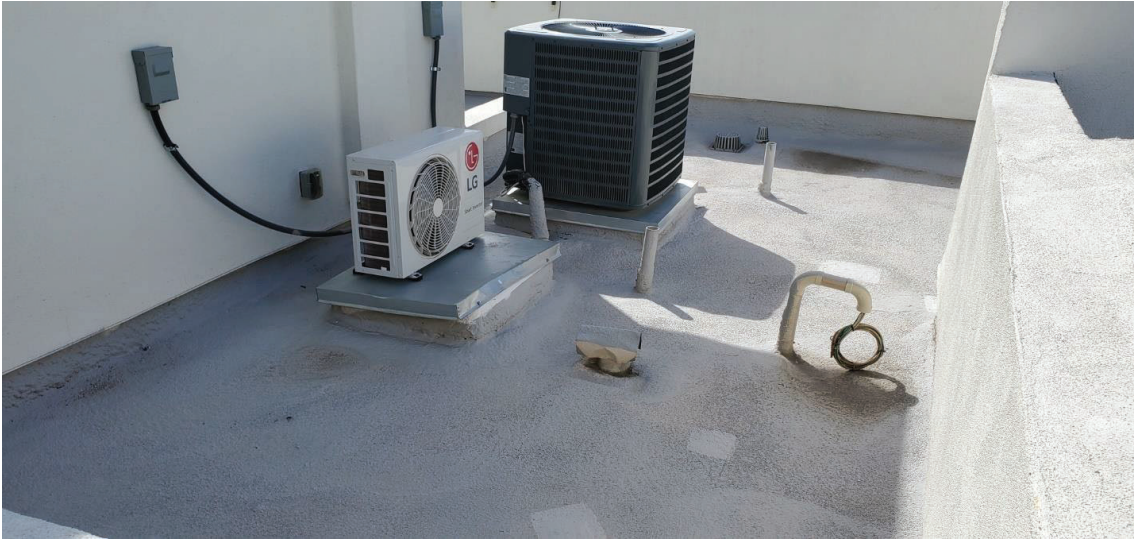
View of typical roof condition and slope.

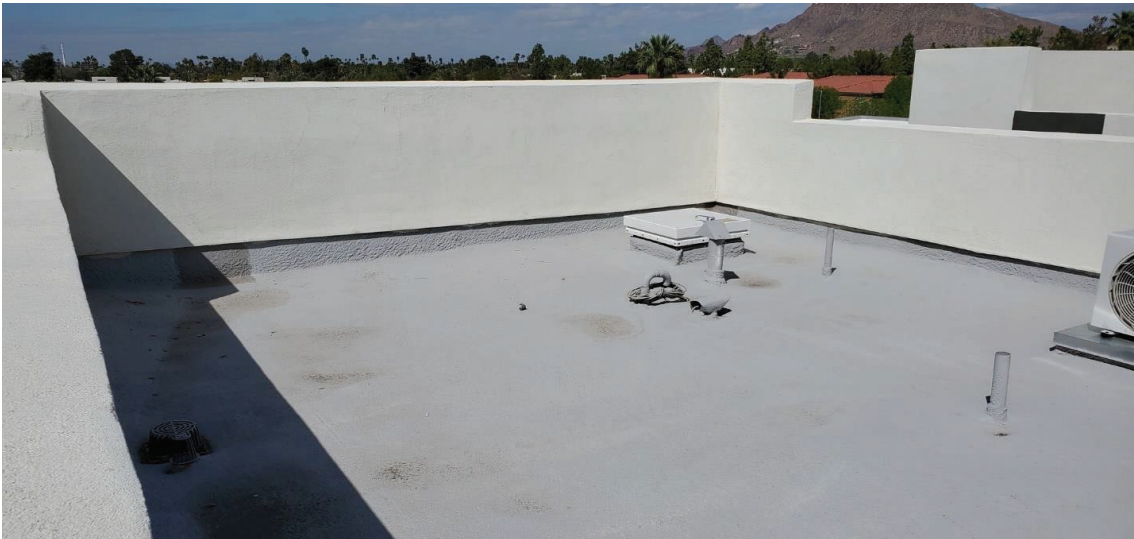
View of typical roof condition and slope.

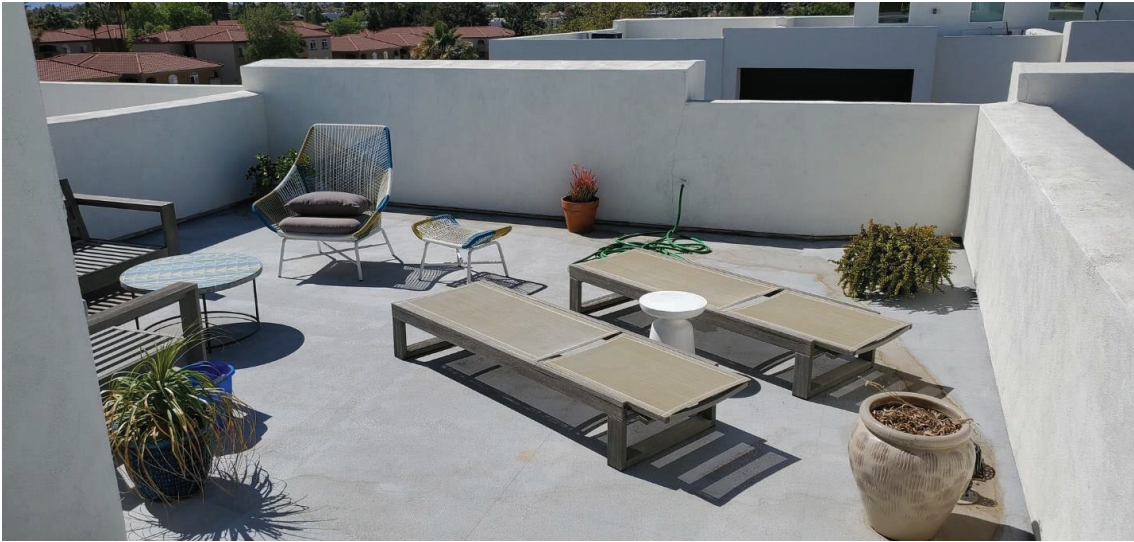
View of typical roof condition and slope.

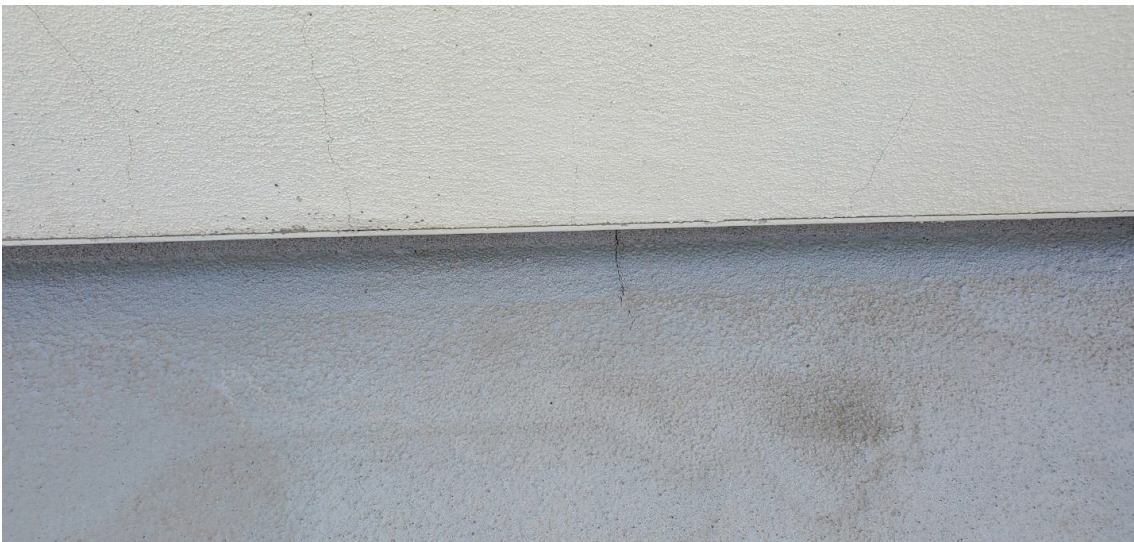
View of crack/tear in roof surface.

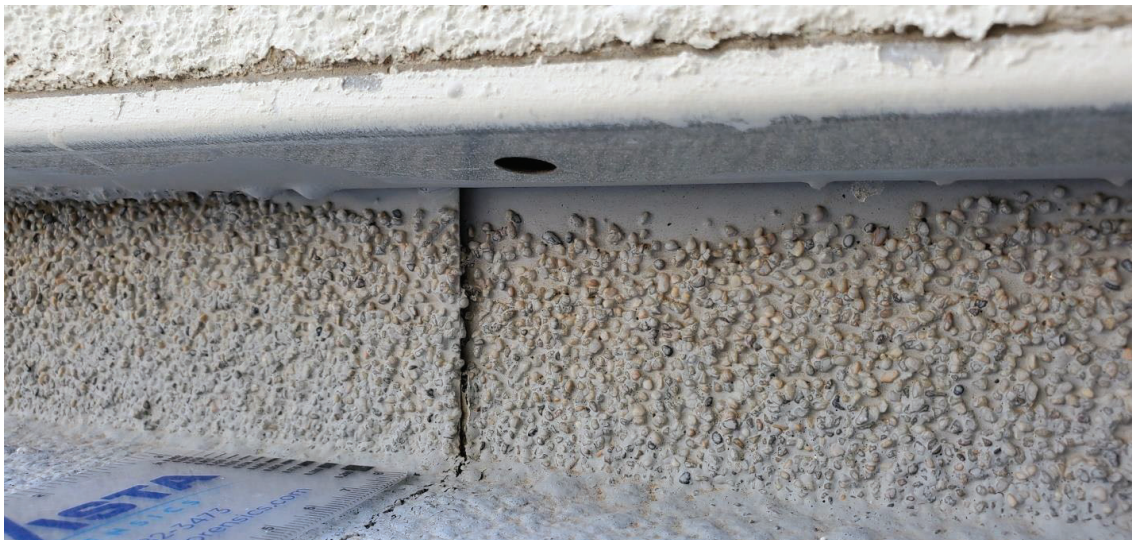
View of flashing termination at location of tear in roof depicted in previous photograph.

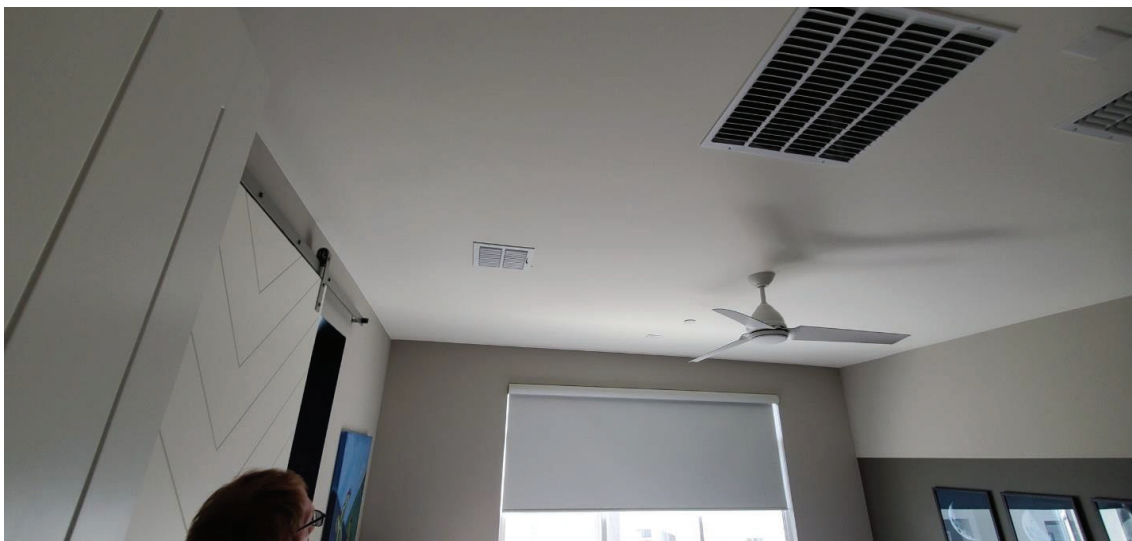
View of room with ceiling stain and crack below location of tear in roofing depicted in previous photograph.

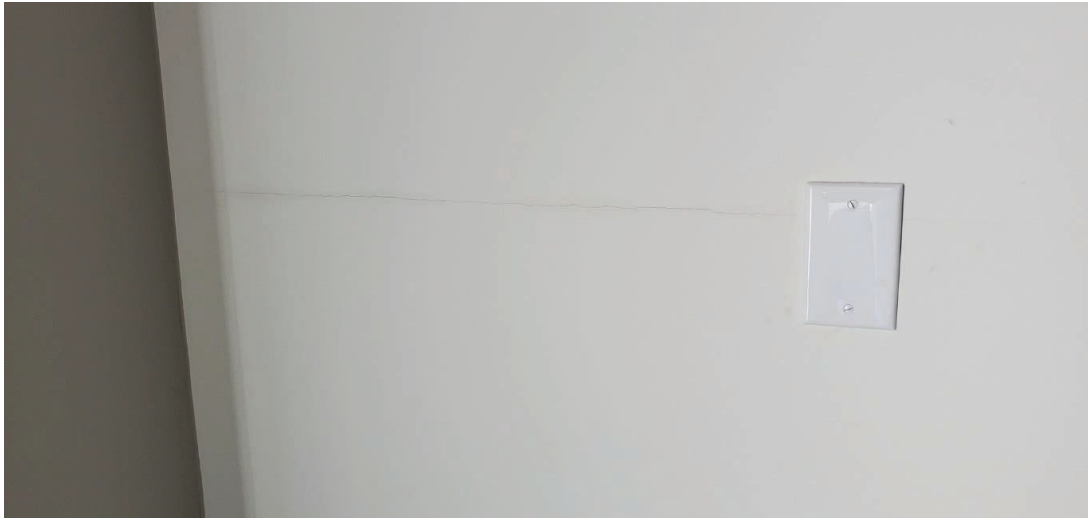
View of ceiling stain and crack below general location of tear in roofing depicted in previous photograph.
