**Applicable Code/Industry Standard References/Project-Specific Documents:**

Otak, Inc., "K. Hovnanian Homes, Gallery Townhomes," revised date August 2, 2016, Sheet A8.05 "Exterior Details," illustrates the following:

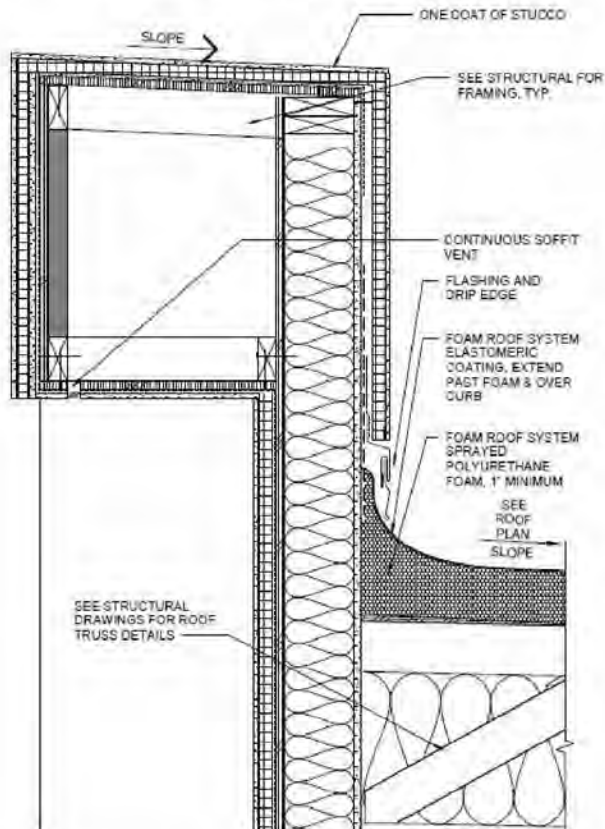
Stucco Manufacturers Association (SMA), prepared by the Northwest Wall and Ceiling Bureau, "Portland Cement Plaster Stucco Resource Guide," Third Edition, 1997, Section "Recommendation/Standards for design and installation," states the following:

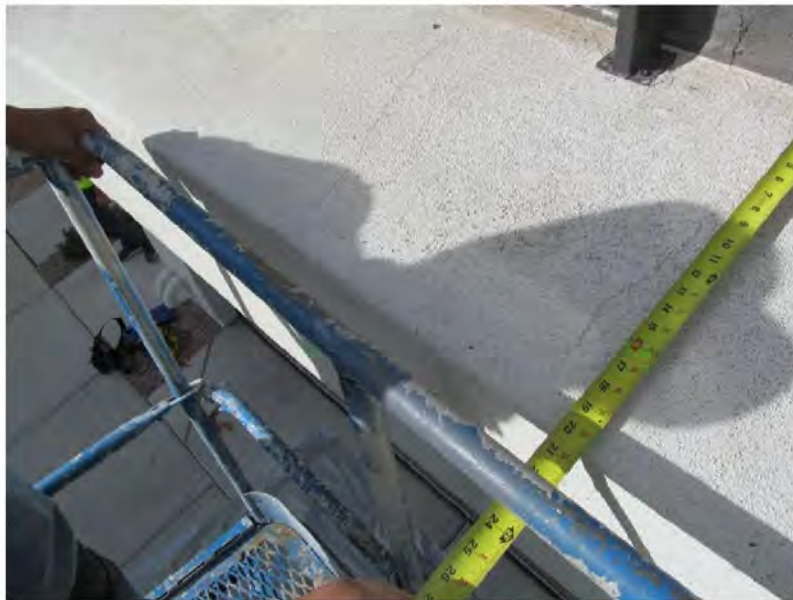
March 9, 2021, Disc IT6, Photograph 56, SSR, Building A, pop-out box stucco cracks.

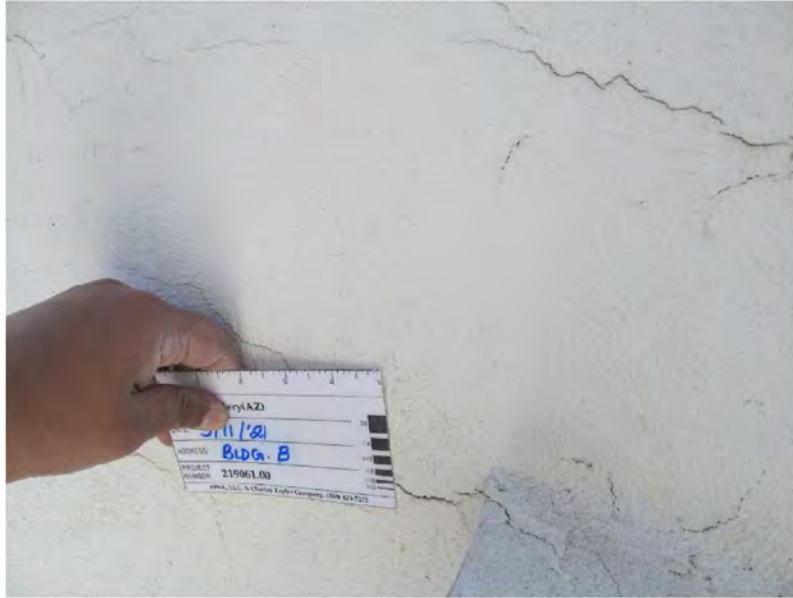
March 11, 2021, Disc IT10, Photograph 170, SSR, Building B, roof parapet wall stucco cracks.

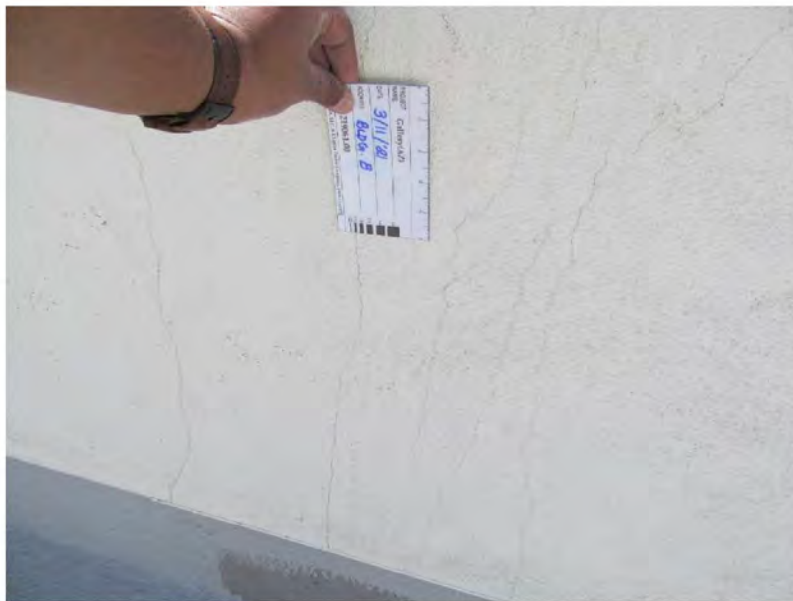
March 11, 2021, Disc IT10, Photograph 207, SSR, Building B, roof parapet wall stucco cracks.

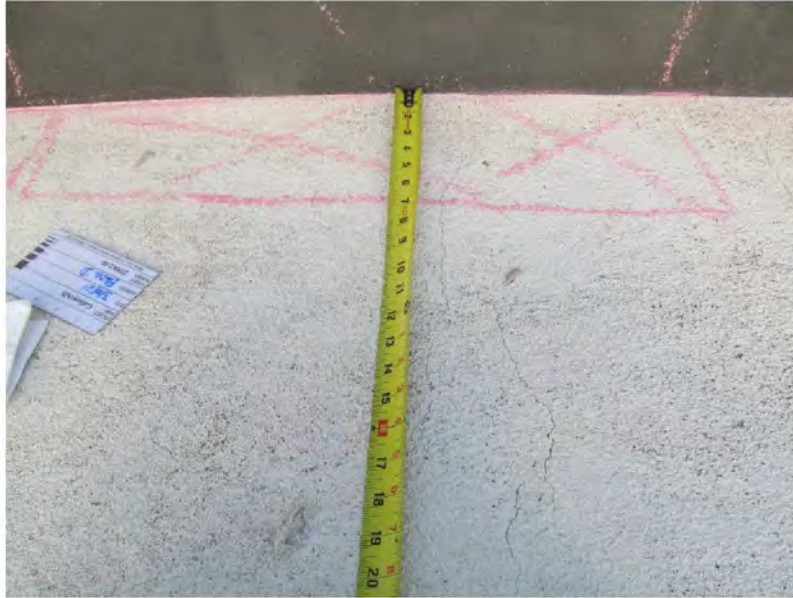
March 10, 2021, Disc IT8, Photograph 54, SSR, Building D, pop-out box stucco cracks.

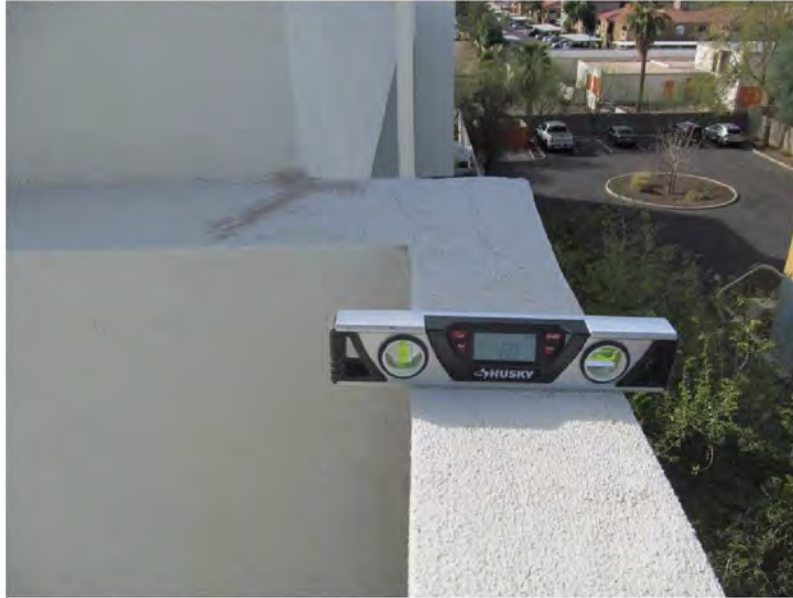
March 11, 2021, Disc IT10, Photograph 70, SSR, Building A, roof parapet wall slopes 6-percent outward.

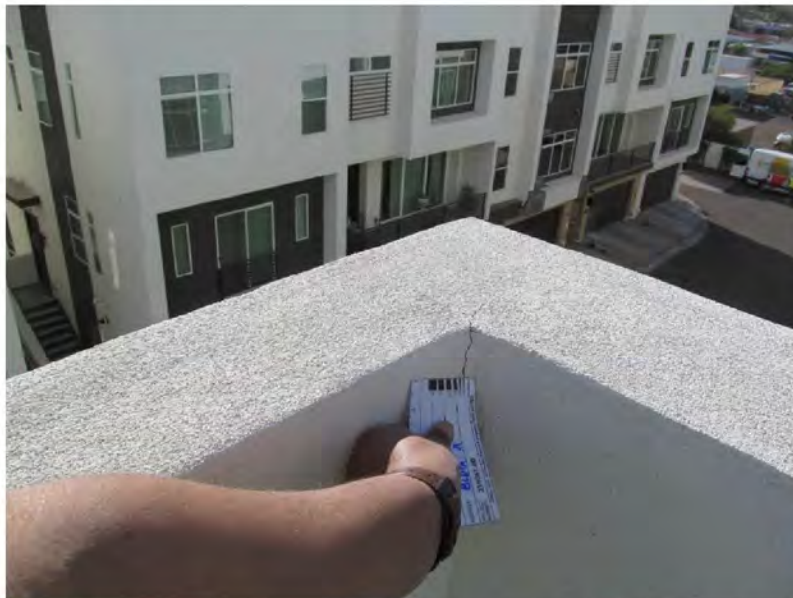
March 11, 2021, Disc IT10, Photograph 37, SSR, Building A, stucco cracks at parapet wall junction.

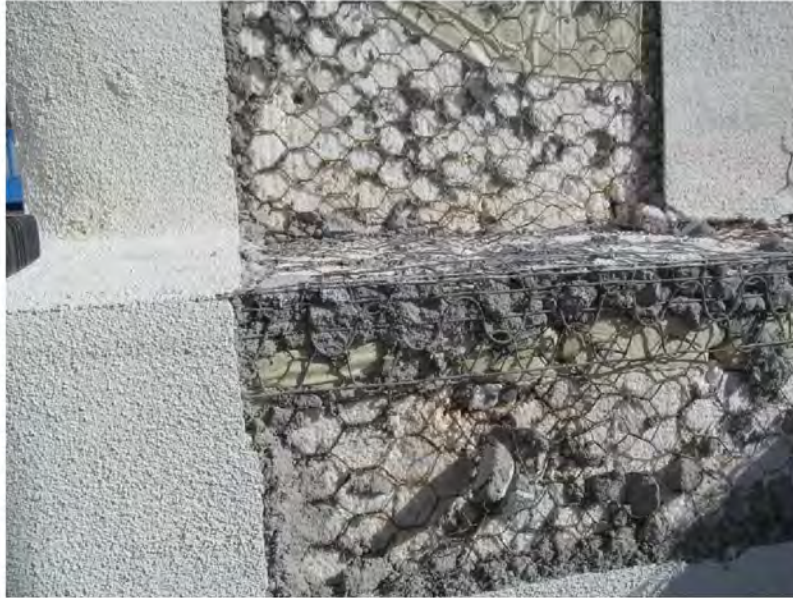
March 11, 2021, Disc IT10, Photograph 67, SSR, Building A, rusted lath, rusted fasteners, and stains on EPS foam board due to moisture intrusion.

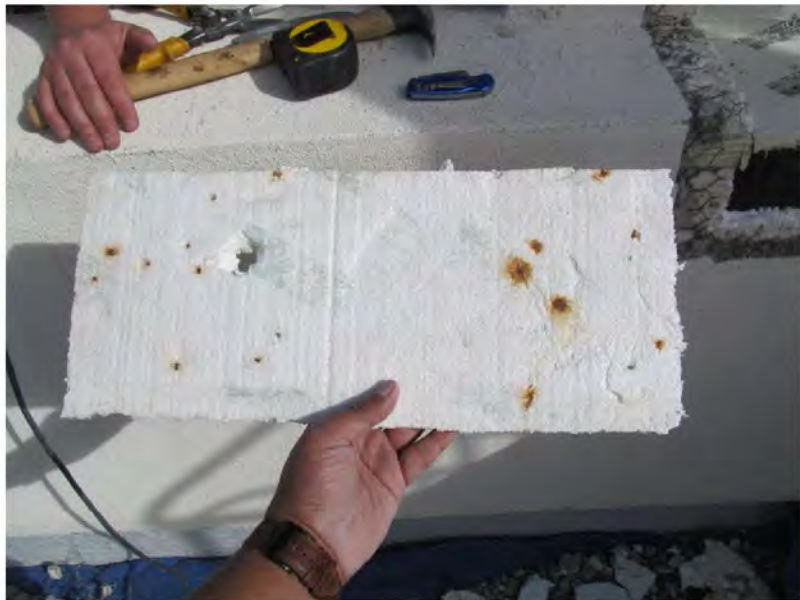
March 11, 2021, Disc IT10, Photograph 103, SSR, Building A, reverse side of EPS foam board shows stains due to corrosion of fasteners.

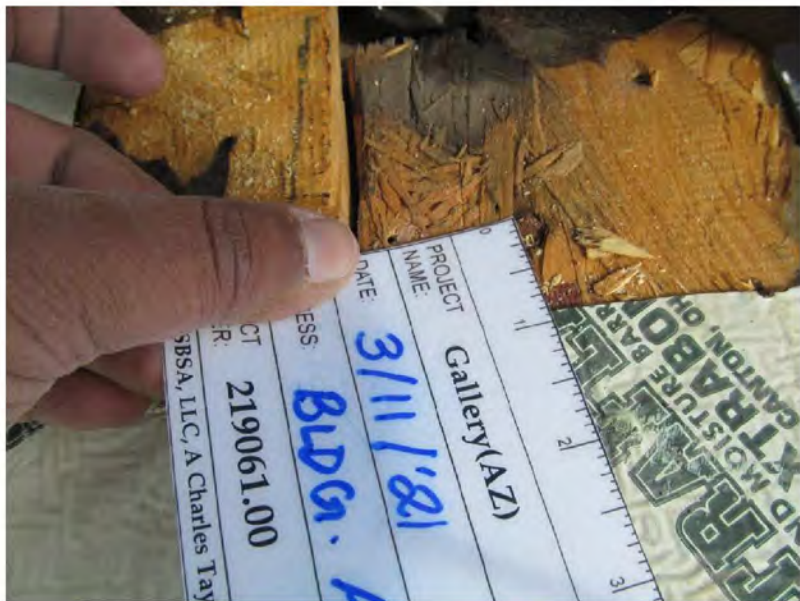
March 11, 2021, Disc IT10, Photograph 125, SSR, Building A, top plate under SAM has stains and rusted fasteners.

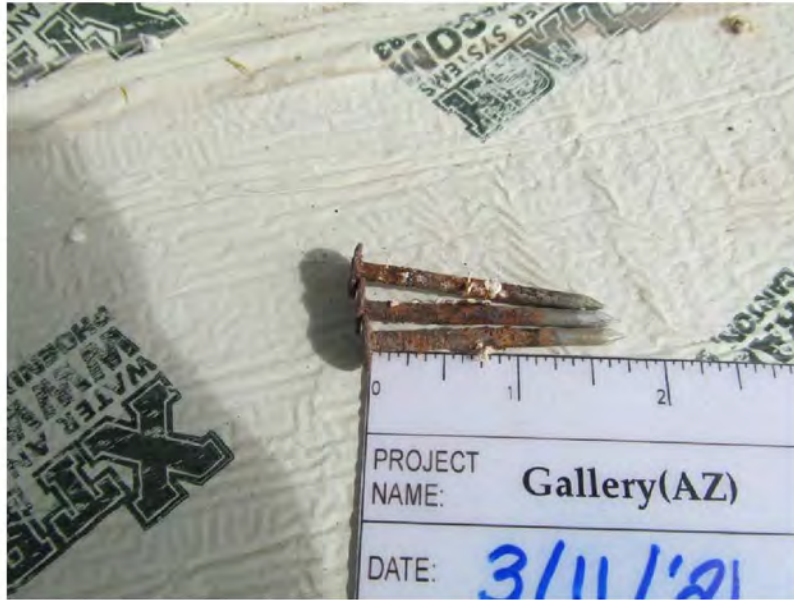
March 11, 2021, Disc IT10, Photograph 132, SSR, Building A, top plate under SAM has stains and rusted fasteners.

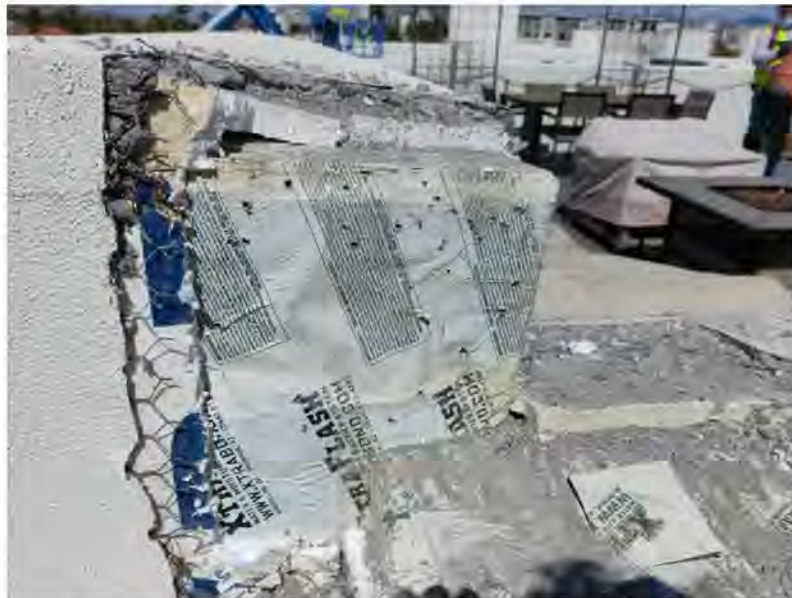
March 11, 2021, Disc IT10, Photograph 378, SSR, Building D, puncture holes in SAM allow moisture intrusion.

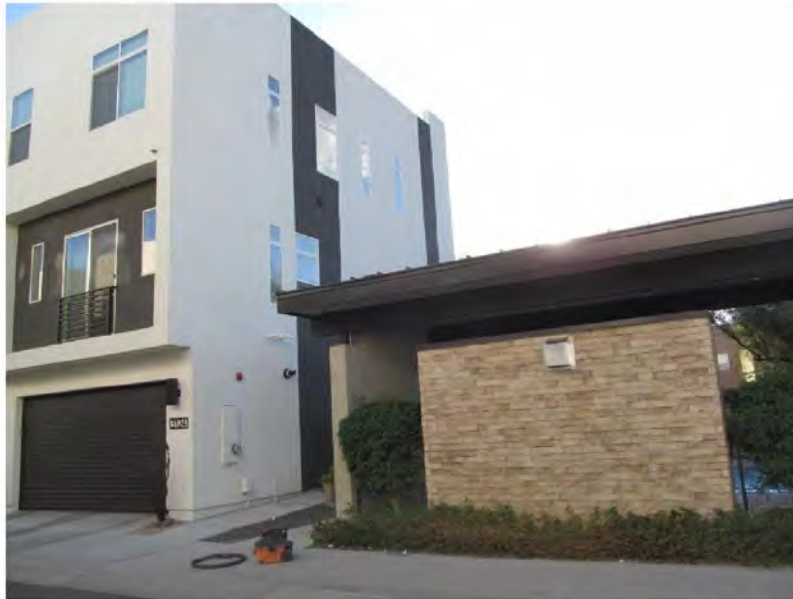
March 10, 2021, Disc OBS 5, Photograph 2, SSR, Building A, missing horizontal movement joints at floorlines.

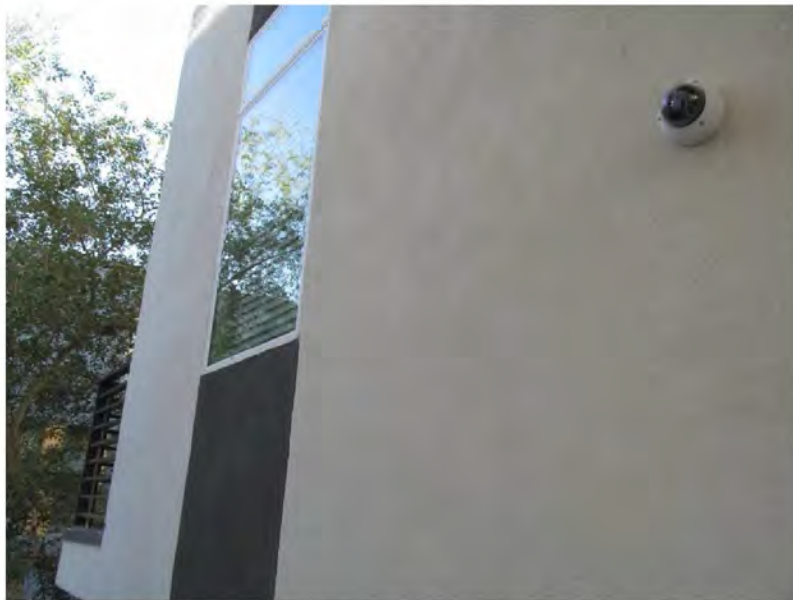
March 10, 2021, Disc OBS 5, Photograph 28, SSR, Building A, horizontal stucco crack. See below photo for close-up view of damage.

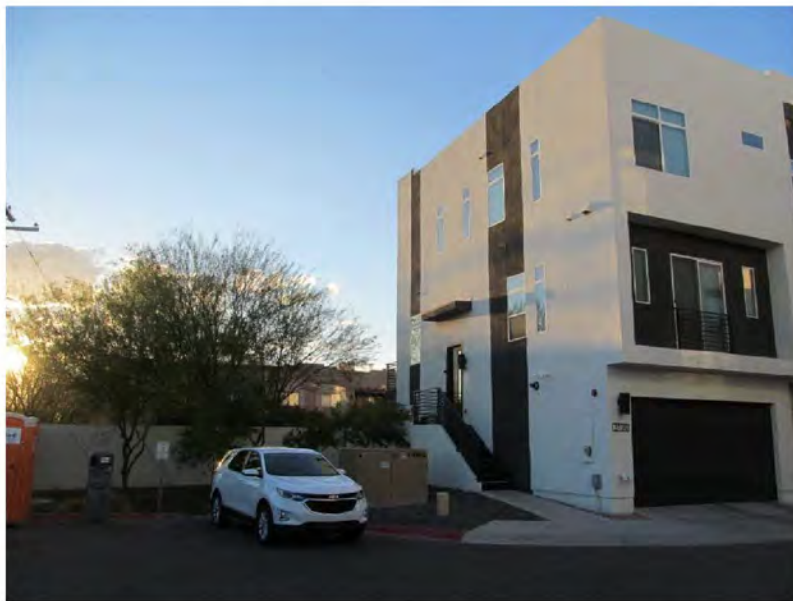
March 10, 2021, Disc OBS 5, Photograph 63, SSR, Building B, missing horizontal movement joints at floorlines.

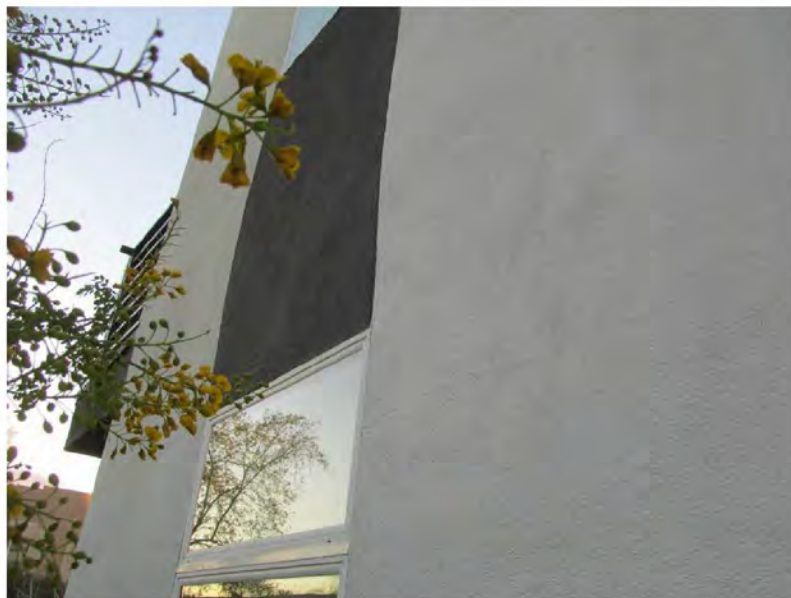
March 10, 2021, Disc OBS 5, Photograph 95, SSR, Building B, stucco cracks.

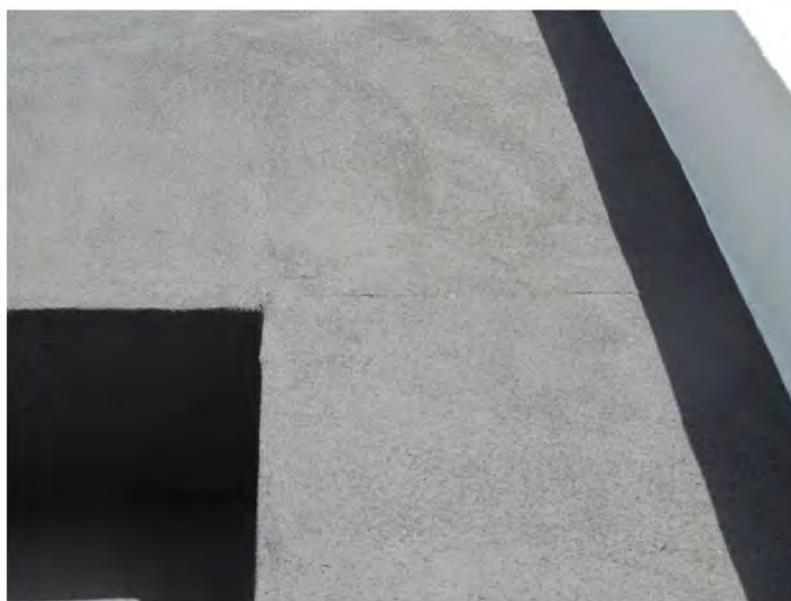
March 9, 2021, Disc IT5, Photograph 169, JJF, Building B, missing control joint and horizontal crack in stucco at floorline.

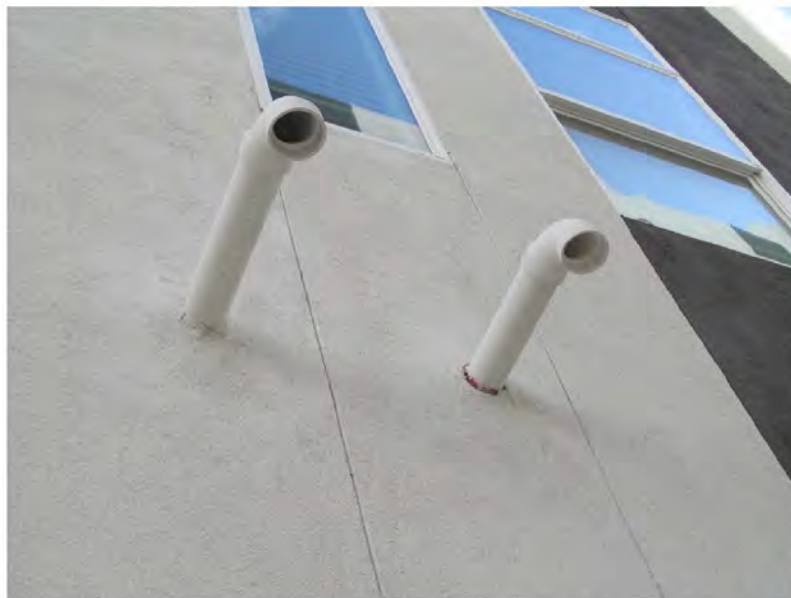
March 11, 2021, Disc OBS 6, Photograph 30, JJF, Building C, vertical control joints were provided on side elevations at re-entrant corners.

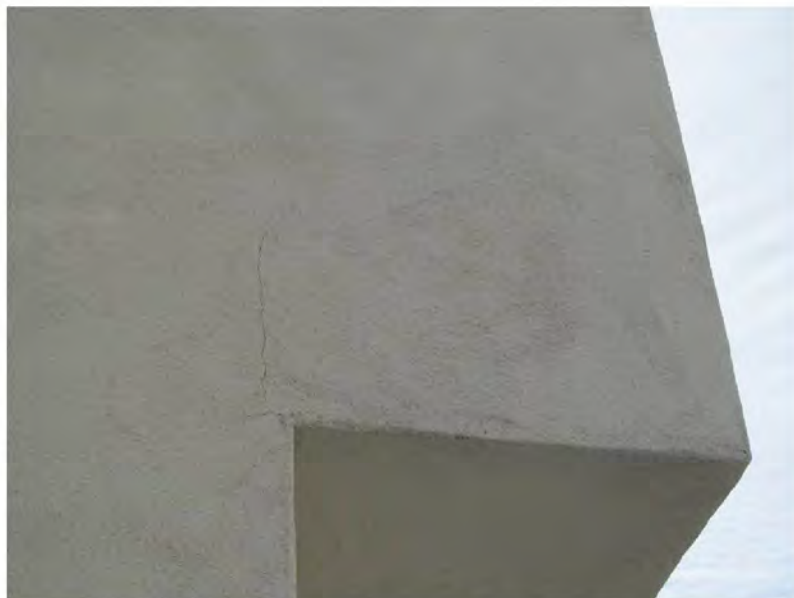
March 11, 2021, Disc OBS 6, Photograph 209, JJF, Building C, stucco cracks.

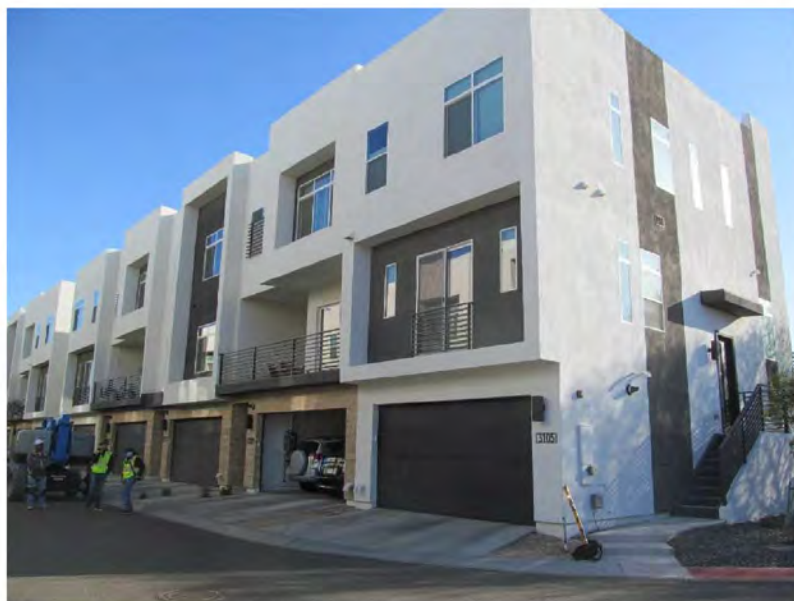
March 10, 2021, Disc IT 8, Photograph 6, SSR, Building D, missing horizontal movement joints at floorlines.

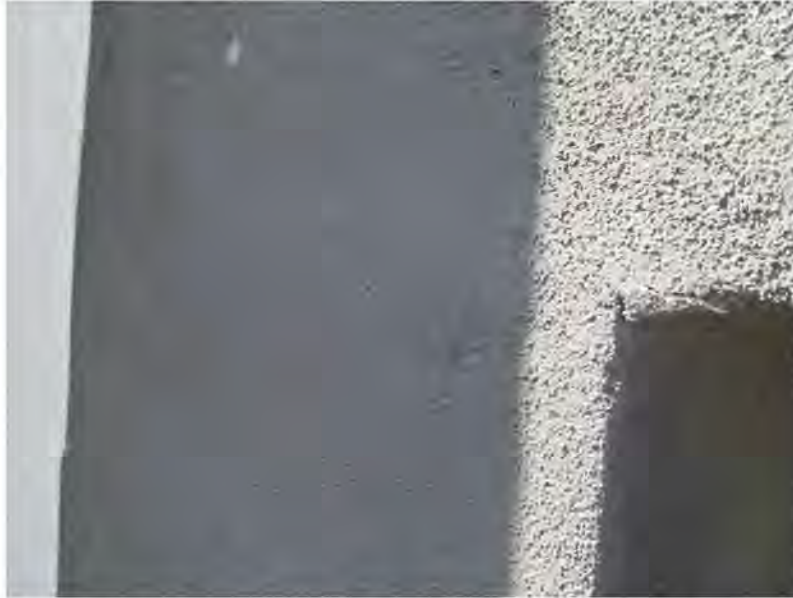
March 10, 2021, Disc IT7, Photograph 97, JF, Building D, missing control joint and horizontal crack in stucco at floorline.

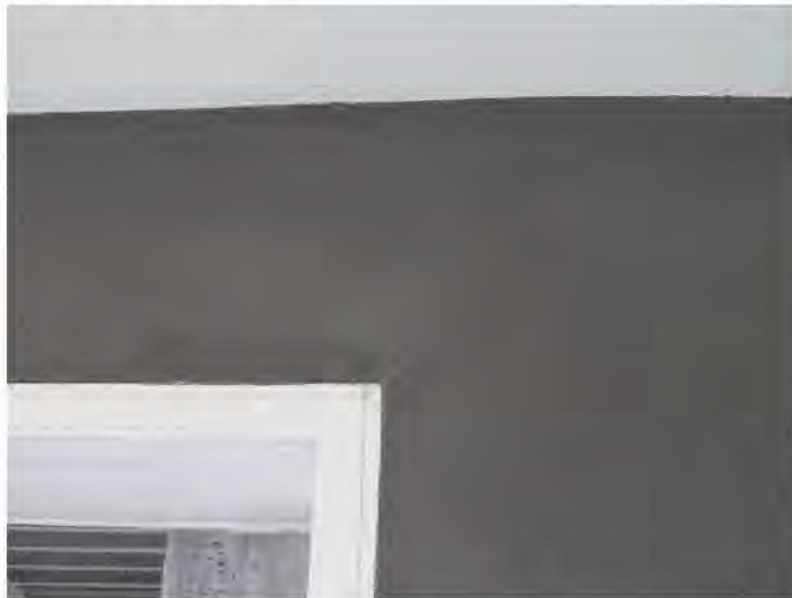
March 9, 2021, Disc IT5, Photograph 3, JJF, Building A, missing flashing at sliding door head.

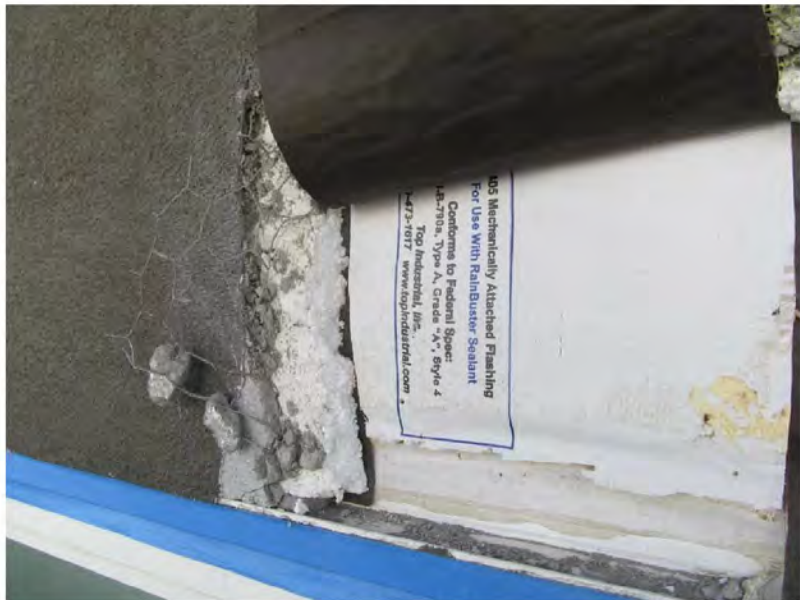
March 9, 2021, Disc IT6, Photograph 286, SSR, Building A, missing flashing at sliding door head.

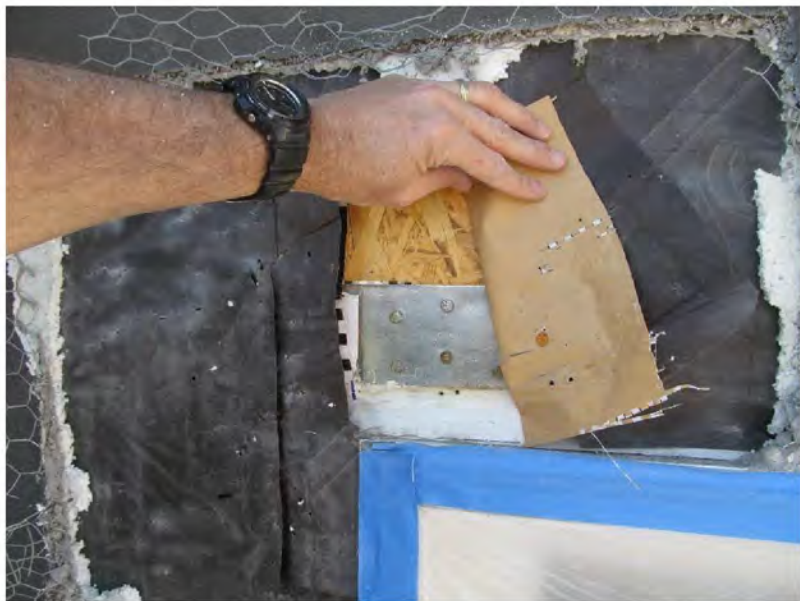
March 10, 2021, Disc IT7, Photograph 139, JJF, Building D, missing flashing at sliding door head.

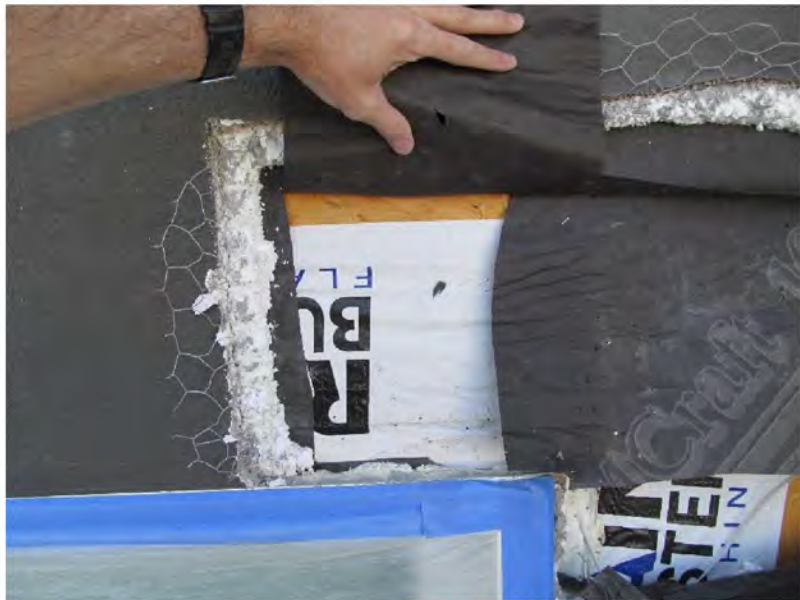
March 10, 2021, Disc IT7, Photograph 212, JJF, Building C, missing flashing at sliding door head.

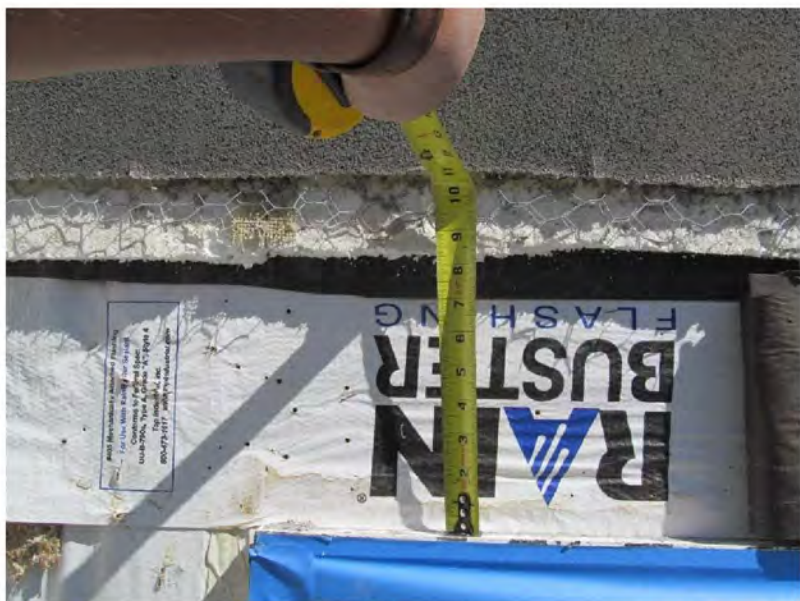
March 10, 2021, Disc IT8, Photograph 219, SSR, Building D, missing flashing at window head.

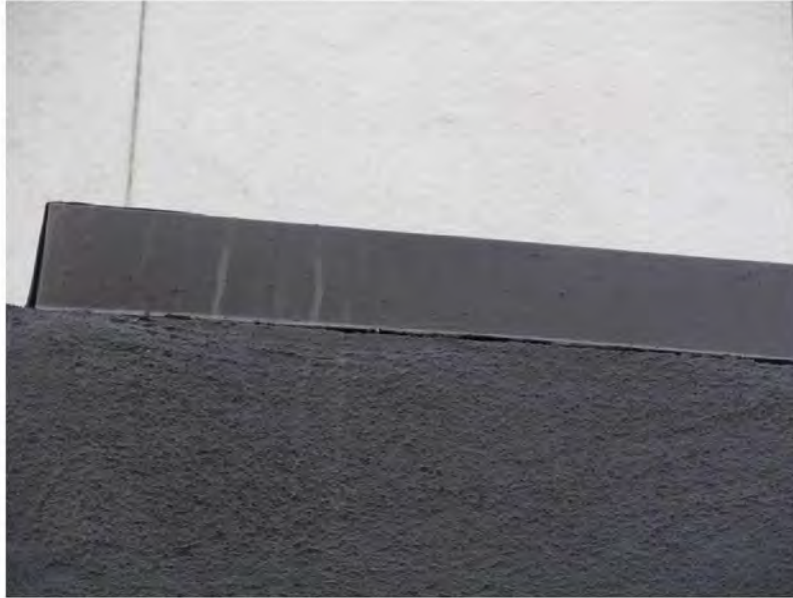
March 10, 2021, Disc OBS5, Photograph 69, SSR, Building. B, awning edge flashing inset at stucco.

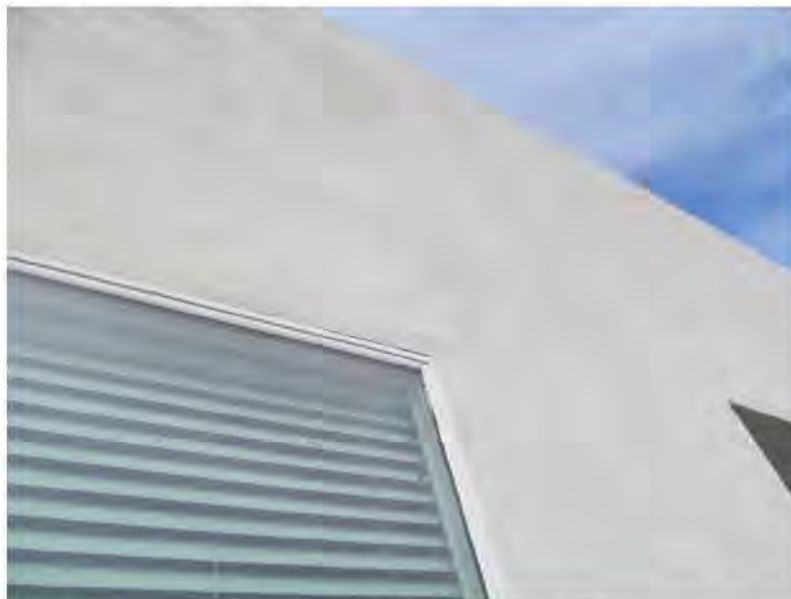
March 9, 2021, Disc IT6, Photograph 12, SSR, Building A, non-compliant isolation joint at window to stucco interface with a diagonal crack at top right corner of window.

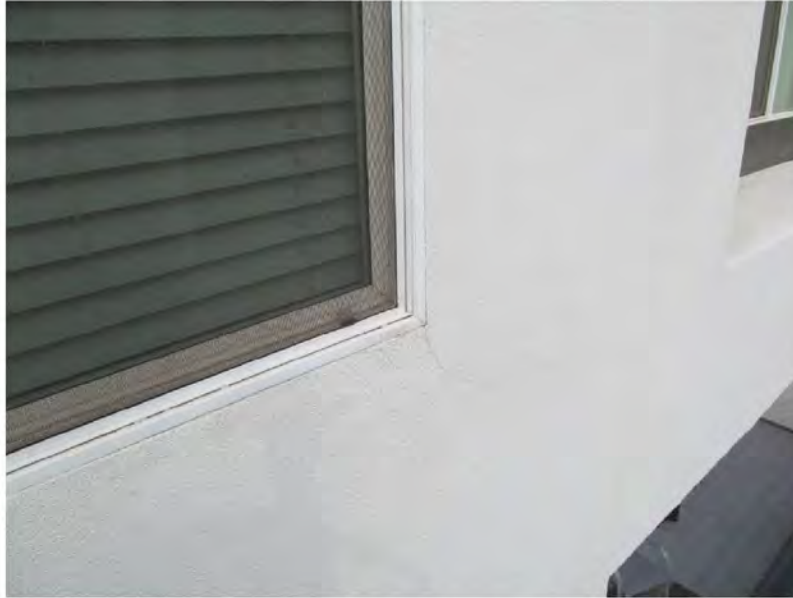
March 9, 2021, Disc IT6, Photograph 14, SSR, Building A, non-compliant isolation joint at window to stucco interface with a diagonal crack at bottom right corner of window.

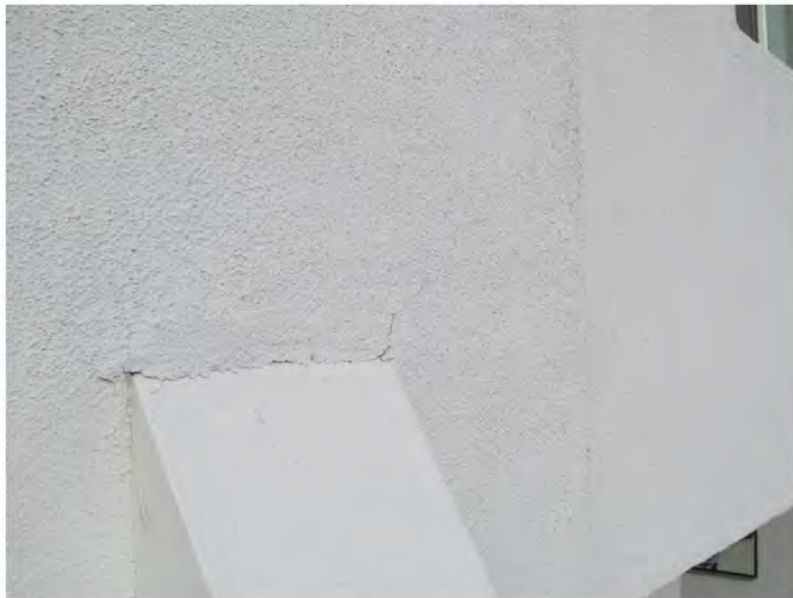
March 9, 2021, Disc IT6, Photograph 27, SSR, Building A, non-compliant isolation joint at penetration to stucco interface with a diagonal crack at top right corner of dryer vent.

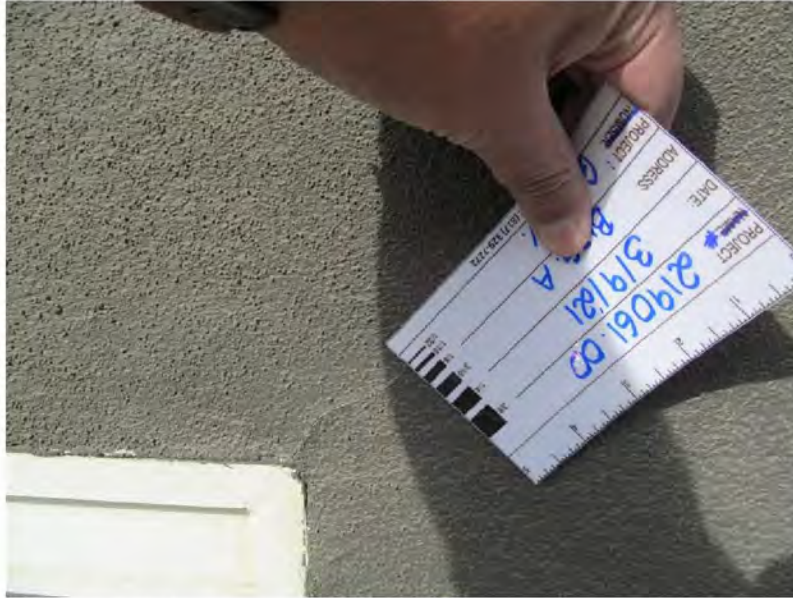
March 9, 2021, Disc IT6, Photograph 39, SSR, Building A, non-compliant isolation joint at sliding door to stucco interface with a diagonal crack at top right corner of sliding door.

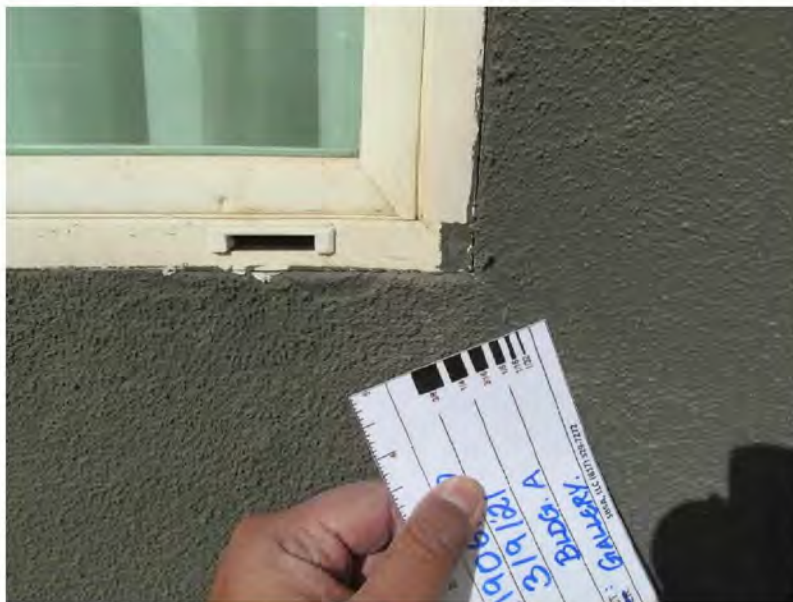
March 9, 2021, Disc IT6, Photograph 81, SSR, Building A, non-compliant isolation joint at window to stucco interface with a diagonal crack at bottom right corner of window.

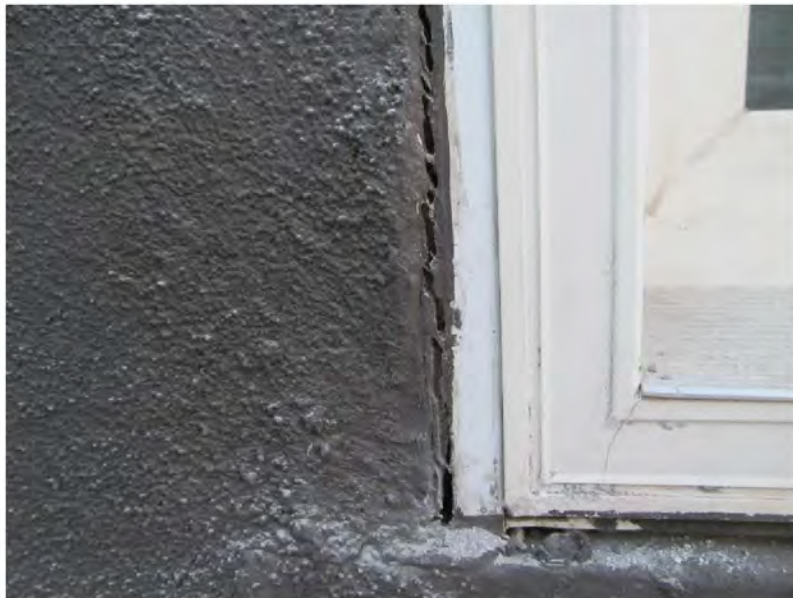
March 10, 2021, Disc IT7, Photograph 149, JJF, Building D, failed sealant joint at door to stucco interface; no backer rod visible.

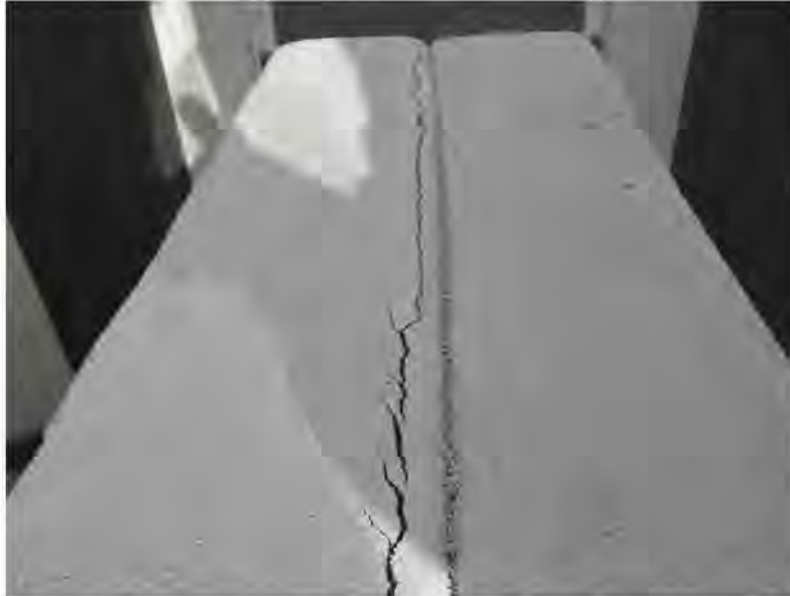
March 11, 2021, Disc OBS6, Photograph 28, JBF, stairs between Buildings C and D, cracking and separation of stair wall. SBSA understands builder performed repairs at this location.

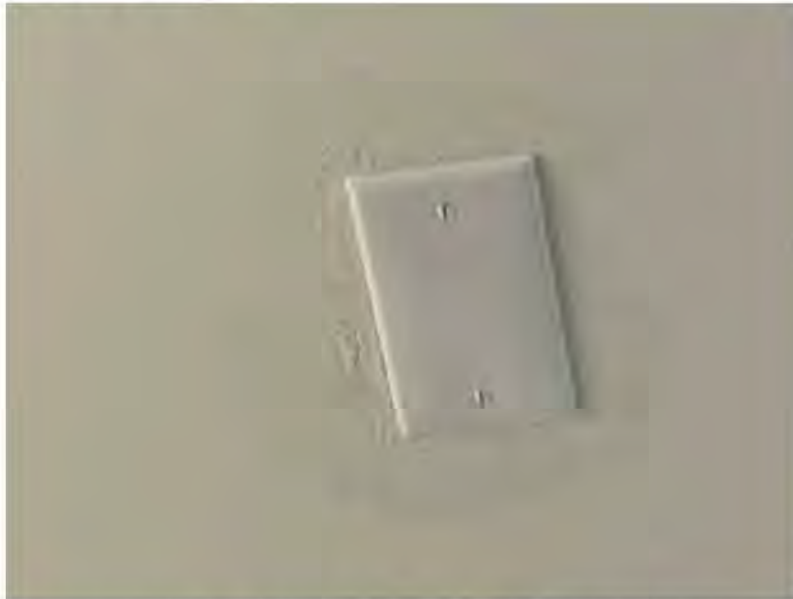
Homeowner-disclosed photo, disclosed on June 18, 2021, Building B - Unit 3112, Bates Number GALLERY-CHANG 3112-000006, water stains at ceiling due to previous roof leak event.

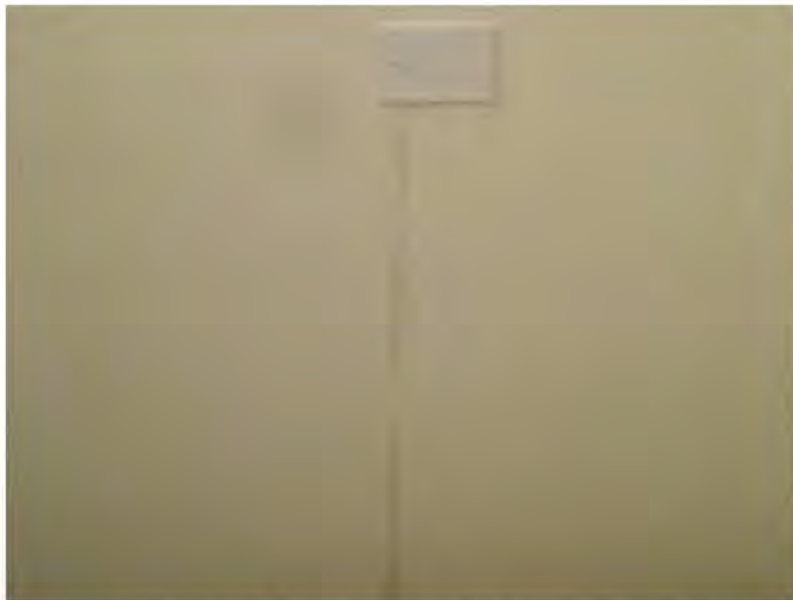
Homeowner-disclosed photo, disclosed on June 18, 2021, Building B - Unit 3110, Bates Number GALLERY-LINE 3110-000002, water stains at ceiling due to previous roof leak event.

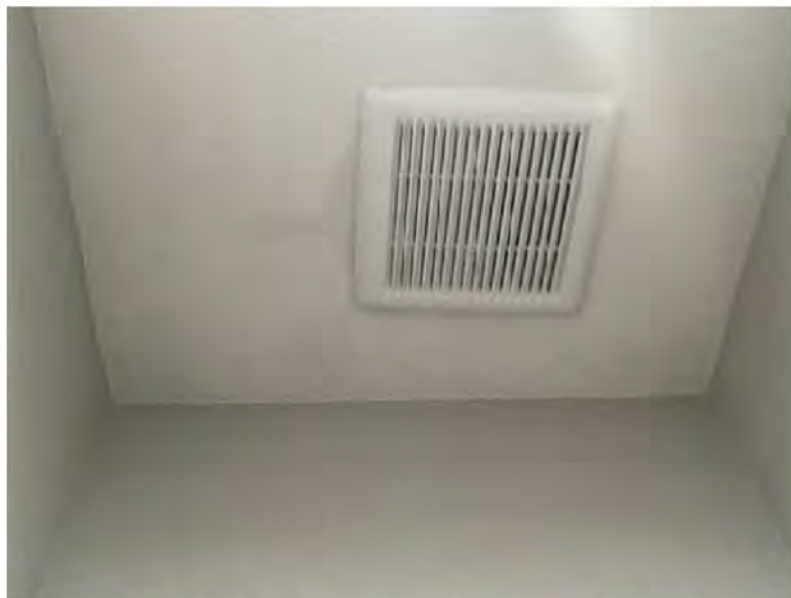
Homeowner-disclosed photo, disclosed on June 18, 2021, Building B - Unit 3110, Bates Number GALLERY-LINE 3110-000004, water stains at vent due to previous roof leak event.

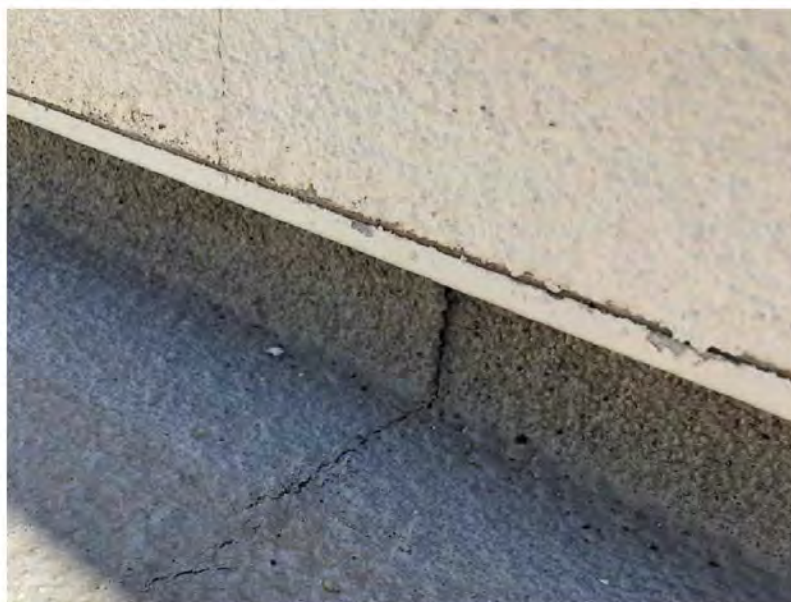
Nautilus-disclosed photo, disclosed on June 16, 2021, Building B - Unit 3110, Photo Number 6, tear and split of roof surface adjacent to drains.

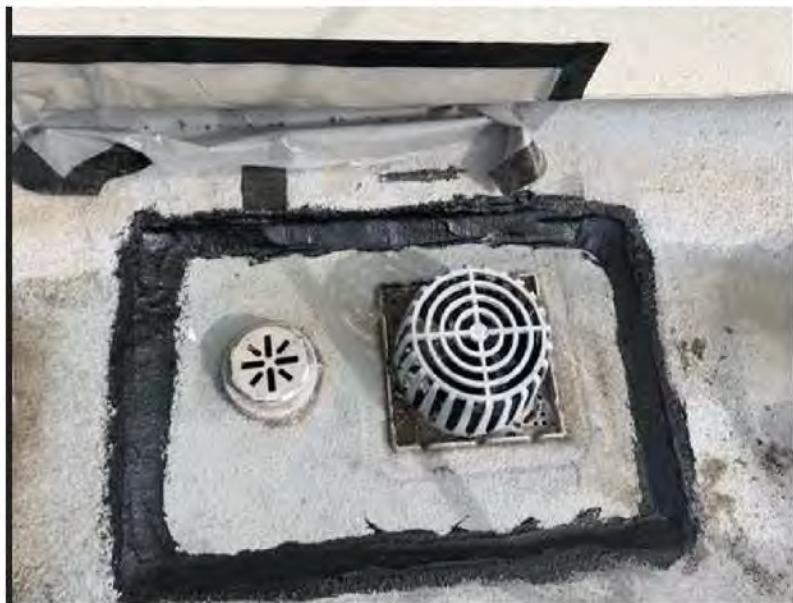
Nautilus photo, disclosed on June 16, 2021, Building B – Unit 3110, Photo Number 21, temporary repairs to reduce future roof leaks.

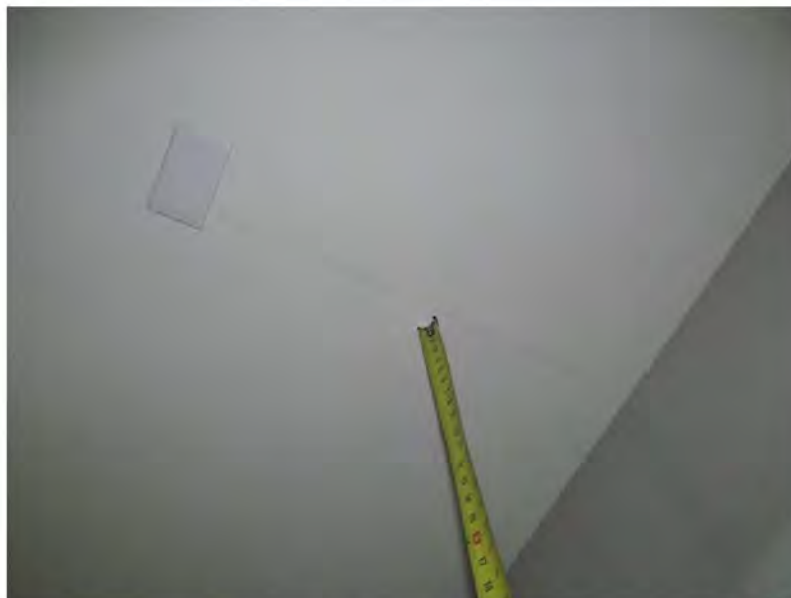
March 10, 2021, Disc IT8, Photograph 302, SSR, Building B - Unit 3110, stains at ceiling under the roof.

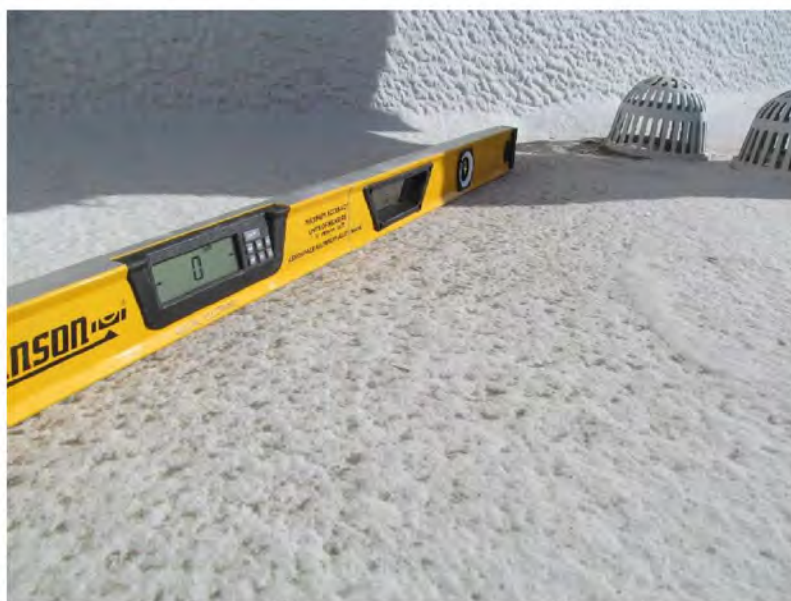
March 11, 2021, Disc IT10, Photograph 44, SSR, Building A, 0-inch-per-foot slope at cricket towards point of drainage.

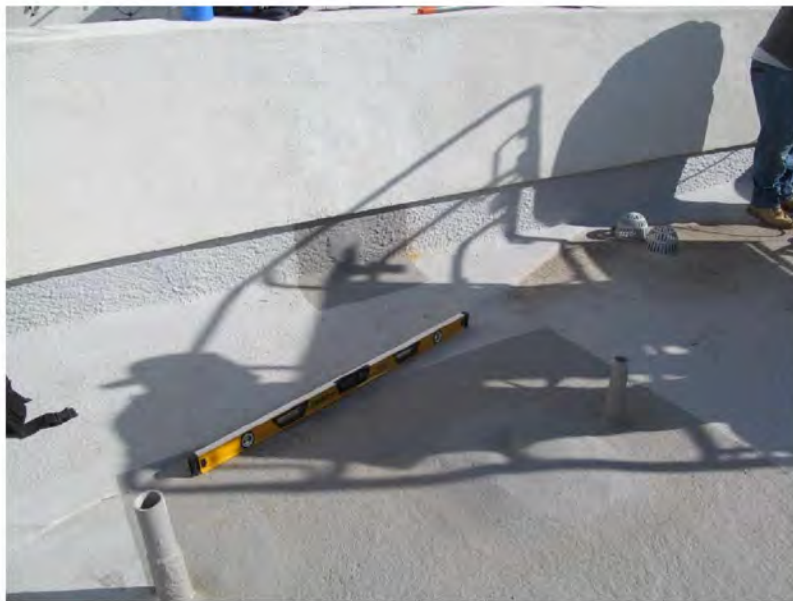
March 11, 2021, Disc IT10, Photograph 52, SSR, Building A, 0-inch-per-foot slope at cricket towards point of drainage. Note stains indicate ponding water.

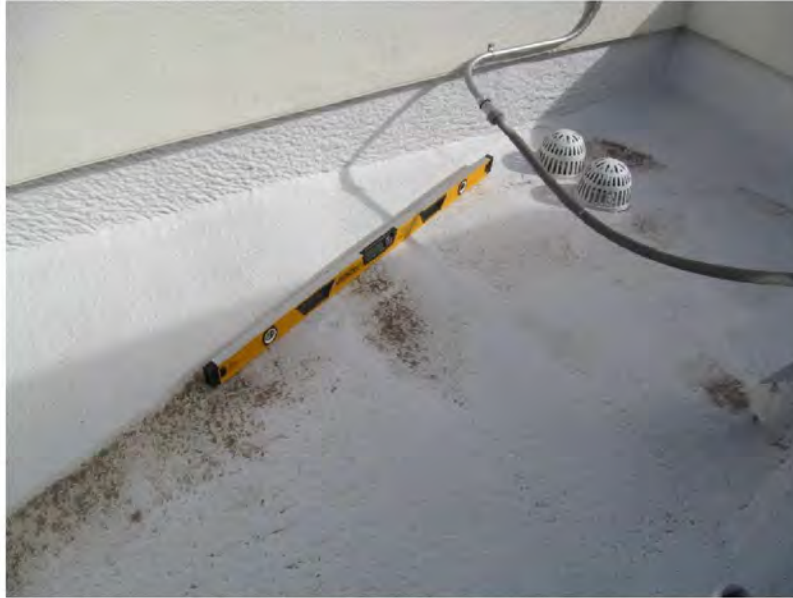
March 11, 2021, Disc IT10, Photograph 94, SSR, Building A, 0-inch-per-foot slope at cricket towards point of drainage. Note stains indicate ponding water.

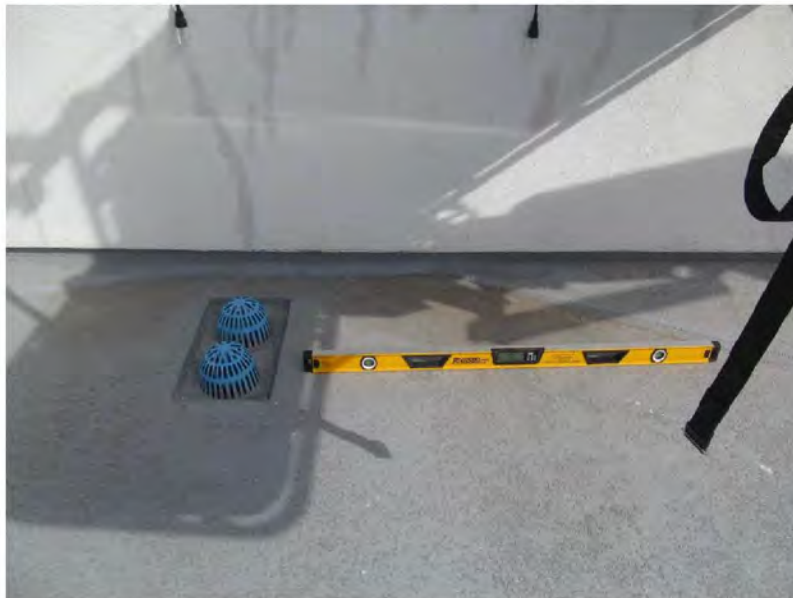
March 11, 2021, Disc IT10, Photograph 99, SSR, Building A, 0-inch-per-foot slope at cricket towards point of drainage. Note stains indicate ponding water.

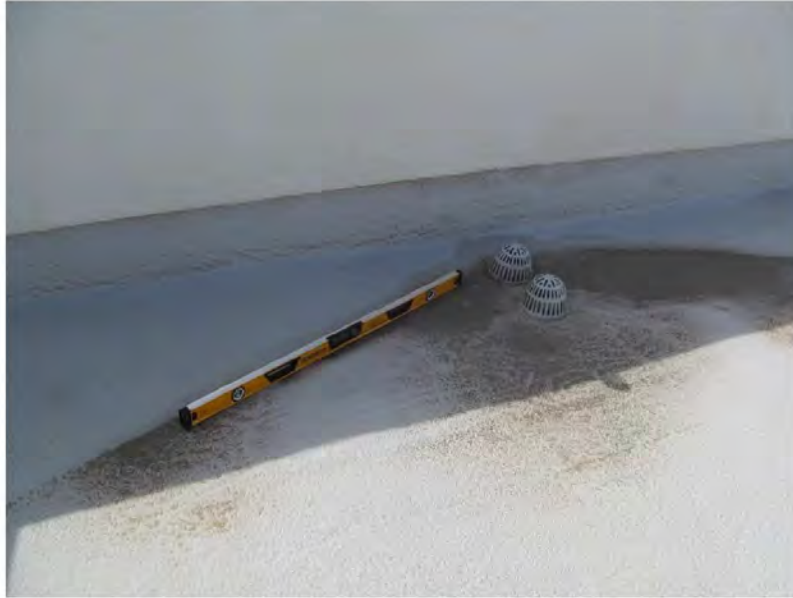
March 11, 2021, Disc IT10, Photograph 157, SSR, Building A, 0-inch-per-foot slope at cricket towards point of drainage. Note stains indicate ponding water.
