**Applicable Code/Industry Standard References/Project-Specific Documents:**

Otak, Inc., "K. Hovnanian Homes, Gallery Townhomes," revised date August 2, 2016, Sheet A8.05 "Exterior Details," illustrates the following:

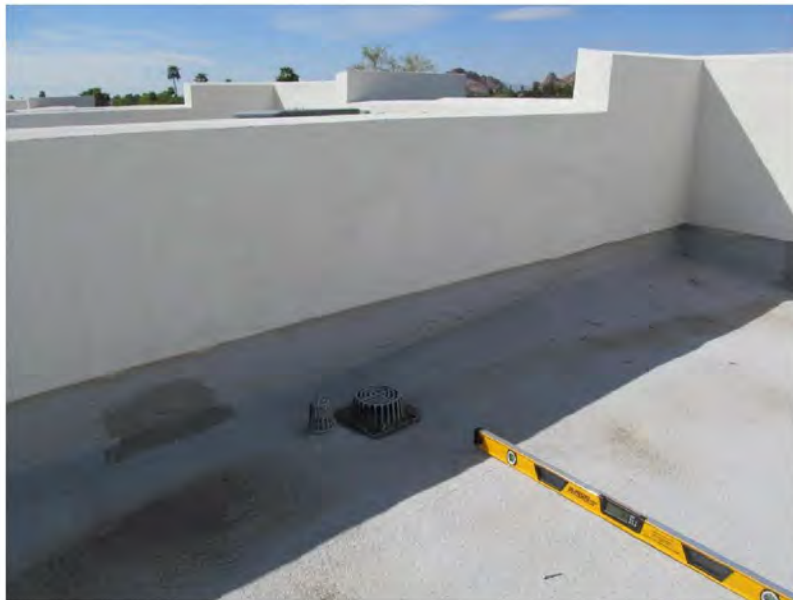
March 11, 2021, Disc IT10, Photograph 203, SSR, Building B, 1/8-inch-per-foot slope towards point of drainage. Note stains indicate ponding water.

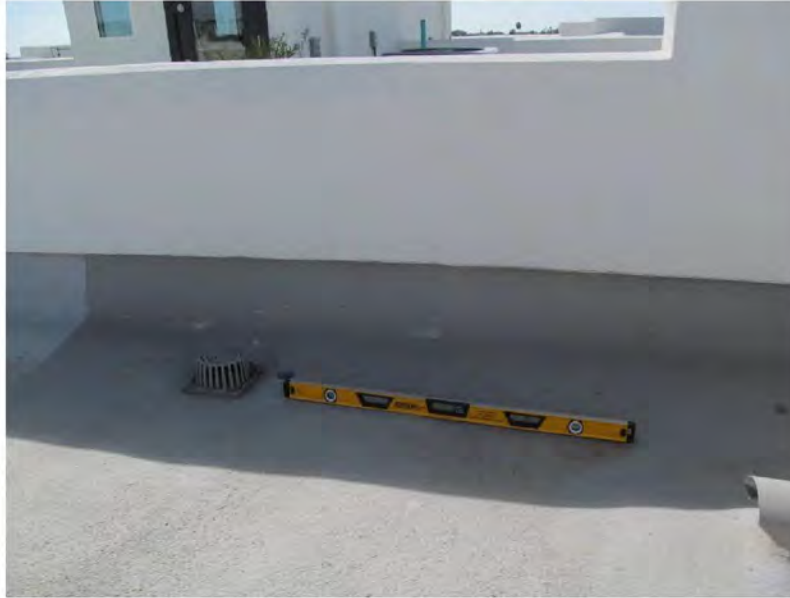
March 11, 2021, Disc IT10, Photograph 236, SSR, Building B, 0-inch-per-foot slope towards point of drainage. Note stains indicate ponding water.

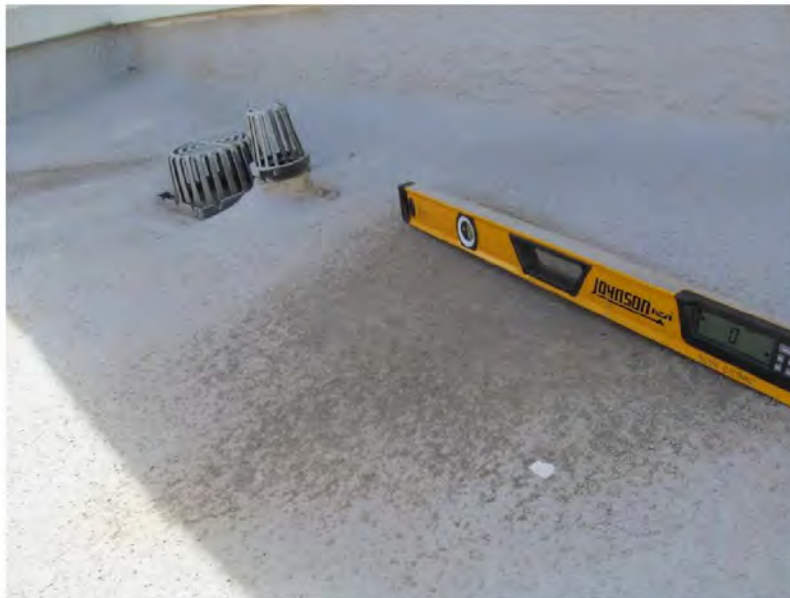
March 11, 2021, Disc IT10, Photograph 287, SSR, Building B, 0-inch-per-foot slope at cricket towards point of drainage. Note stains indicate ponding water.

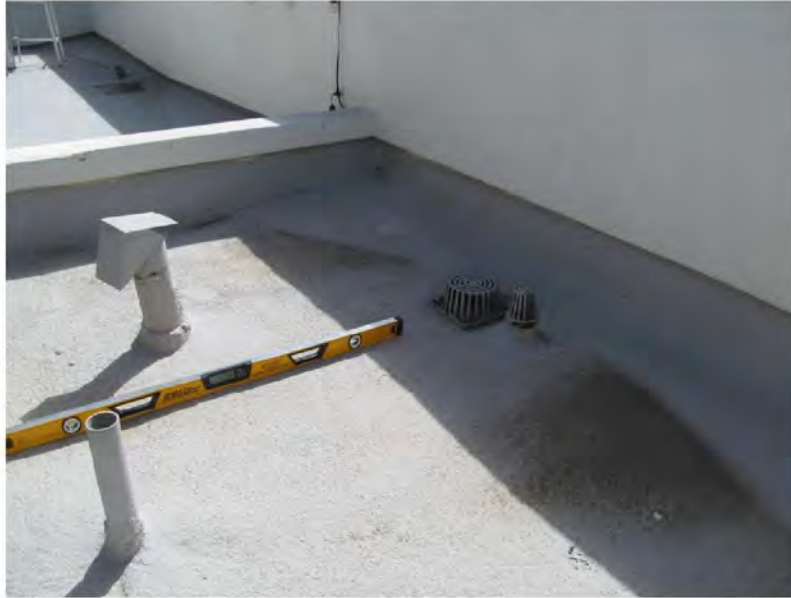
March 11, 2021, Disc IT10, Photograph 288, SSR, Building B, 1/8-inch-per-foot slope towards point of drainage. Note stains indicate ponding water.

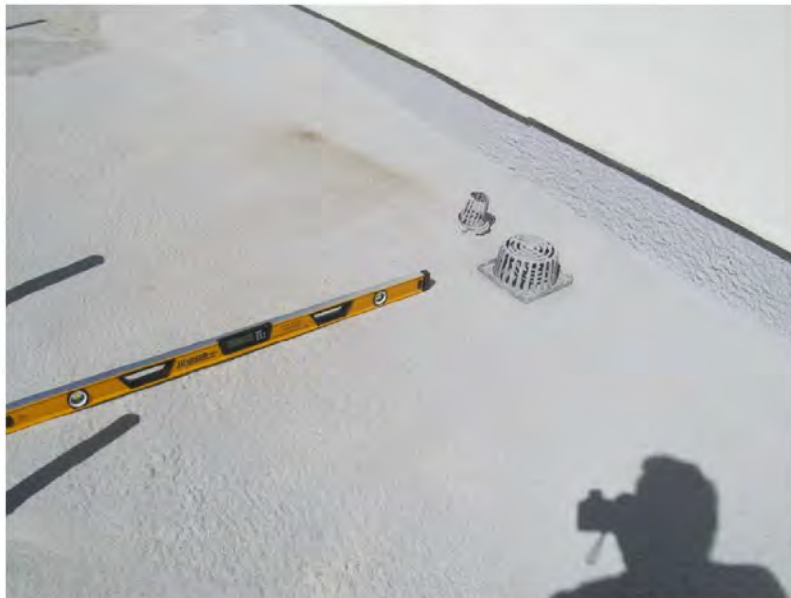
March 11, 2021, Disc IT10, Photograph 331, SSR, Building B, 1/4-inch-per-foot slope towards point of drainage as required by the project-specific drawings. Note stains indicate ponding water.

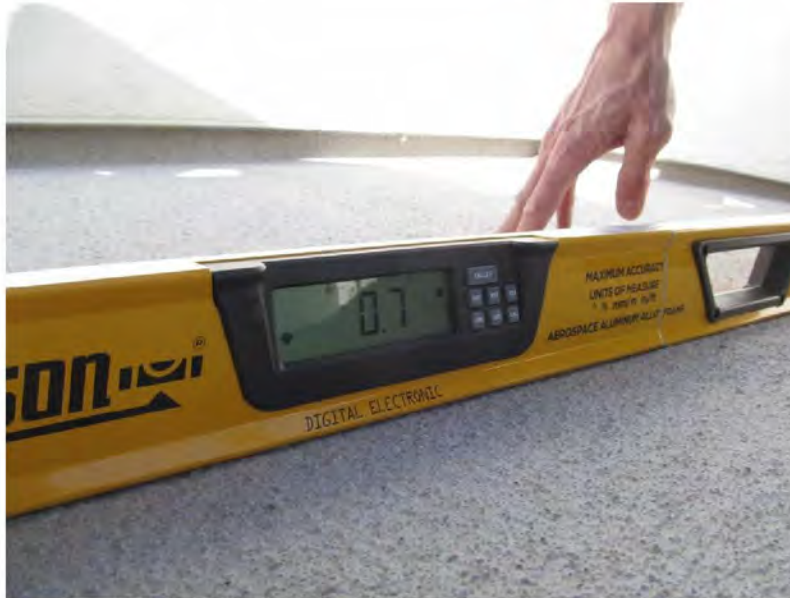
March 10, 2021, Disc IT8, Photograph 331, SSR, Building B - Unit 3110, 0.7-percent slope at cricket towards point of drainage.

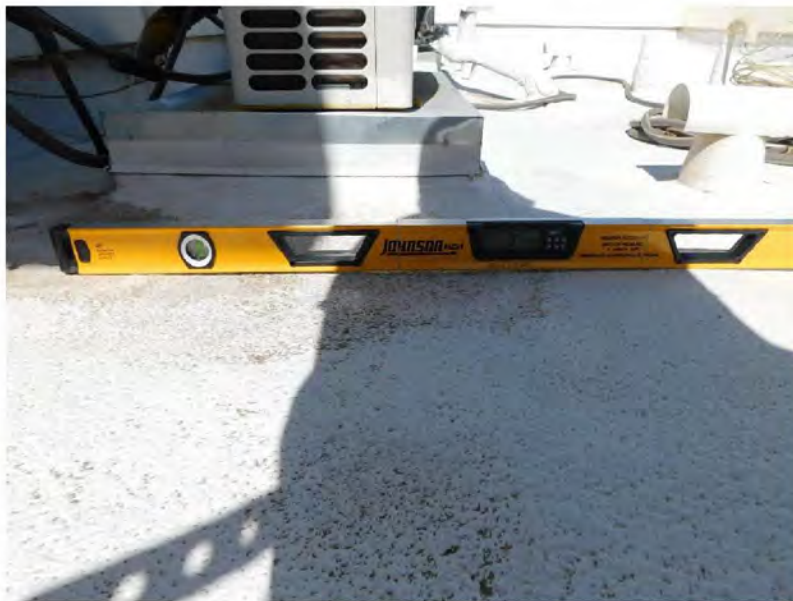
March 11, 2021, Disc OBS7, Photograph 365, PER, Building C, no crickets at upslope locations of rooftop equipment. Note stains indicate ponding water.

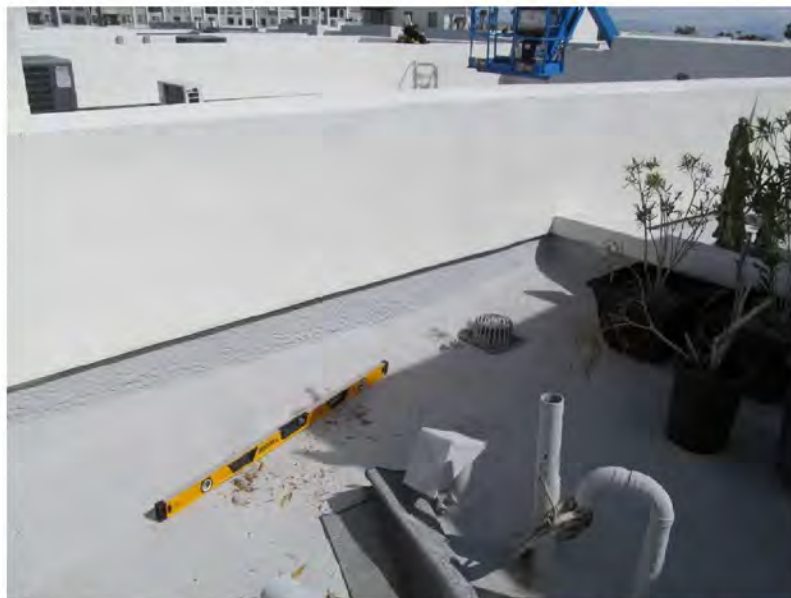
March 11, 2021, Disc OBS7, Photograph 293, PER, Building D, 0-inch-per-foot slope at cricket towards point of drainage.

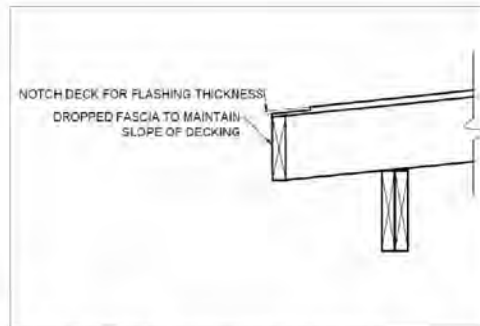
Figure 6. Fascia detail to maintain slope to free drainage edge.

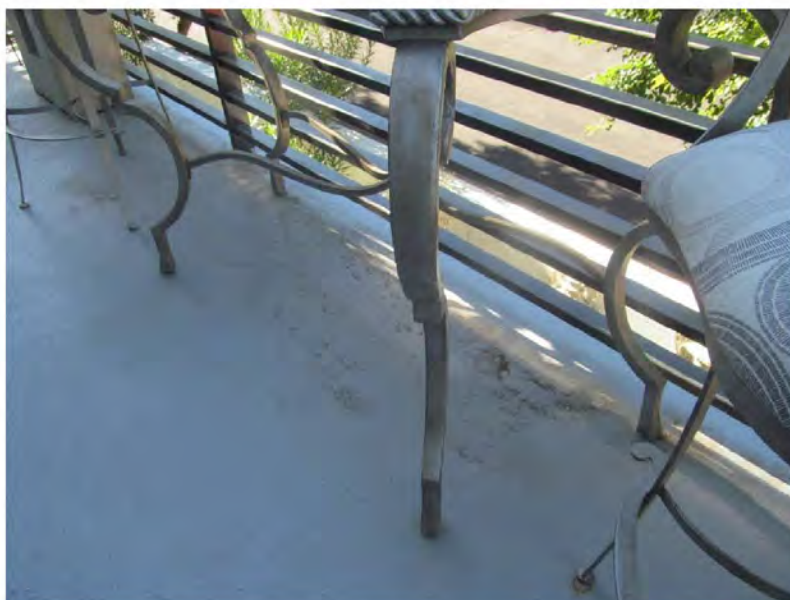
December 19, 2018, Disc OBS1, Photograph 167, JBF, Building A - Unit 3124, stains indicate ponding water at the deck edge.

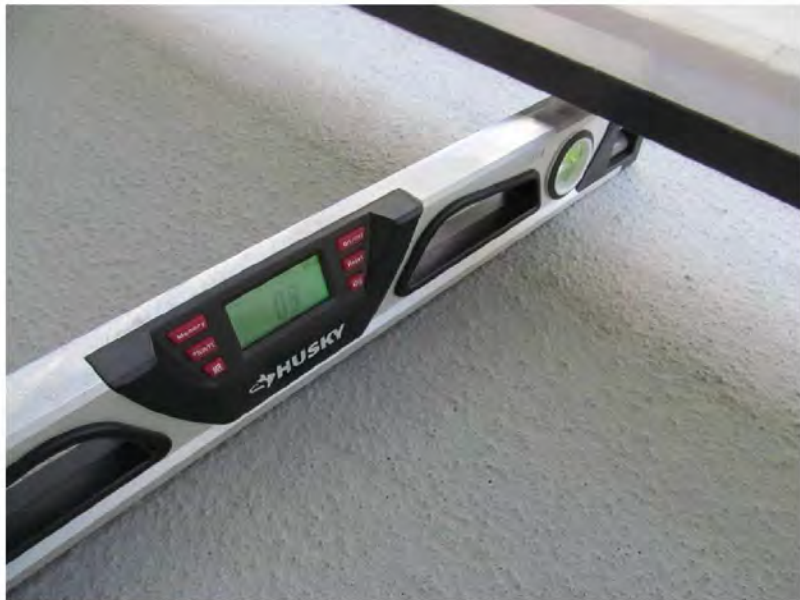
October 14, 2019, Disc OBS2, Photograph 462, SSR, Building A - Unit 3122, 0.9-percent slope at the deck edge.

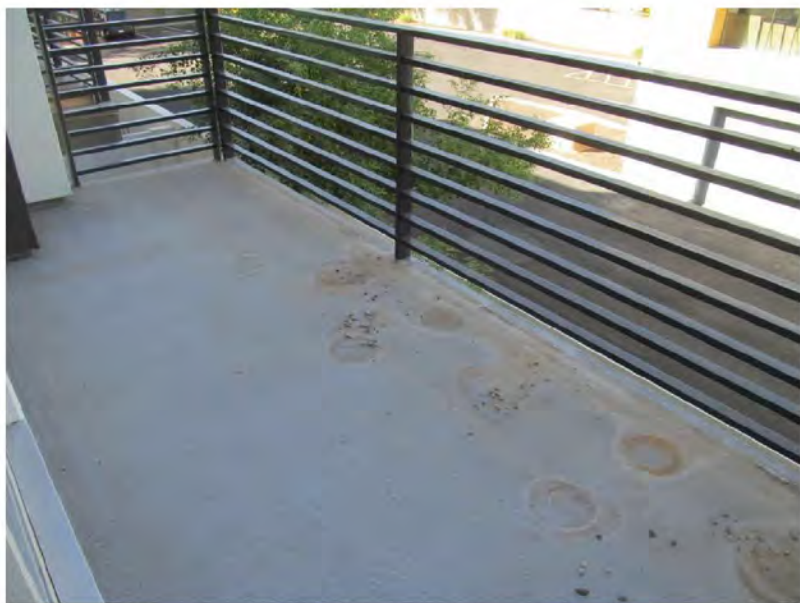
October 14, 2019, Disc OBS2, Photograph 64, SSR, Building B - Unit 3116, stains indicate ponding water at the deck edge.

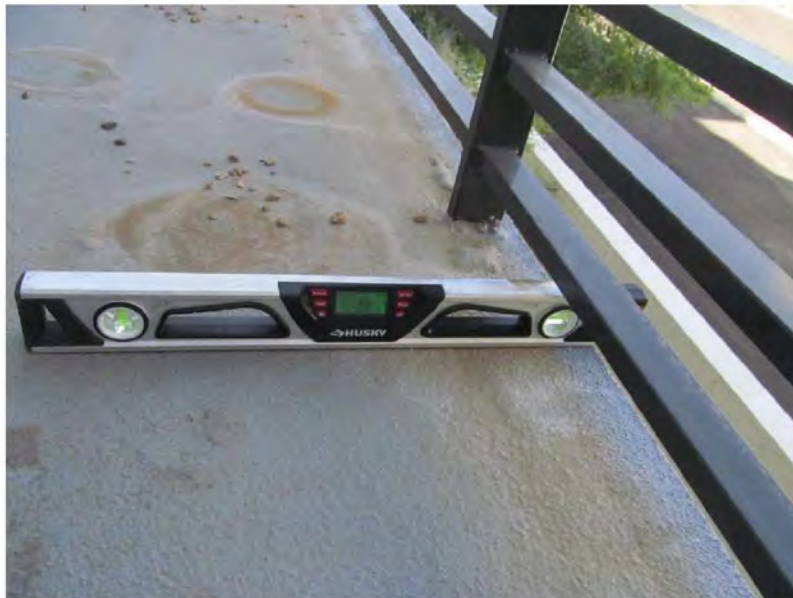
October 14, 2019, Disc OBS2, Photograph 71, SSR, Building B - Unit 3116, 0.9-percent slope at the deck edge.

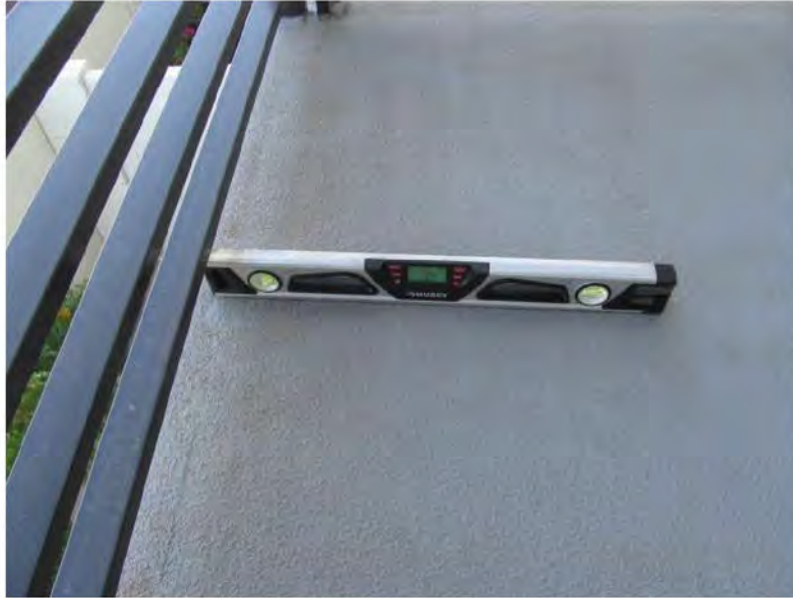
October 15, 2019, Disc OBS3, Photograph 175, SSR, Building B - Unit 3106, 0.4-percent slope at the deck edge and stains of water ponding at the edge.

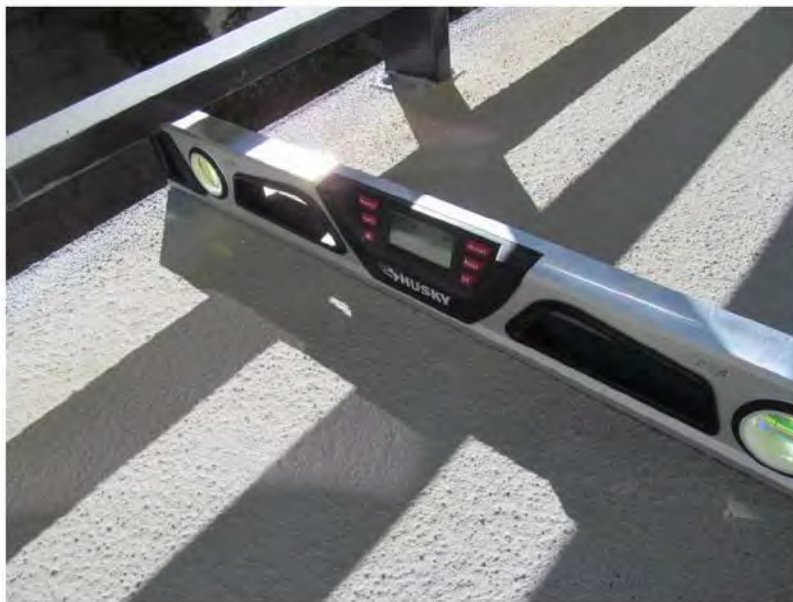
October 15, 2019, Disc OBS3, Photograph 36, SSR, Building C - Unit 3123, 1.4-percent slope at the deck edge.

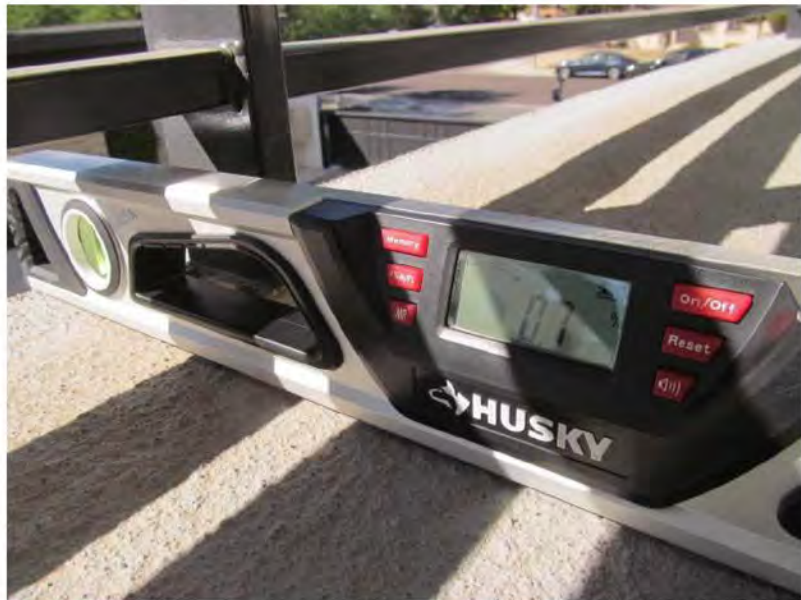
October 15, 2019, Disc OBS3, Photograph 277, SSR, Building C - Unit 3125, 0.7-percent slope at the deck edge and stains of water ponding at the edge.

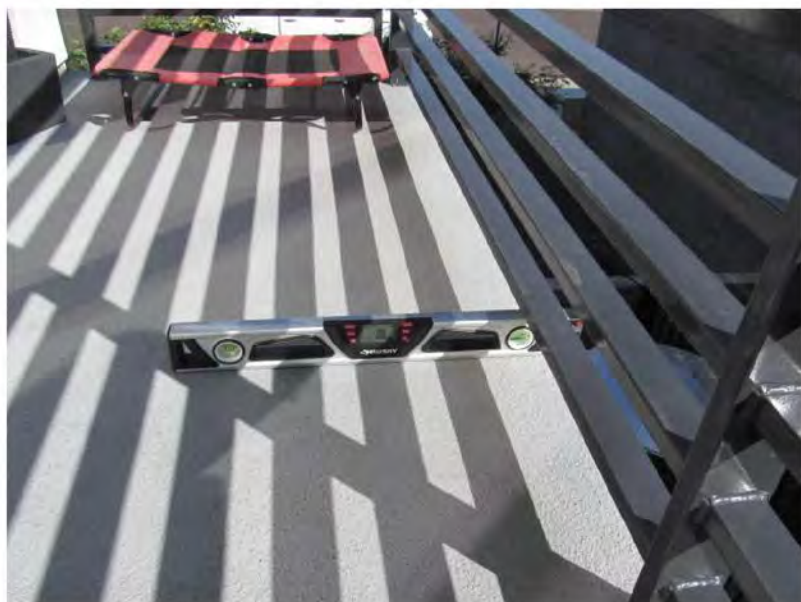
October 16, 2019, Disc OBS4, Photograph 22, SSR, Building C - Unit 3127, 0.8-percent slope at the deck edge and stains of water ponding at the edge.

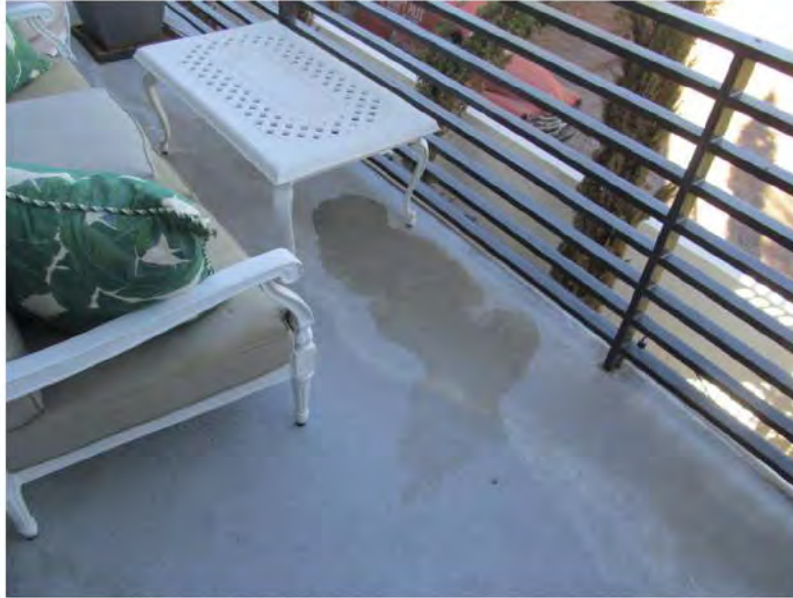
October 15, 2019, Disc OBS3, Photograph 401, SSR, Building D - Unit 3105, stains of water ponding at the edge.

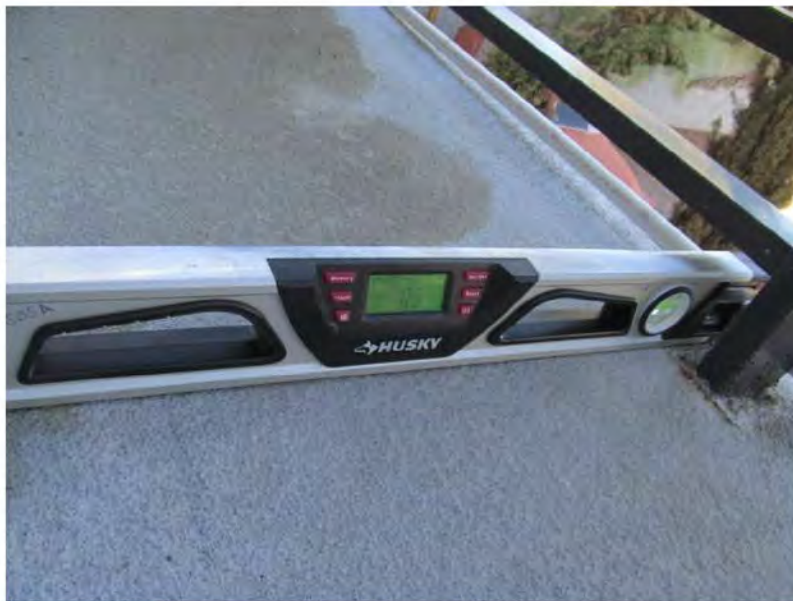
October 15, 2019, Disc OBS3, Photograph 414, SSR, Building D - Unit 3105, 0.3-percent slope at the deck edge and stains of water ponding at the edge.
