1 **BURG SIMPSON ELDREDGE**
2 **HERSH & JARDINE P.C.**

3 8310 South Valley Highway, Suite 270
4 Englewood, CO 80112
5 Phone: (303) 792-5595
6 Fax: (303) 708-0527
7 Craig S. Nuss – 033839
8 Penny J. Manship – 034985
9 pmanship@burgsimpson.com

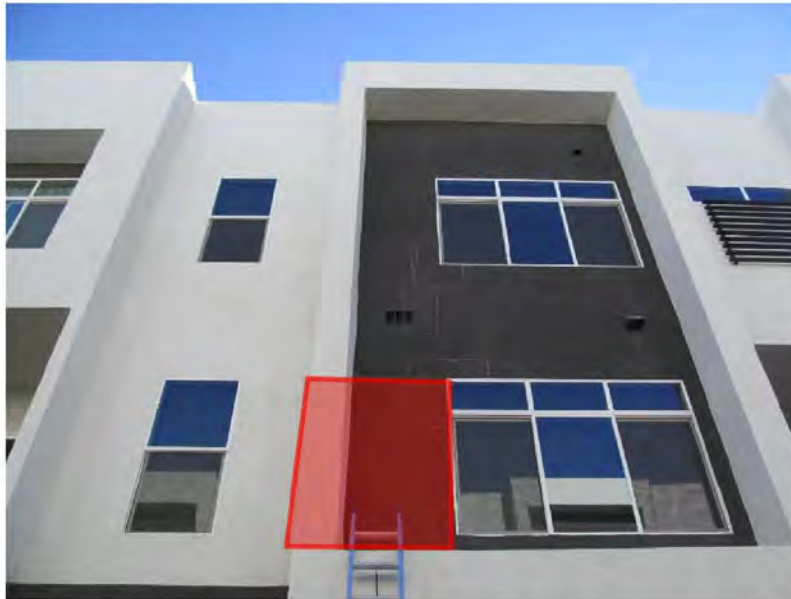
March 10, 2021, Disc IT8, Photograph 41, SSR, Building D - Unit 3111, overall view of building elevation with non-compliant LFRS. Red box outlines the approximate area within which the exterior sheathing was identified to be missing.

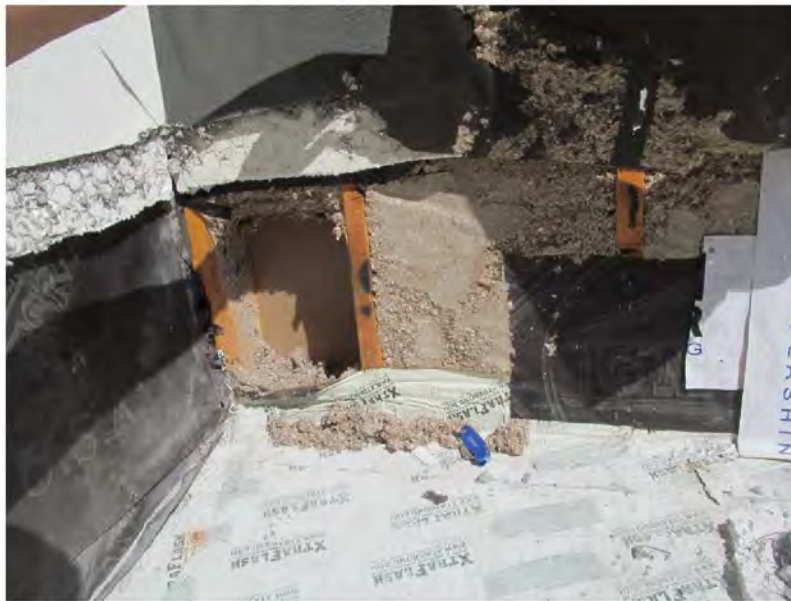
March 10, 2021, Disc IT8, Photograph 237, SSR, Building D - Unit 3111, missing OSB sheathing at existing stud framing.

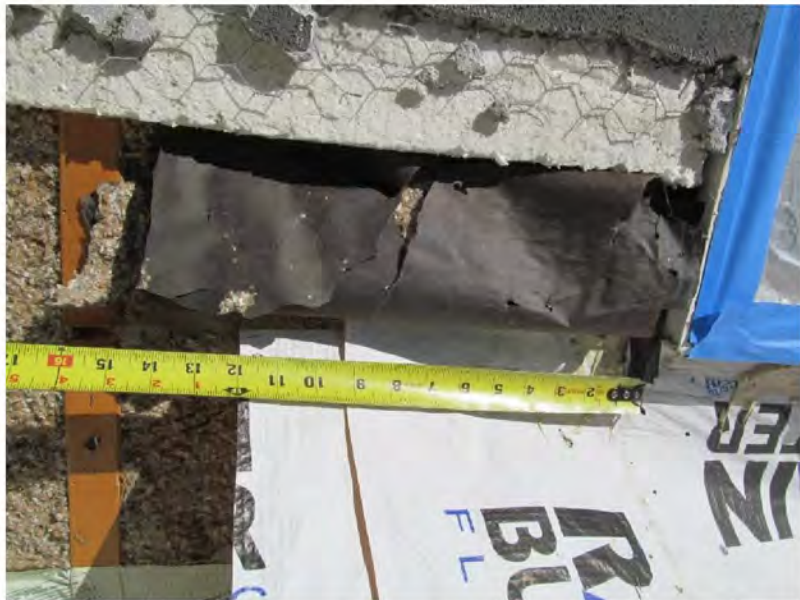
March 10, 2021, Disc IT8, Photograph 248, SSR, Building D - Unit 3111, missing OSB sheathing at existing stud framing.

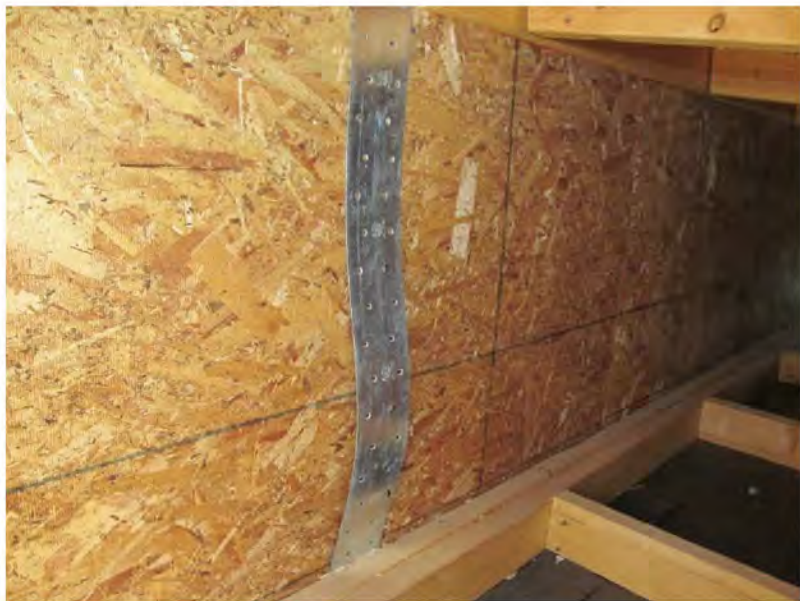
March 10, 2021, Disc IT8, Photograph 278, SSR, Building D - Unit 3111, CS-16 metal strap is disengaged and buckled.

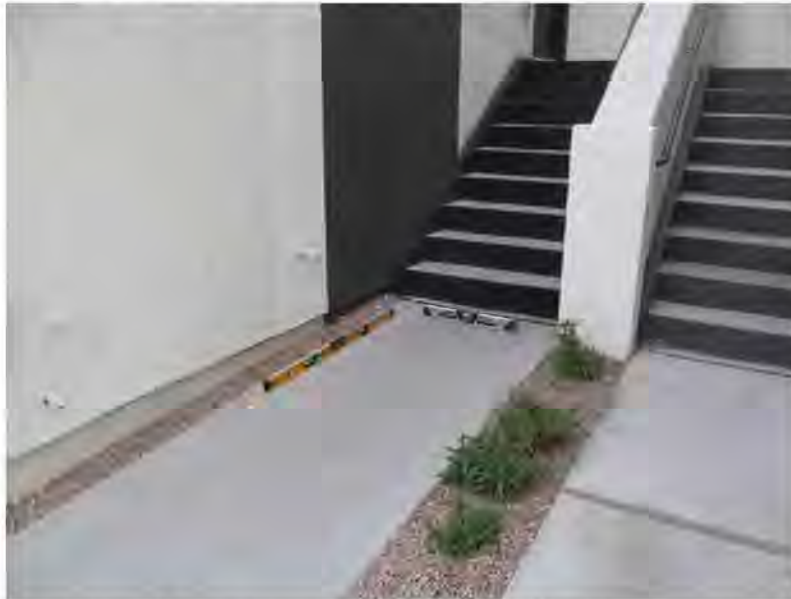
March 10, 2021 Disc OBS5, Photograph 97, SSR, Building B, north side, no landing constructed at bottom of stairs. Longitudinal slope of sidewalk is 4.7-percent.

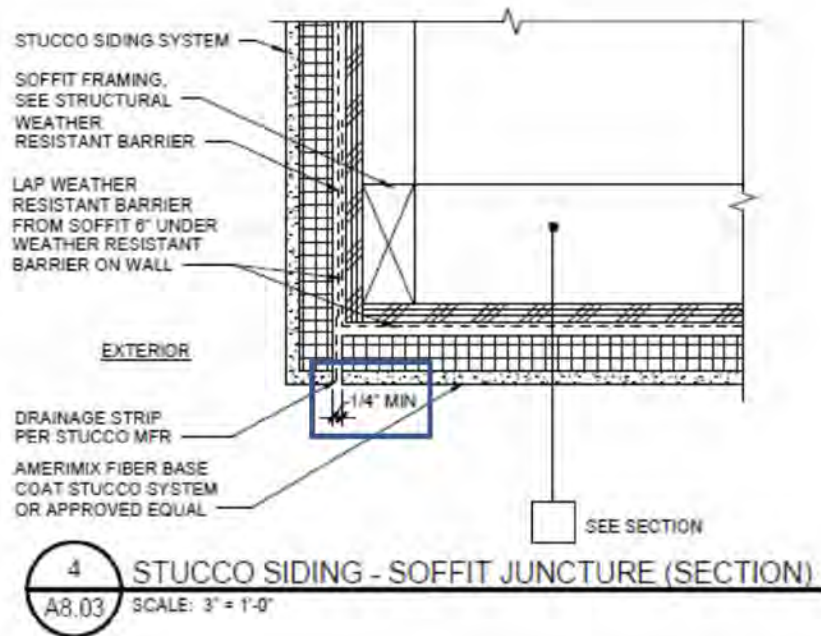
ICC Evaluation Service Report (ESR), Evaluation Report ESR-3529 "Evaluation Subject: Amerimix Fiber Base Coat Stucco," reissued February 2017, Section 4.0 "Installation," subsection 4.2 "Application over Open Framing," states the following:

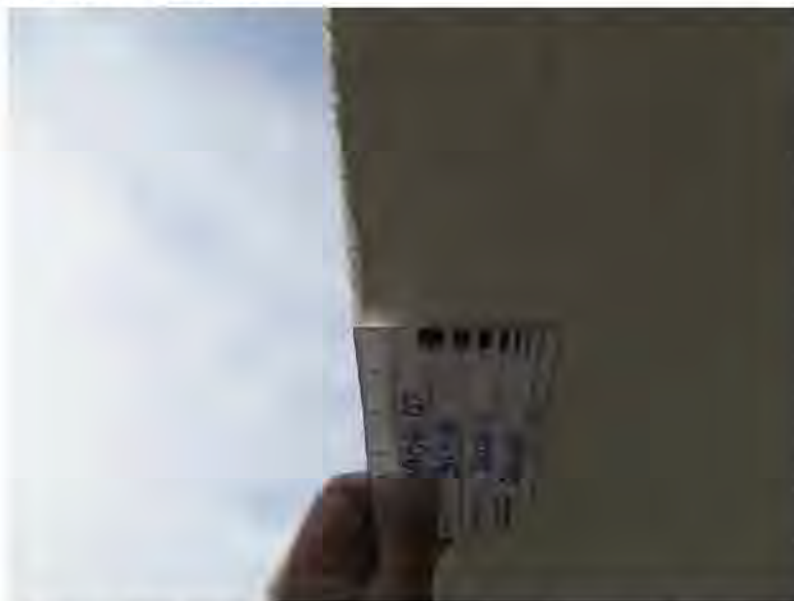
March 9, 2021, Disc IT6, Photograph 32, SSR, Building A, no weep mechanism at soffit and stucco crack along the edge.

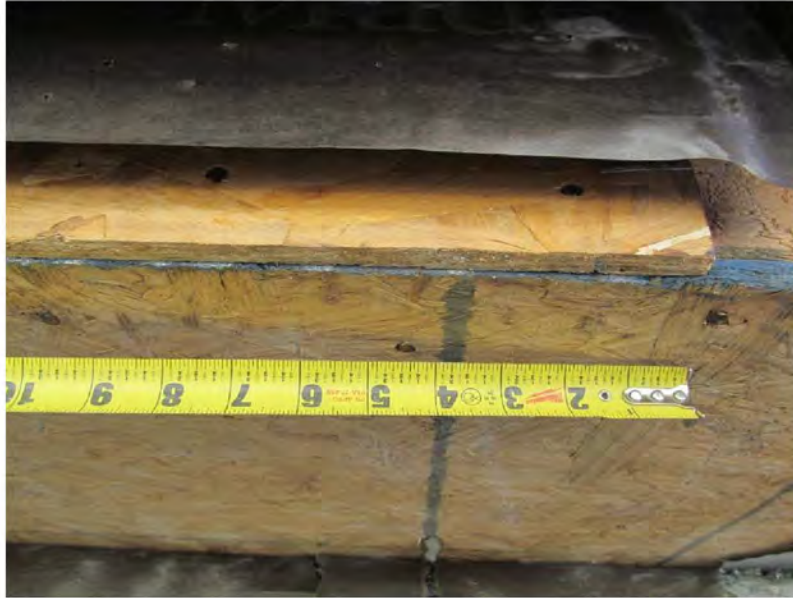
March 9, 2021, Disc IT6, Photograph 266, SSR, Building A, sheathing bottom edge stained at wall-soffit junction.

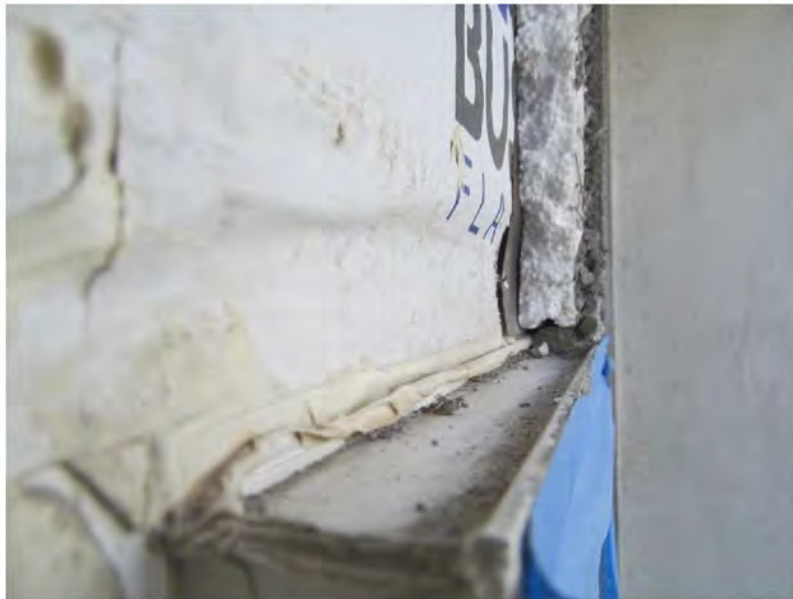
March 9, 2021, Disc IT6, Photograph 280, SSR, Building A, no weep mechanism at stucco termination above window head.

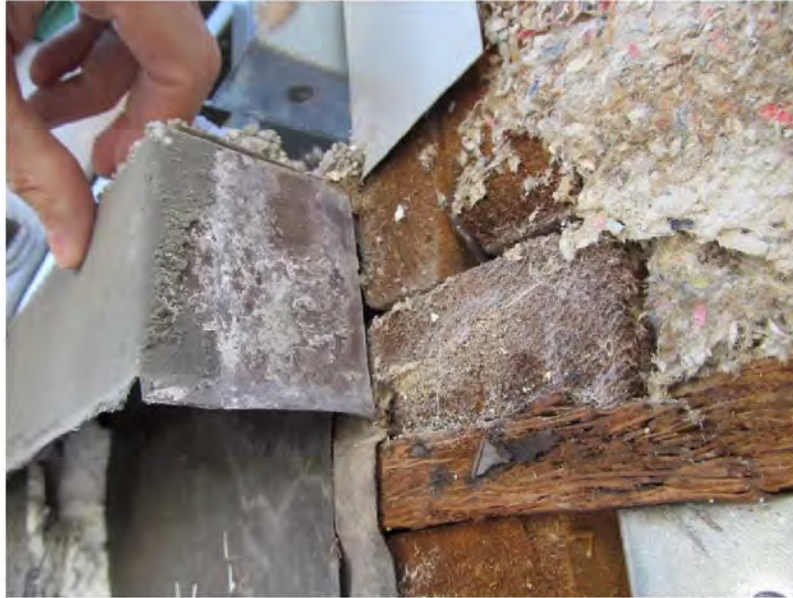
March 9, 2021, Disc IT5, Photograph 73, JJF, Building B, visible stains at sheathing edge and deterioration.

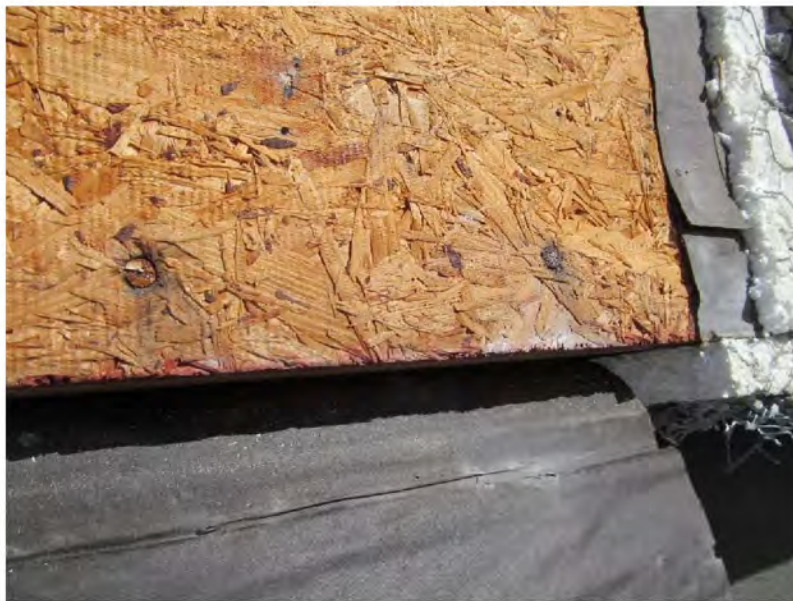
March 9, 2021, Disc IT5, Photograph 164, JJF, Building B, visible stains at sheathing edge and rusted fasteners.

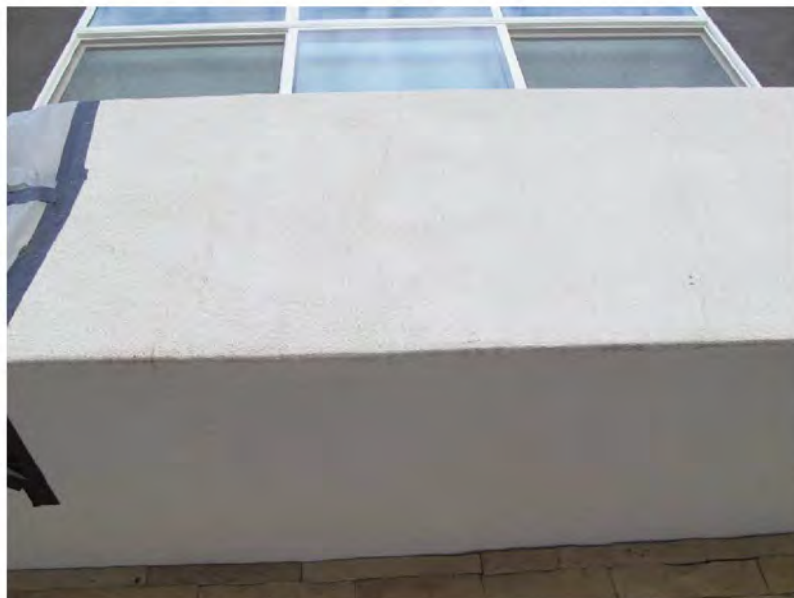
March 11, 2021, Disc OBS6, Photograph 48, JFF, Building C, no weep mechanism at stucco soffits.

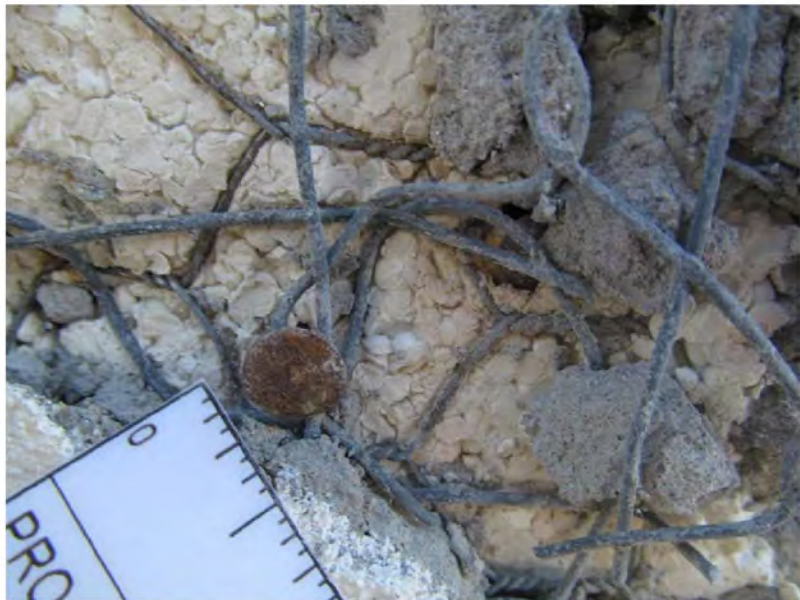
March 10, 2021, Disc IT8, Photograph 96, SSR, Building D, rusted fastener head at EPS foam board.

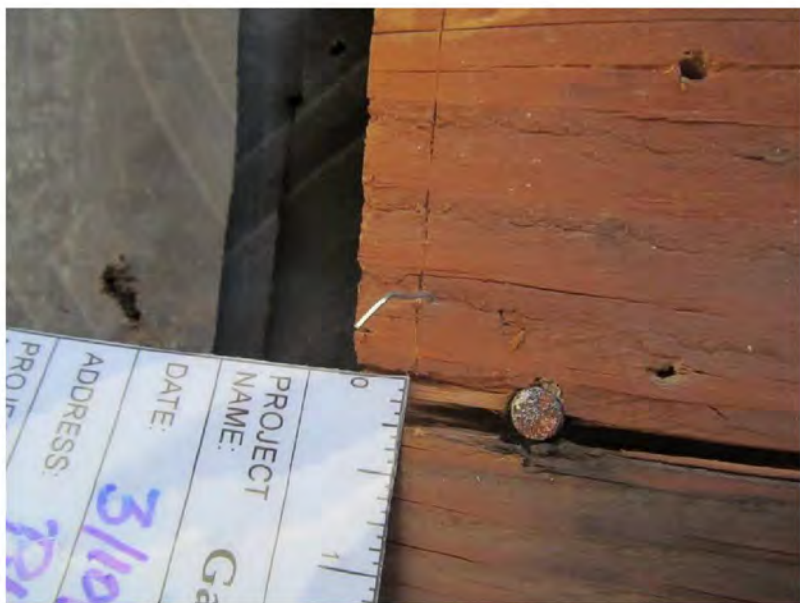
March 10, 2021, Disc IT8, Photograph 96, SSR, Building D, rusted fastener head at framing.

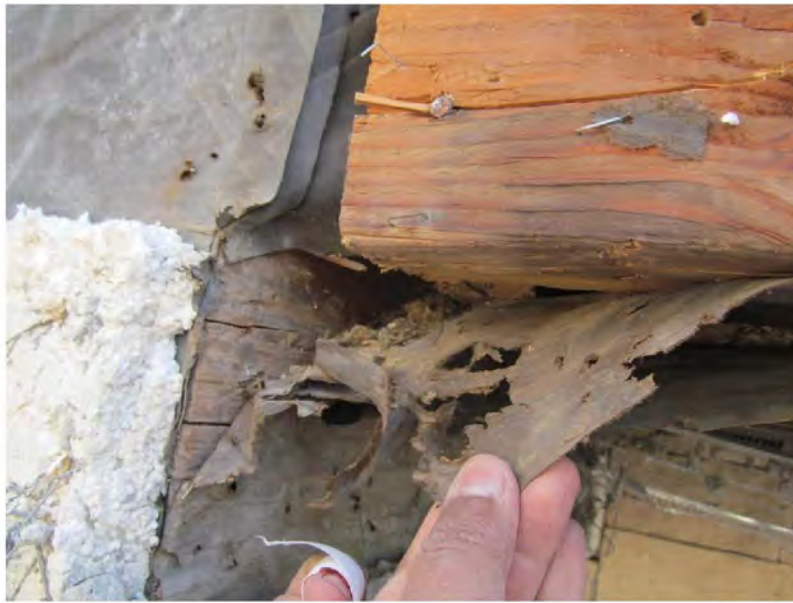
March 10, 2021, Disc IT8, Photograph 120, SSR, Building D, deteriorated WRB over framing with visible stains.

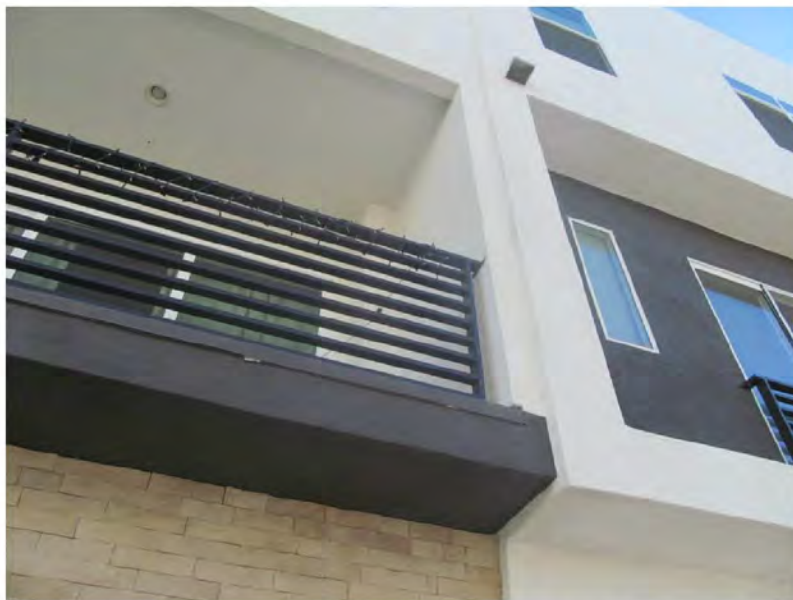
December 19, 2018, Disc OBS1, Photograph 24, JBF, Building D, no weep mechanism at stucco soffits.

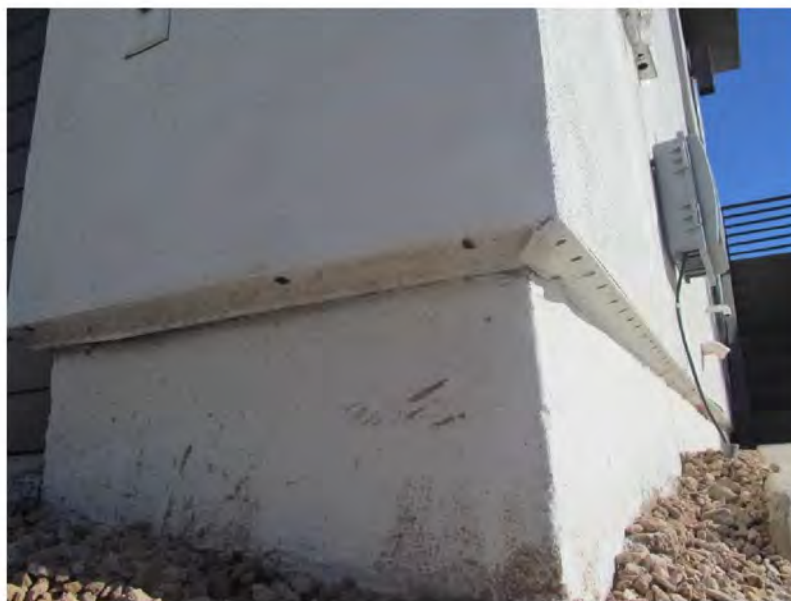
December 19, 2018, Disc OBS1, Photograph 19, JBF, Building D, weep mechanism at base of stucco at top of foundations.

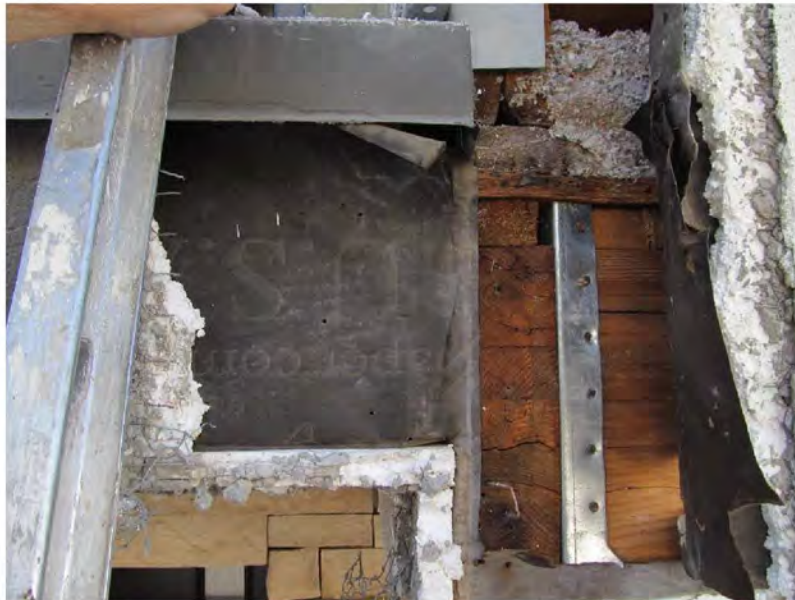
March 9, 2021, Disc IT5, Photograph 75, JJF, Building B, damaged framing due to water intrusion.

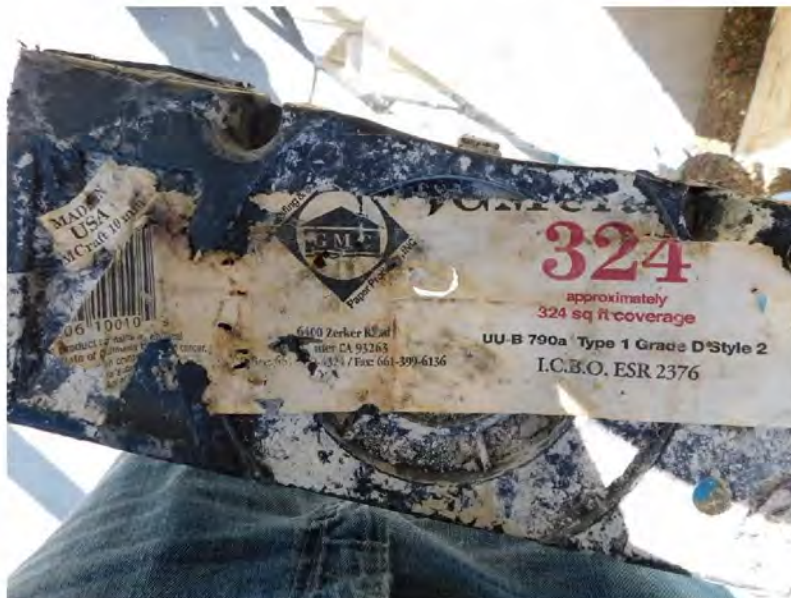
March 10, 2021, Disc IT9, Photograph 124, SSR, Building C, manufacturer's label shows the building paper is Type 1, Grade D, Style 2 building paper with 10-minute water resistance and references ESR 2376.

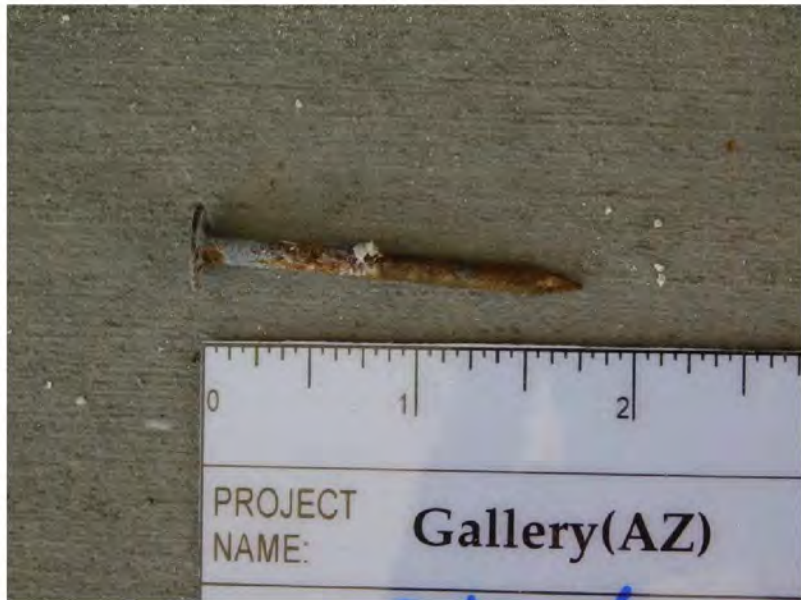
March 10, 2021, Disc IT8, Photograph 93, PER, Building C, deteriorated WRB over framing.

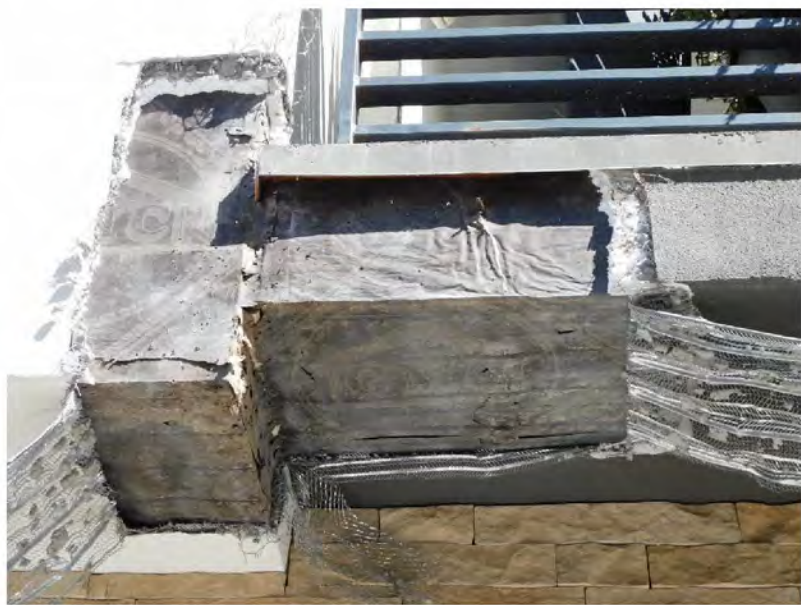
March 10, 2021, Disc IT8, Photograph 101, PER, Building C, deteriorated WRB over framing.

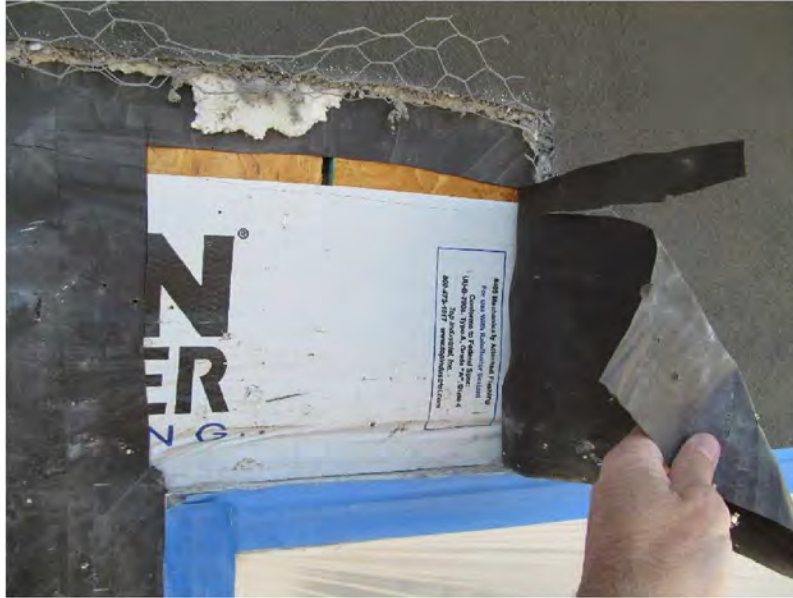
March 10, 2021, Disc IT7, Photograph 136, JJF, Building D, one layer of WRB over sheathing.

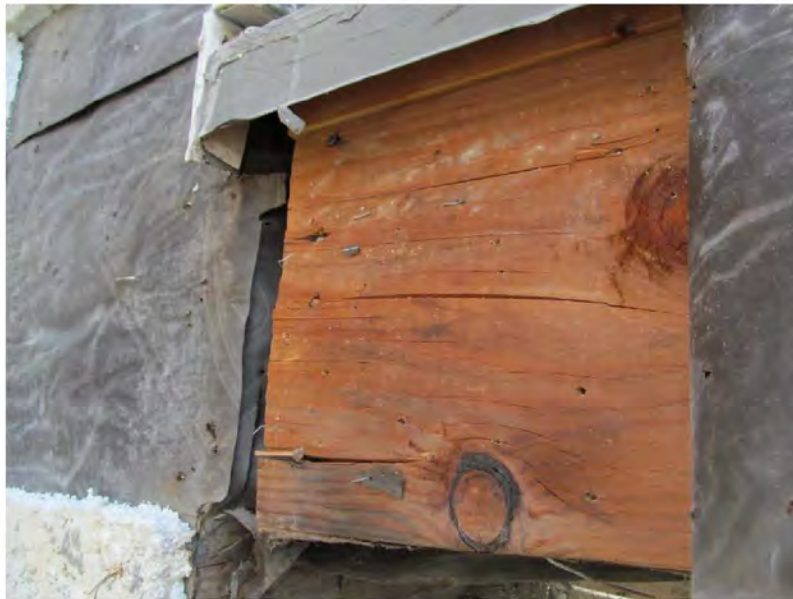
March 10, 2021, Disc IT8, Photograph 114, SSR, Building D, one layer of WRB over framing with visible stains.

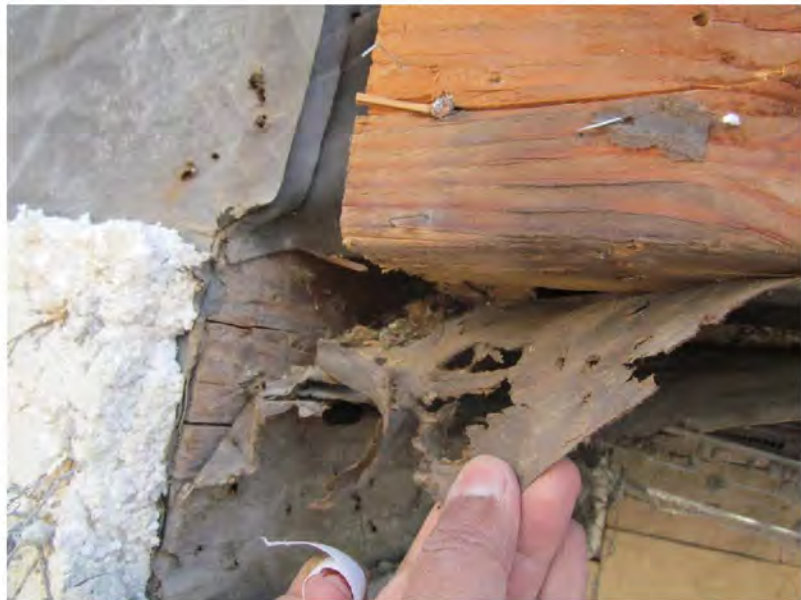
March 10, 2021, Disc IT8, Photograph 120, SSR, Building D, deteriorated WRB over framing with visible stains.

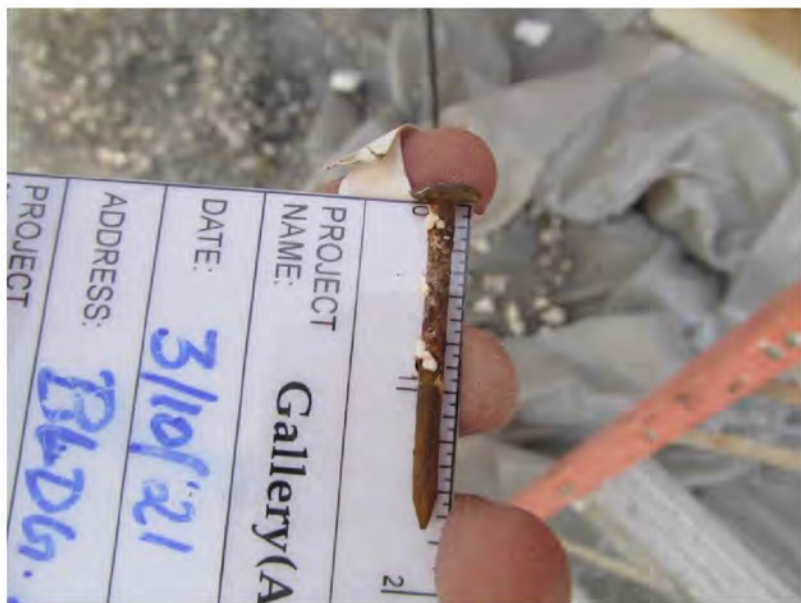
March 10, 2021, Disc IT8, Photograph 172, SSR, Building D, full-depth rusted fasteners.

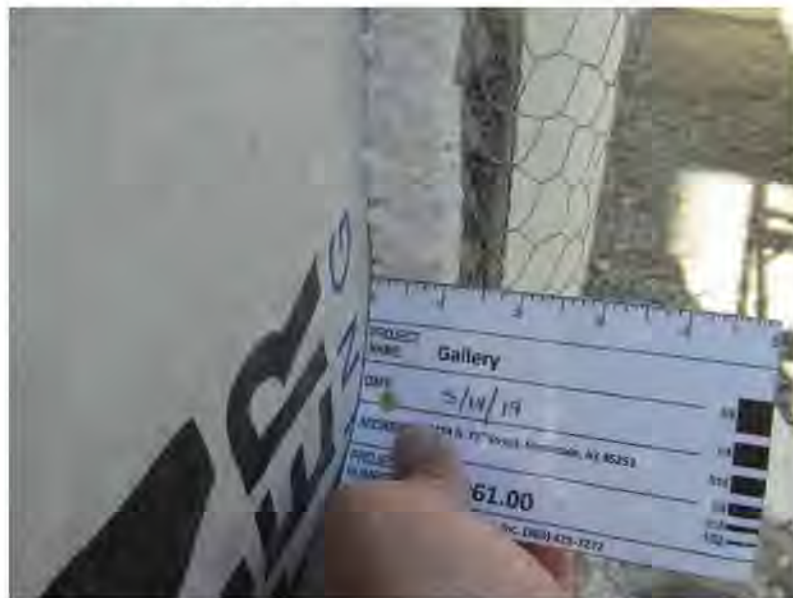
May 14, 2019, Disc IT3, Photograph 18, JBF, Building A, EPS foam board installed tight to WRB and vertical grooves generally missing at the inner face.

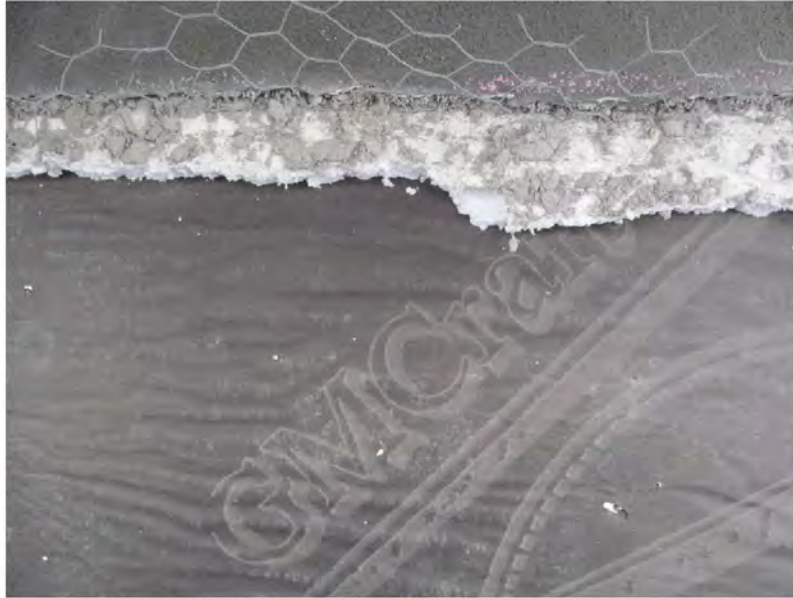
March 9, 2021, Disc IT6, Photograph 271, SSR, Building A, EPS foam board installed tight to GMCraft WRB and vertical grooves generally missing at the inner face.

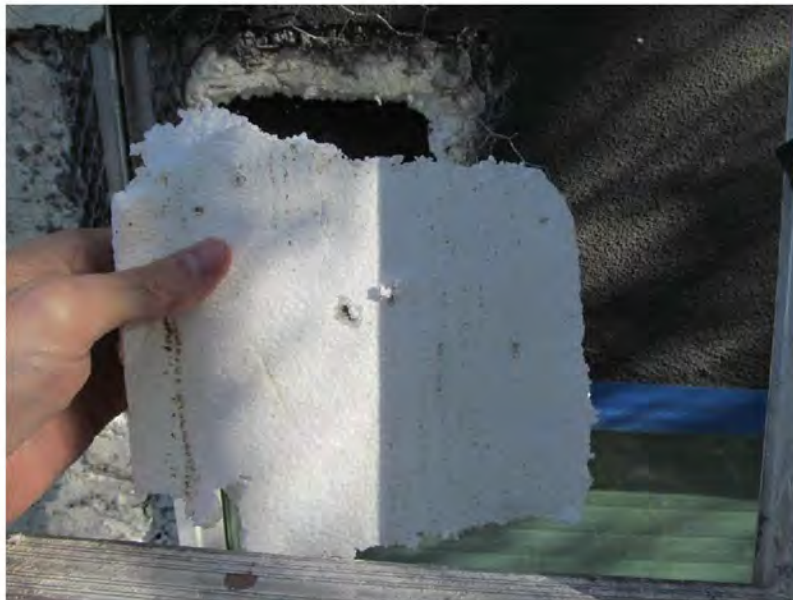
March 10, 2021, Disc IT7, Photograph 20, JJF, Building B, EPS foam board installed over WRB with vertical grooves generally missing at the back face.

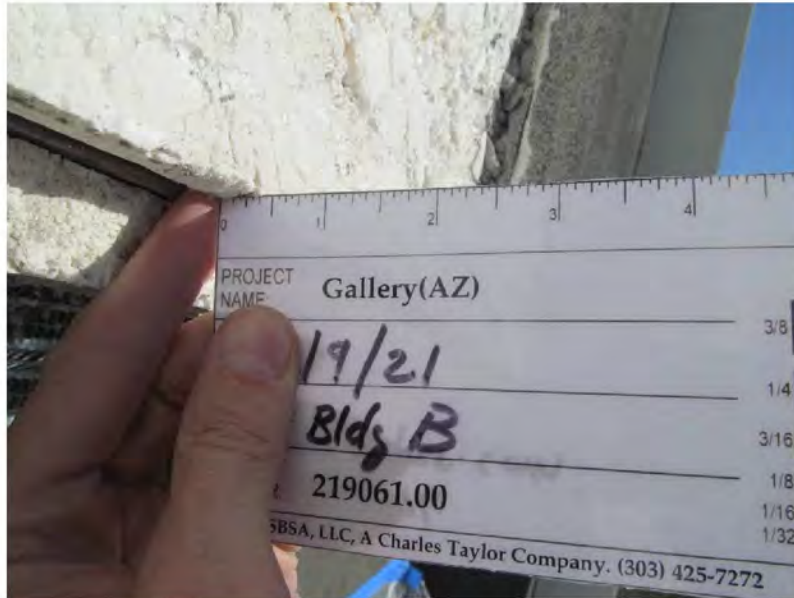
March 9, 2021, Disc IT5, Photograph 155, JJF, Building B, 3/8-inch-thick EPS foam board installed over WRB with vertical grooves generally missing at the back face.

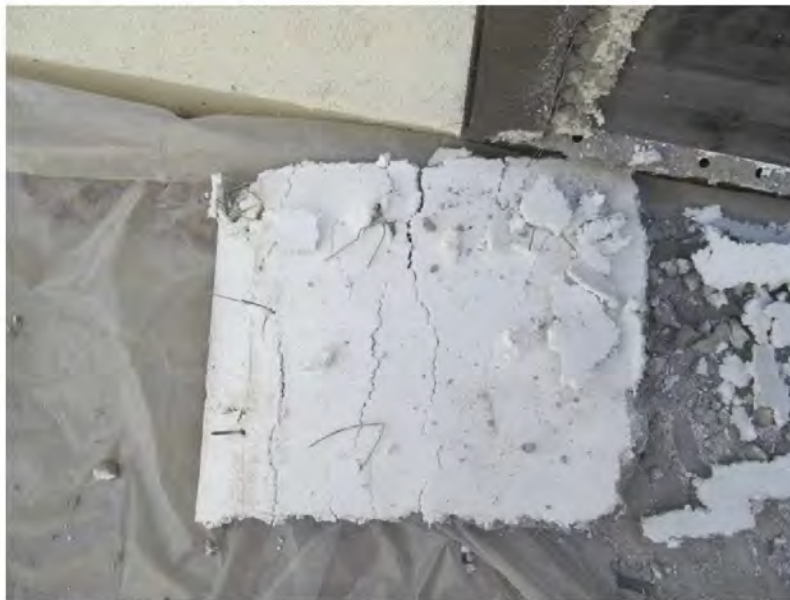
May 13, 2019, Disc IT1, Photograph 116, JBF, Building B, 1/2-inch-thick EPS insulation installed over OSB sheathing does not incorporate vertical grooves.

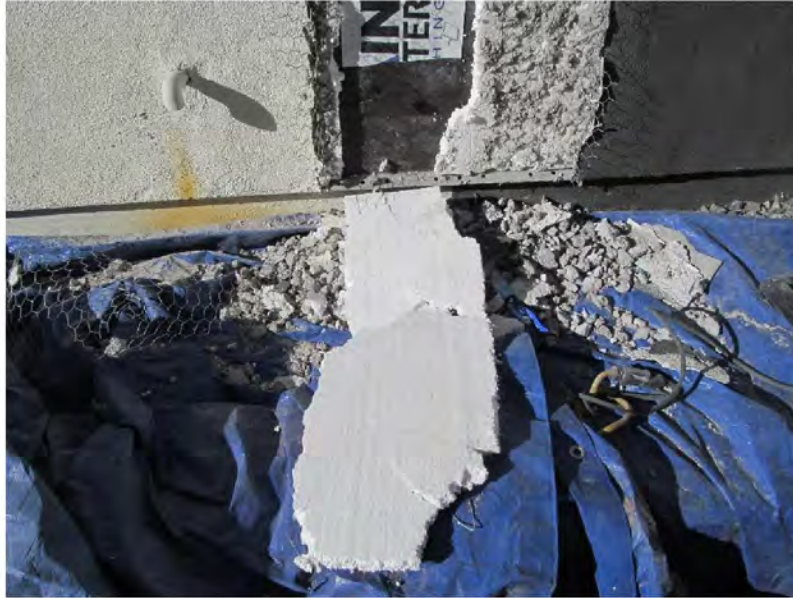
March 10, 2021, Disc IT7, Photograph 279, JJF, Building C, EPS foam board installed over WRB with vertical grooves generally missing at the back face.

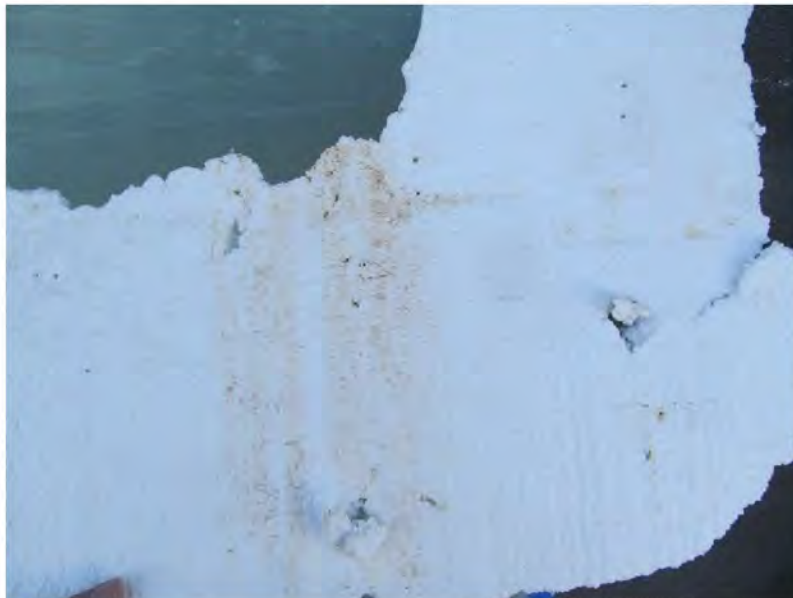
March 10, 2021, Disc IT7, Photograph 210, JJF, Building C, EPS foam board installed tight to WRB and vertical grooves generally missing at the back face.

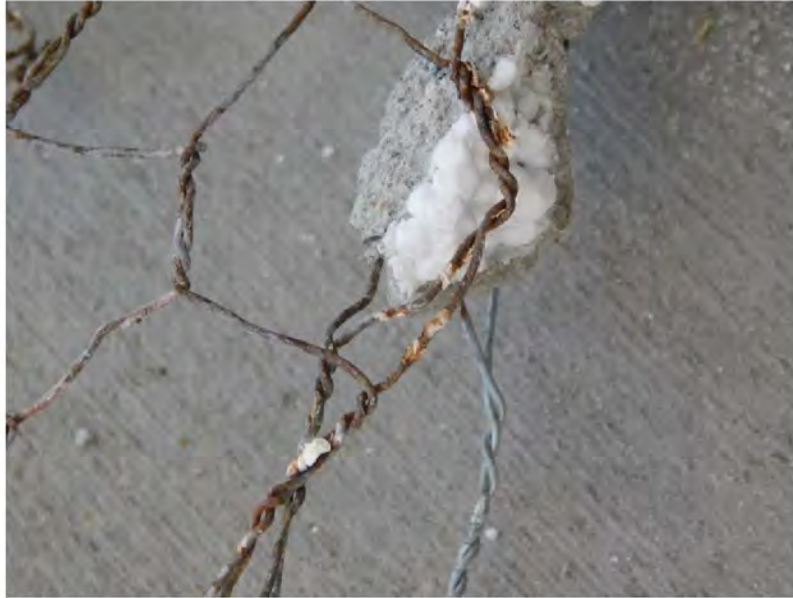
March 10, 2021, Disc IT9, Photograph 92, PER, Building C, rusted lath

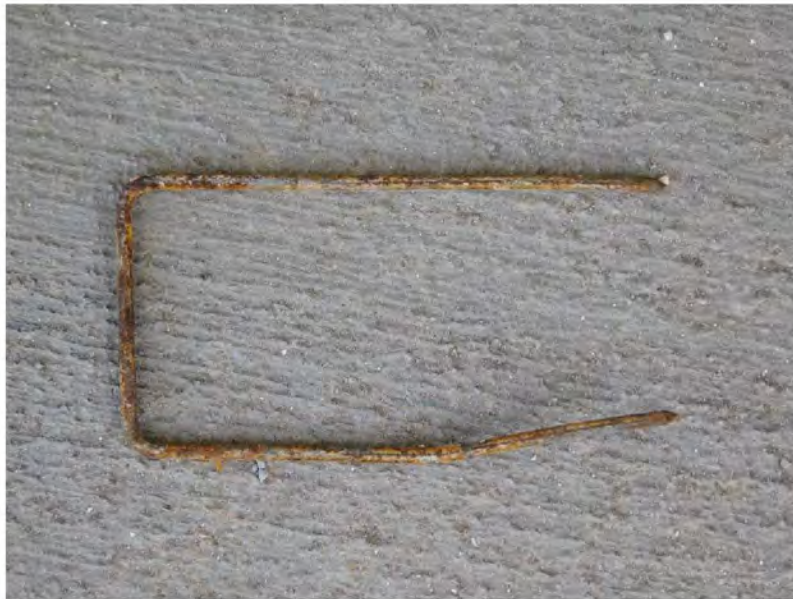
March 10, 2021, Disc IT9, Photograph 90, PER, Building C, rusted staples

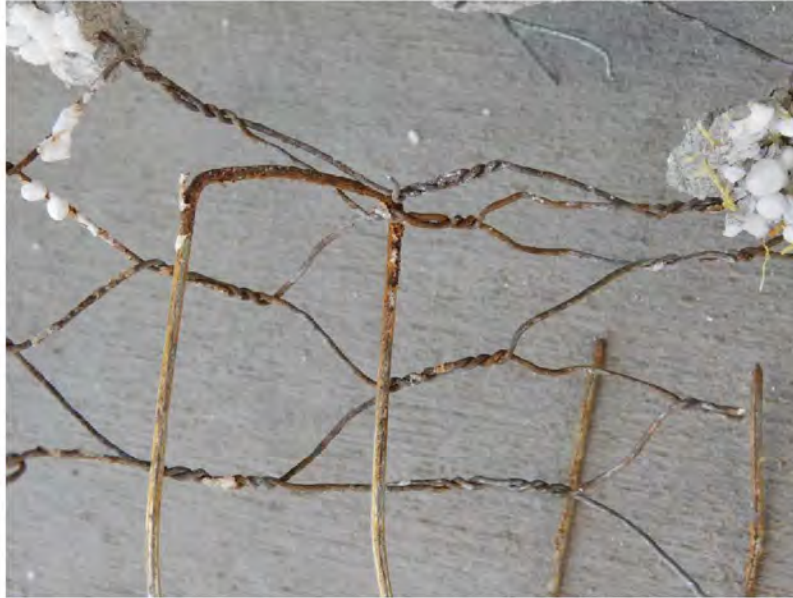
March 10, 2021, Disc IT9, Photograph 87, PER, Building C, rusted staples and lath

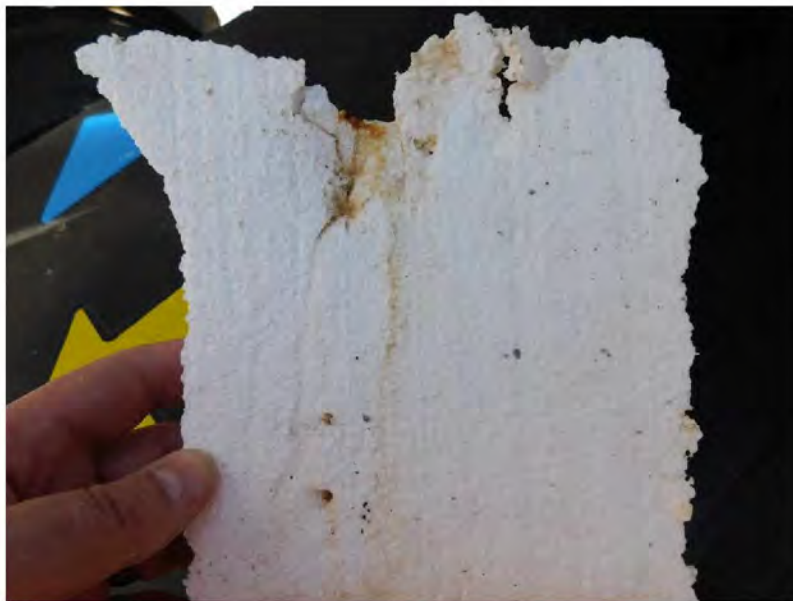
March 10, 2021, Disc IT9, Photograph 95, PER, Building C, EPS foam board installed tight to WRB and vertical grooves generally missing at the back face. Note corrosion from the nails on the EPS foam board.

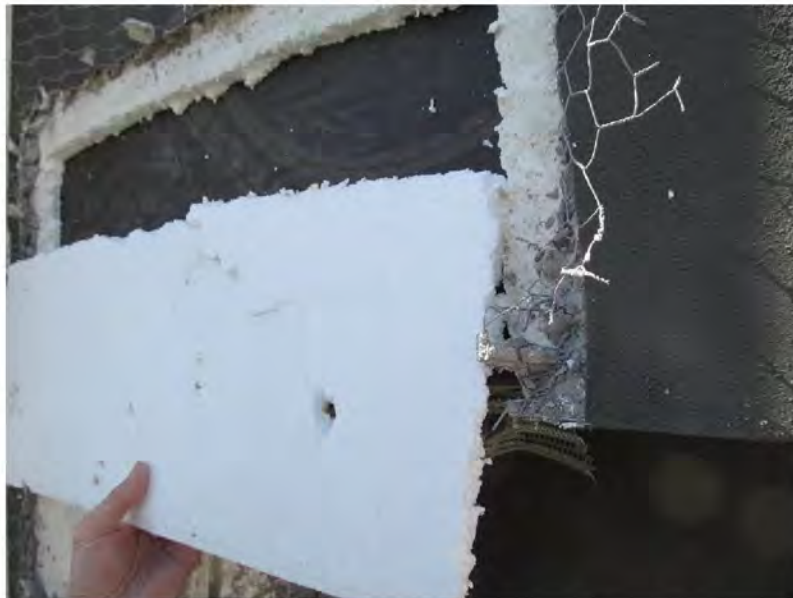
March 10, 2021, Disc IT7, Photograph 117, JJF, Building D, EPS foam board installed over WRB with vertical grooves generally missing at the back face.

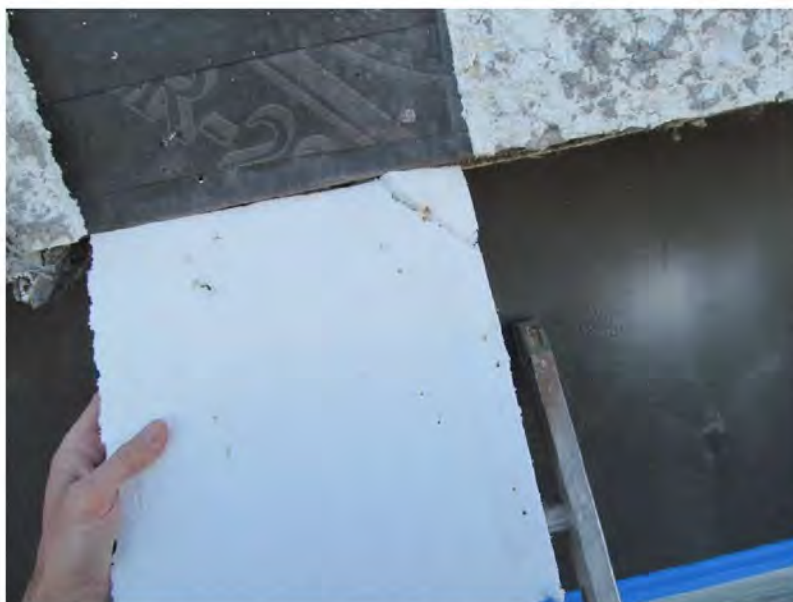
March 10, 2021, Disc IT7, Photograph 226, JJF, Building D, EPS foam board installed over WRB with vertical grooves generally missing at the back face.

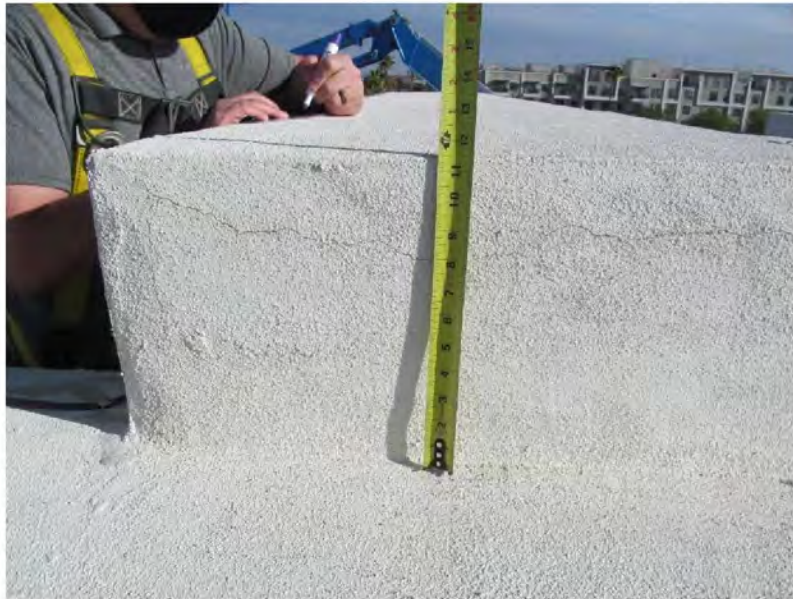
March 11, 2021, Disc IT10, Photograph 3, SSR, Building A, roof parapet wall stucco cracks.

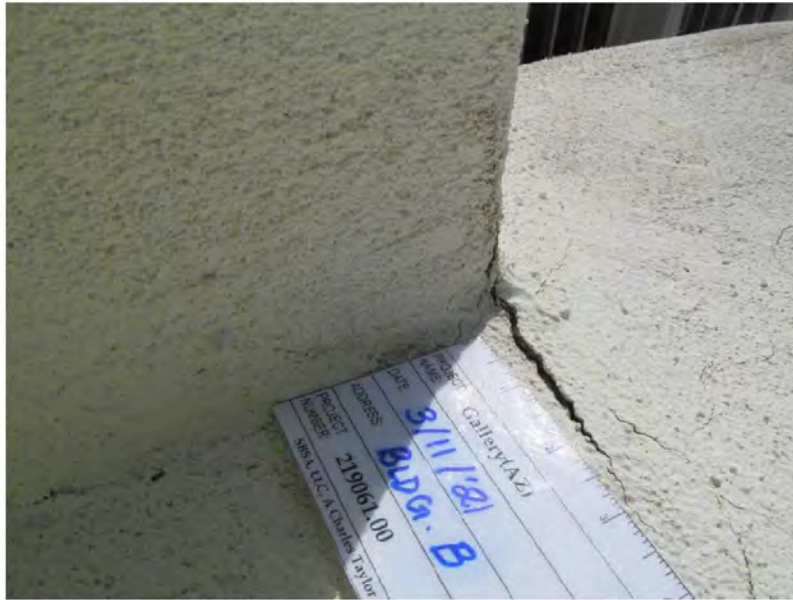
March 11, 2021, Disc IT10, Photograph 241, SSR, Building B, roof parapet wall stucco cracks.

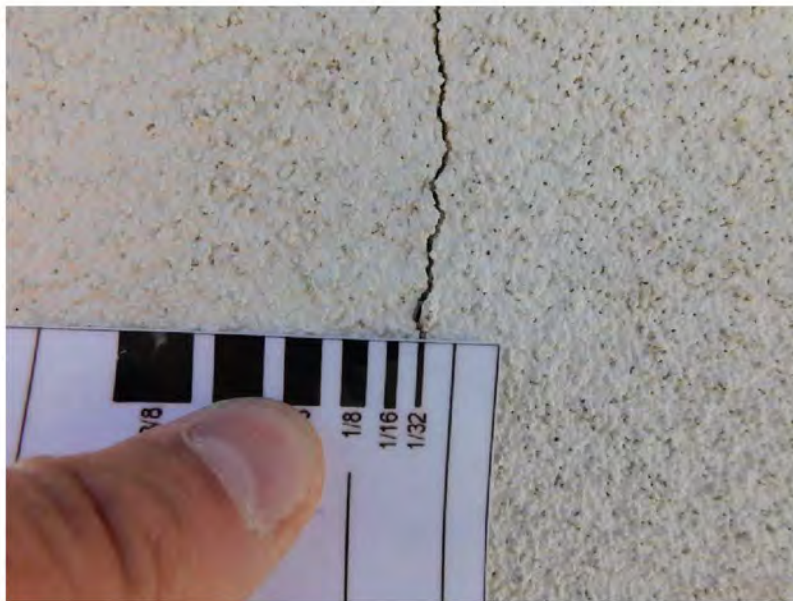
March 11, 2021, Disc OBS7, Photograph 421, PER, Building C, roof parapet wall cracks.

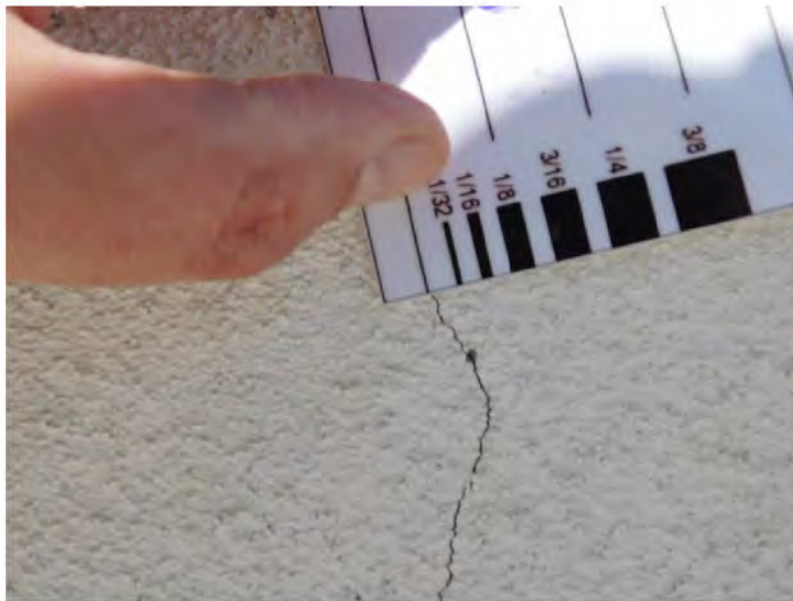
March 11, 2021, Disc OBS7, Photograph 301, PER, Building D, roof parapet wall cracks.

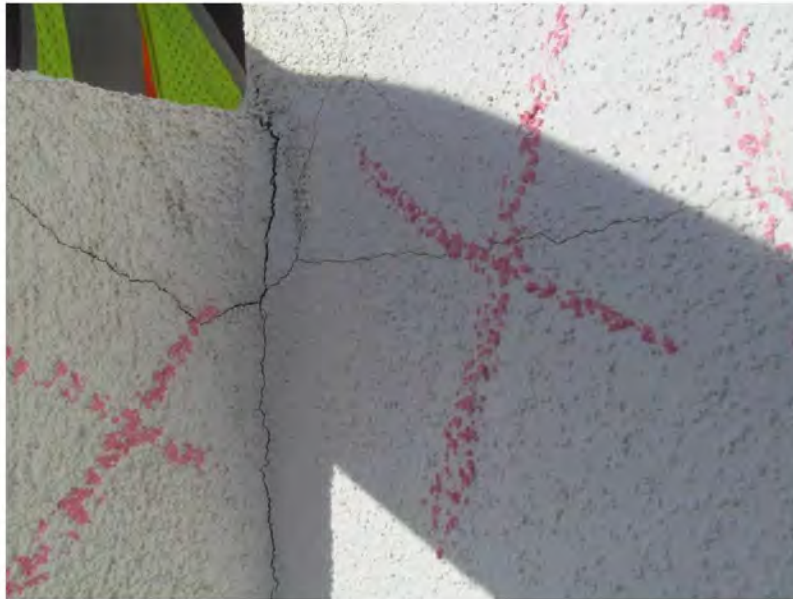
March 11, 2021, Disc IT10, Photograph 19, SSR, Building A, stucco cracks at parapet wall junction.

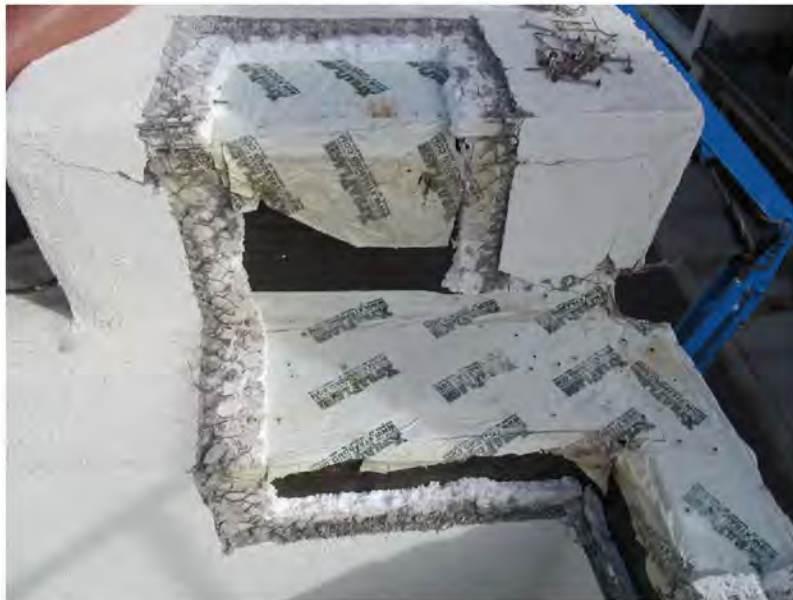
March 11, 2021, Disc IT10, Photograph 102, SSR, Building A, holes and stains in Xtraflash SAM allow moisture intrusion.

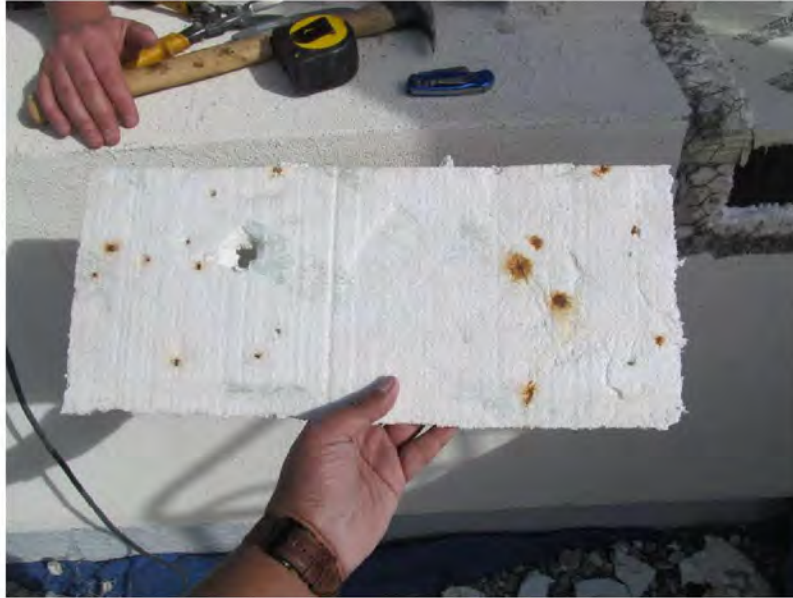
March 11, 2021, Disc IT10, Photograph 103, SSR, Building A, reverse side of EPS foam board shows stains due to corrosion of fasteners.
