1 **BURG SIMPSON ELDREDGE**
2 **HERSH & JARDINE P.C.**

3 8310 South Valley Highway, Suite 270
4 Englewood, CO 80112
5 Phone: (303) 792-5595
6 Fax: (303) 708-0527
7 Craig S. Nuss – 033839
8 Penny J. Manship – 034985
9 pmanship@burgsimpson.com

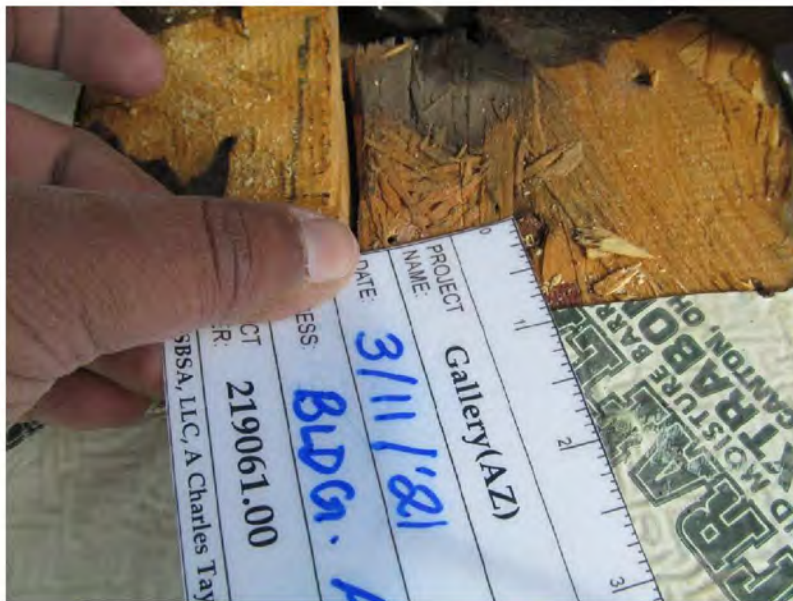
March 11, 2021, Disc IT10, Photograph 125, SSR, Building A, top plate under SAM has stains and rusted fasteners.

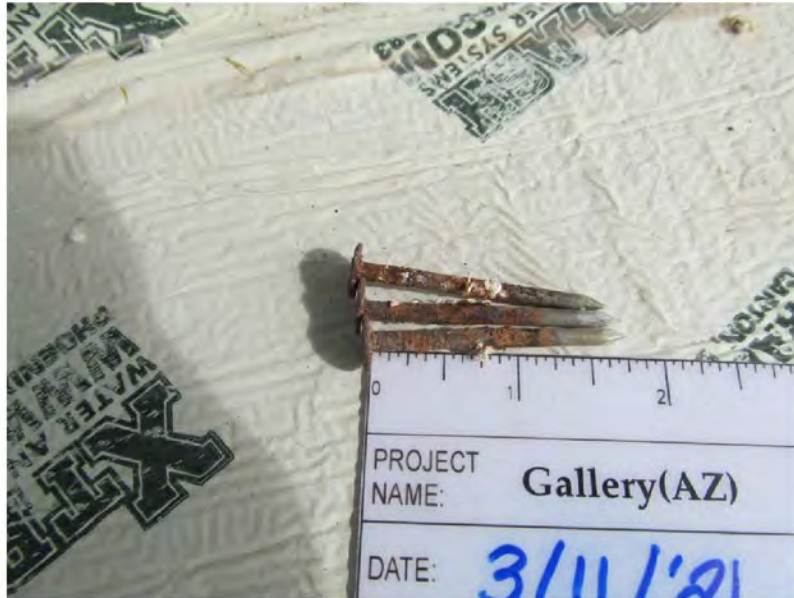
March 11, 2021, Disc IT10, Photograph 132, SSR, Building A, top plate under SAM has stains and rusted fasteners.

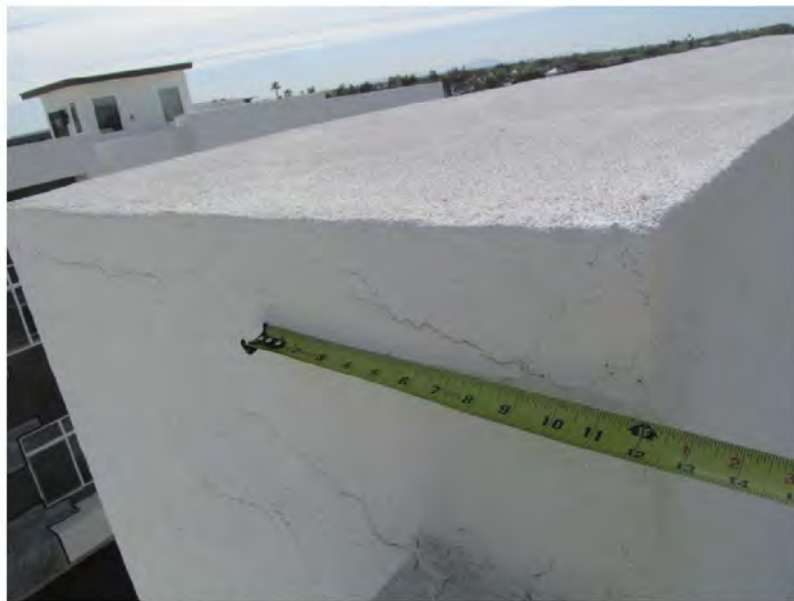
March 11, 2021, Disc IT10, Photograph 172, SSR, Building B, stucco cracks at parapet wall junction.

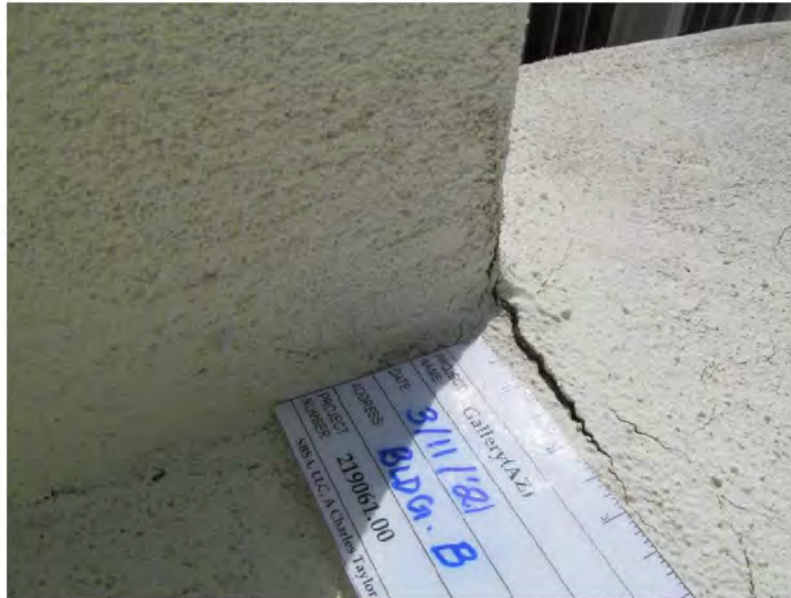
March 11, 2021, Disc IT10, Photograph 241, SSR, Building B, stucco cracks at parapet wall junction.

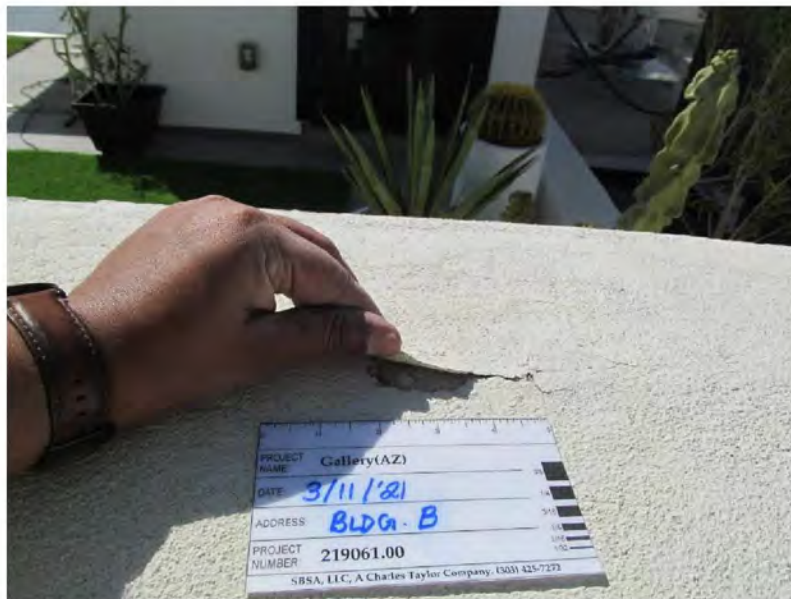
March 11, 2021, Disc IT10, Photograph 244, SSR, Building B, cracks at parapet wall allow stucco to peel off due to the elements and have allowed moisture intrusion.

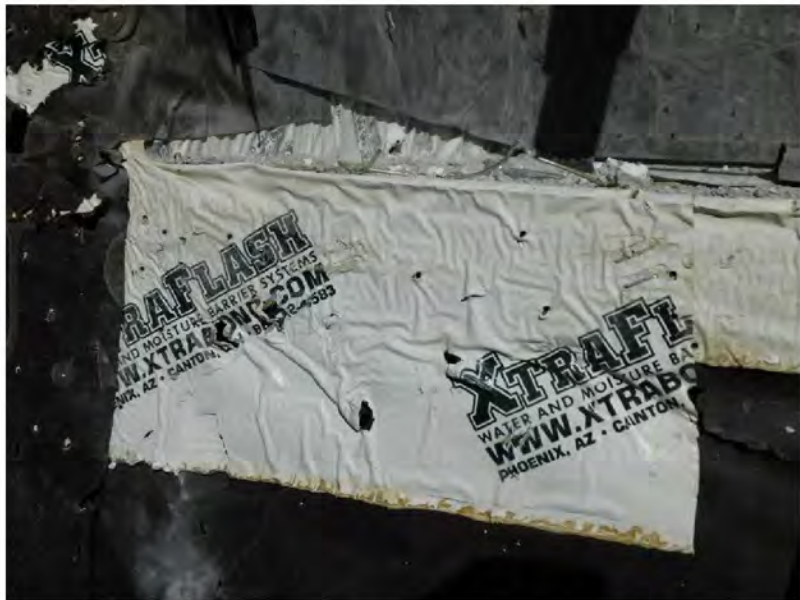
March 10, 2021, Disc IT9, Photograph 185, PER, Building C, holes and stains in Xtraflash SAM allow moisture intrusion.

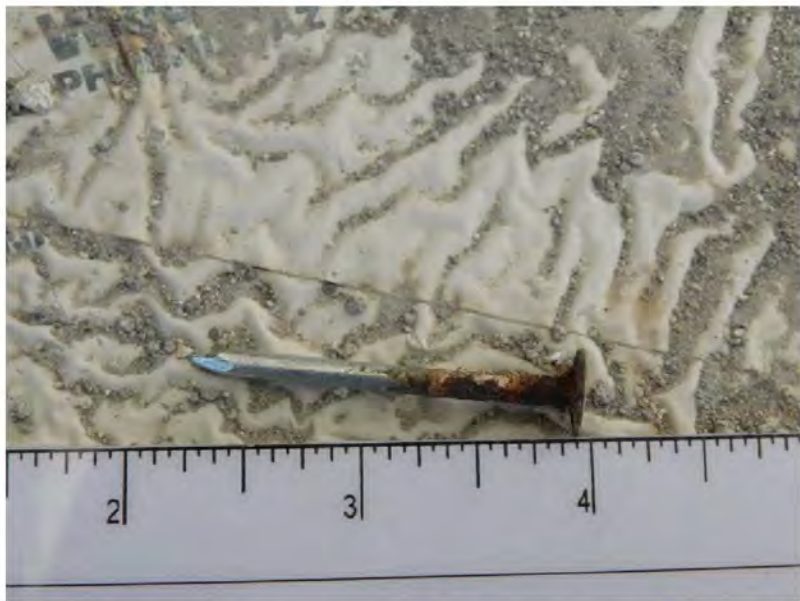
March 10, 2021, Disc IT9, Photograph 188, PER, Building C, holes and stains in Xtraflash SAM allow moisture intrusion.

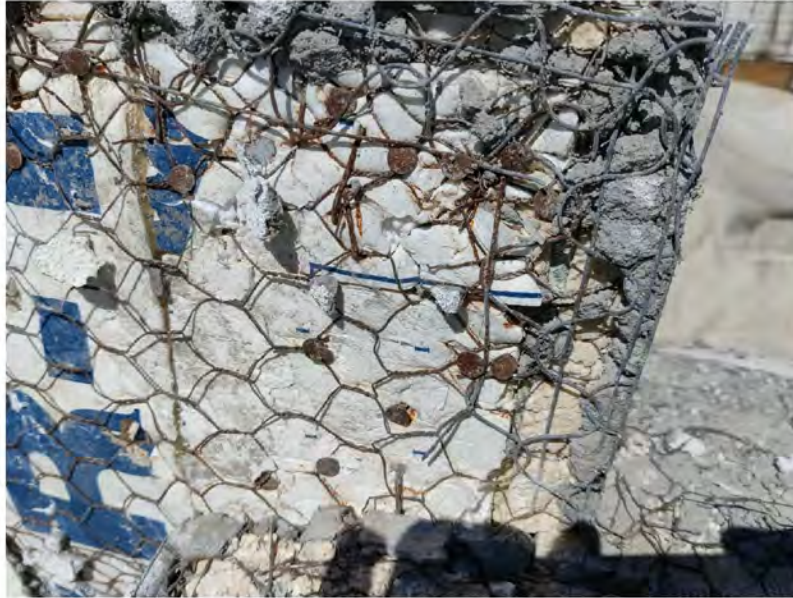
March 11, 2021, Disc IT10, Photograph 372, SSR, Building D, rusted nails and lath indicate moisture intrusion through stucco.

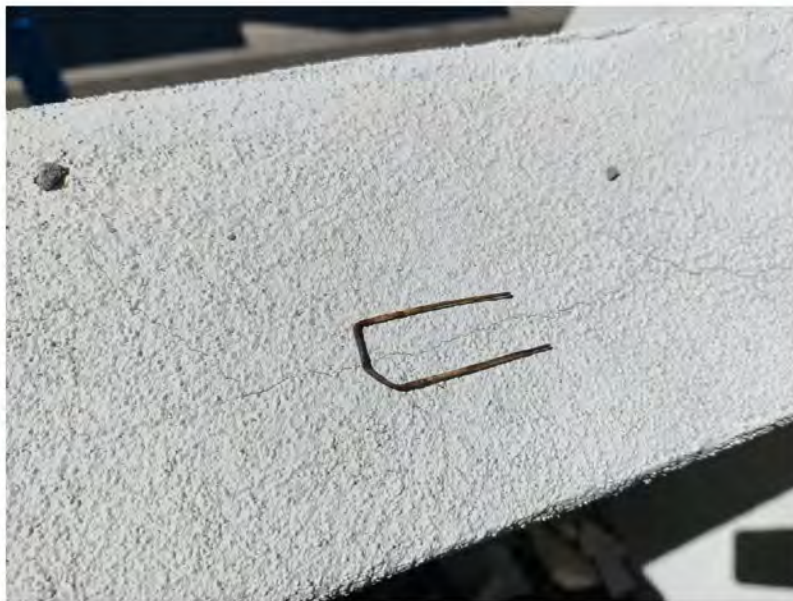
March 11, 2021, Disc IT10, Photograph 374, SSR, Building D, rusted staple.

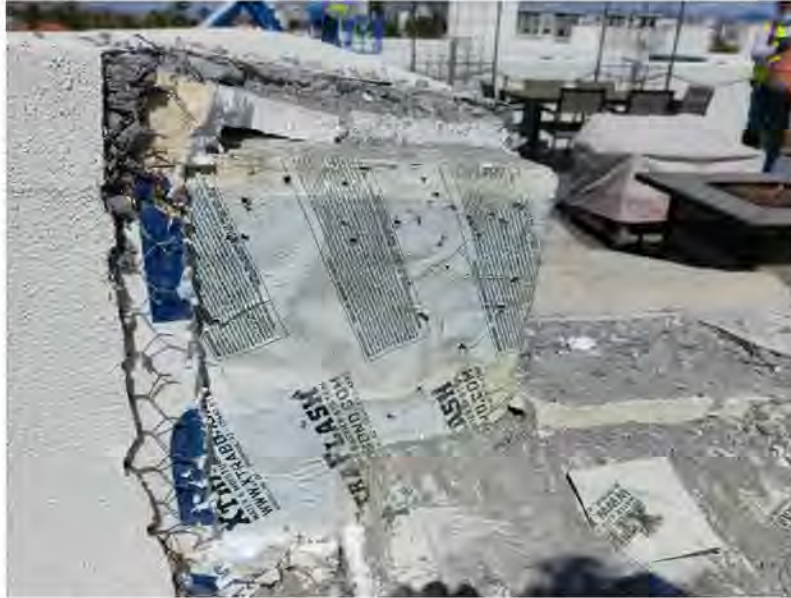
March 11, 2021, Disc IT10, Photograph 378, SSR, Building D, puncture holes in SAM allow moisture intrusion.

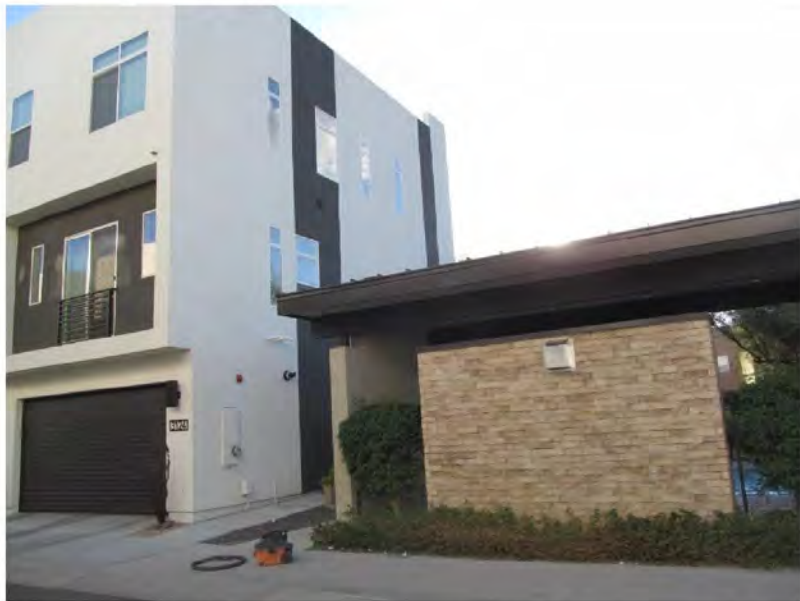
March 10, 2021, Disc OBS 5, Photograph 2, SSR, Building A, missing horizontal movement joints at floorlines.

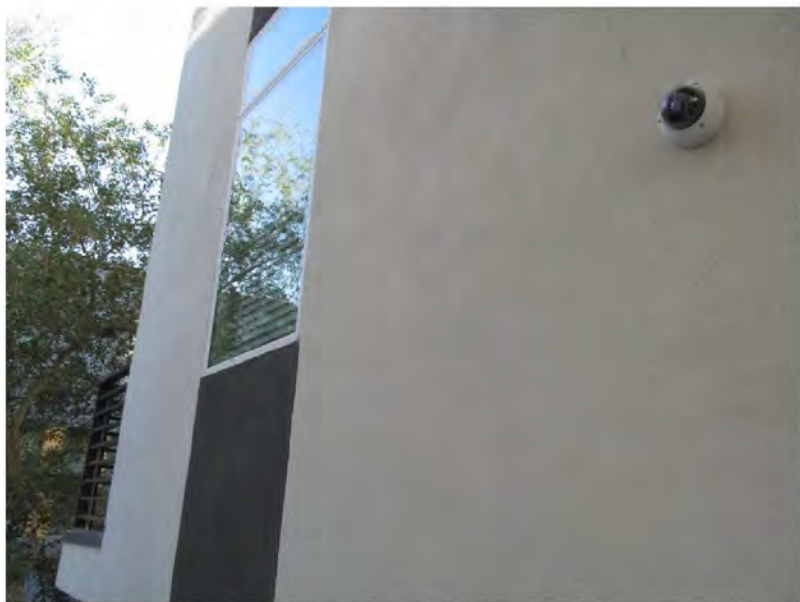
March 10, 2021, Disc OBS 5, Photograph 28, SSR, Building A, horizontal stucco crack. See below photo for close-up view of damage.

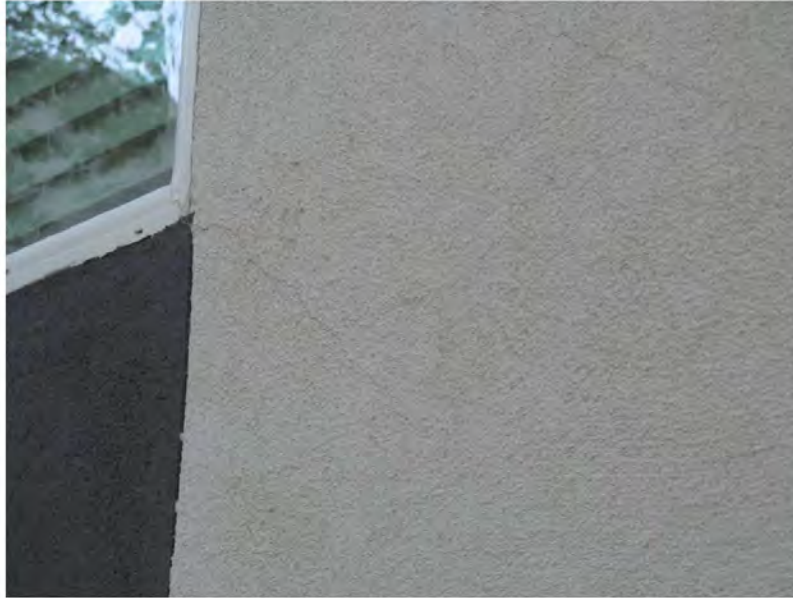
March 10, 2021, Disc OBS 5, Photograph 29, SSR, Building A, horizontal stucco crack.

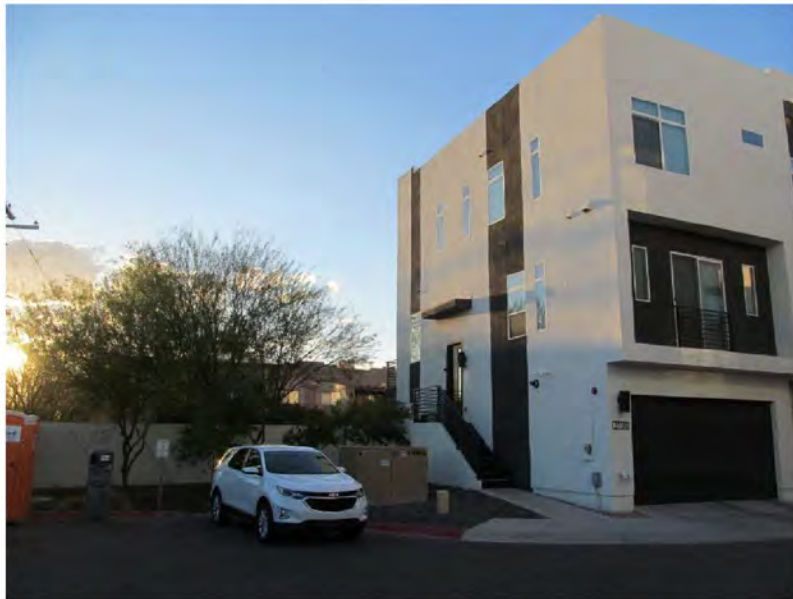
March 10, 2021, Disc OBS 5, Photograph 63, SSR, Building B, missing horizontal movement joints at floorlines.

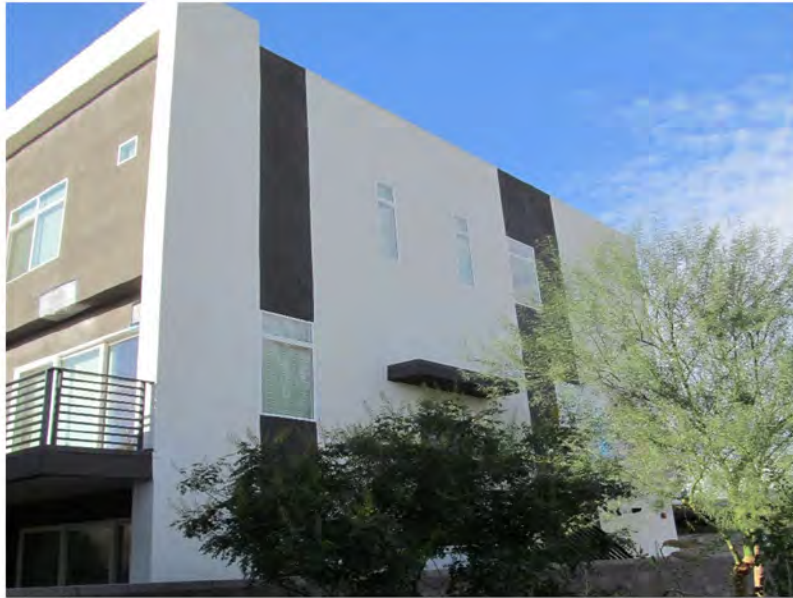
March 11, 2021, Disc OBS 6, Photograph 11, JJF, Building C, missing horizontal movement joints at floorlines.

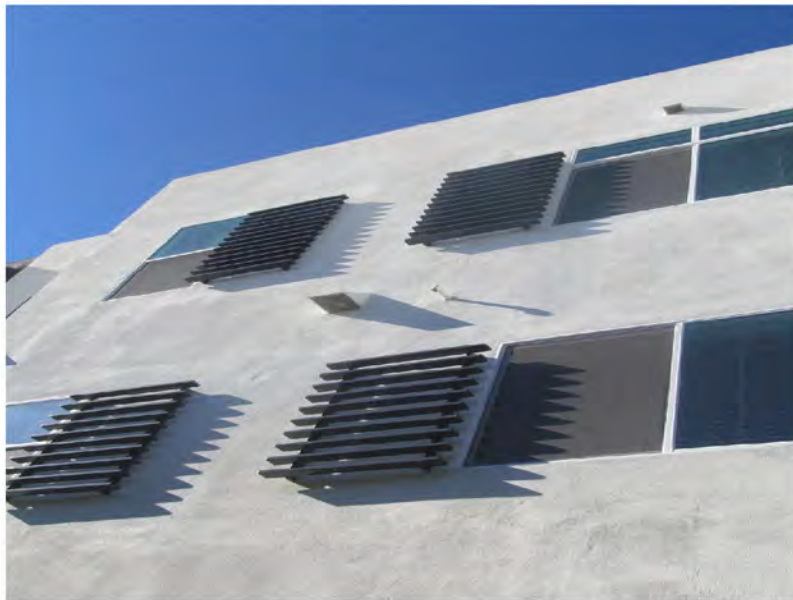
December 18, 2019, Disc OBS 1, Photograph 71, JJF, Building C, missing horizontal movement joints at floorline.

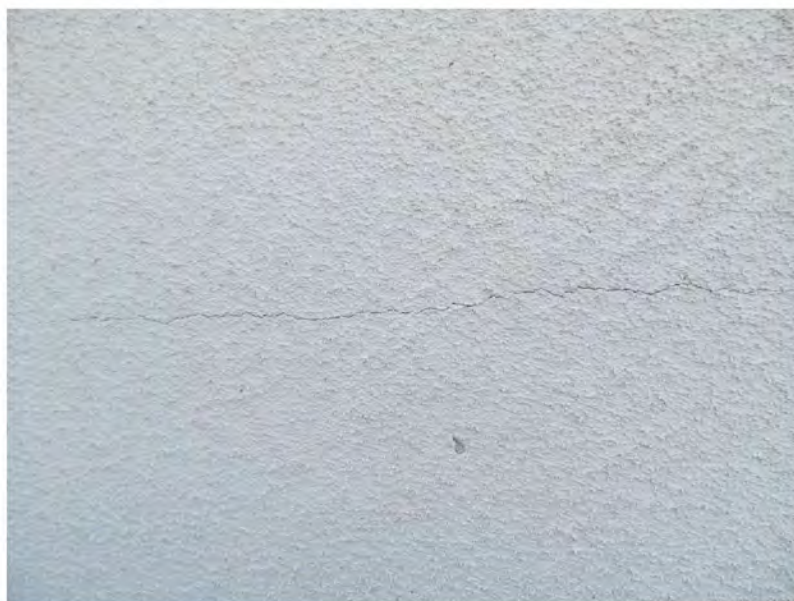
March 11, 2021, Disc OBS 6, Photograph 75, JJF, Building C, stucco cracks.

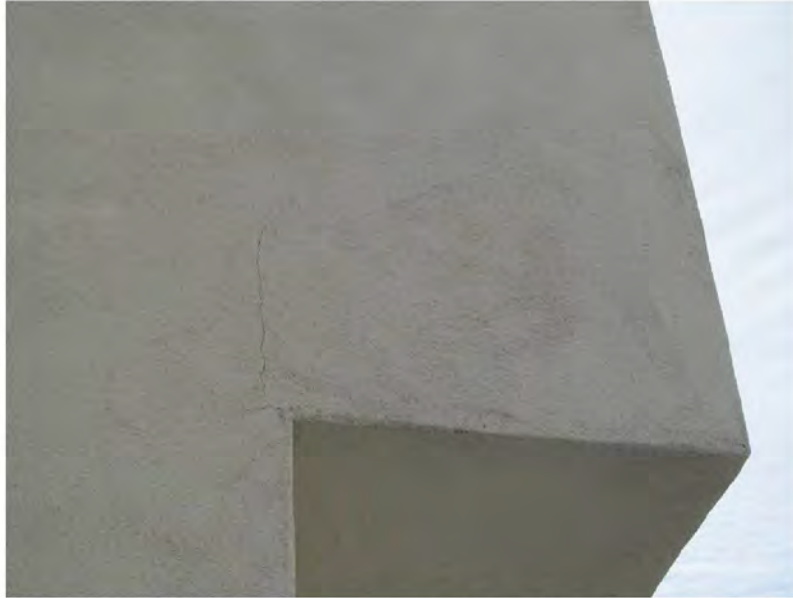
March 11, 2021, Disc OBS 6, Photograph 209, JJF, Building C, stucco cracks.

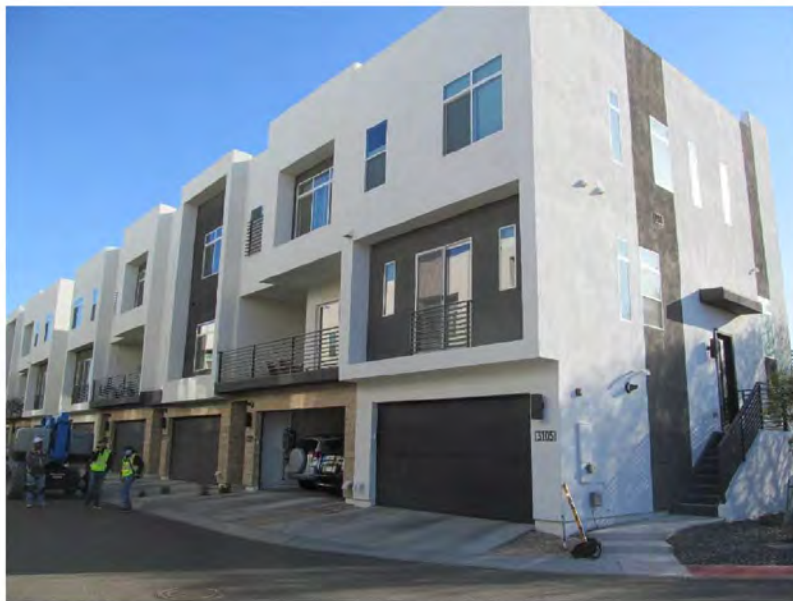
March 10, 2021, Disc IT 8, Photograph 6, SSR, Building D, missing horizontal movement joints at floorlines.

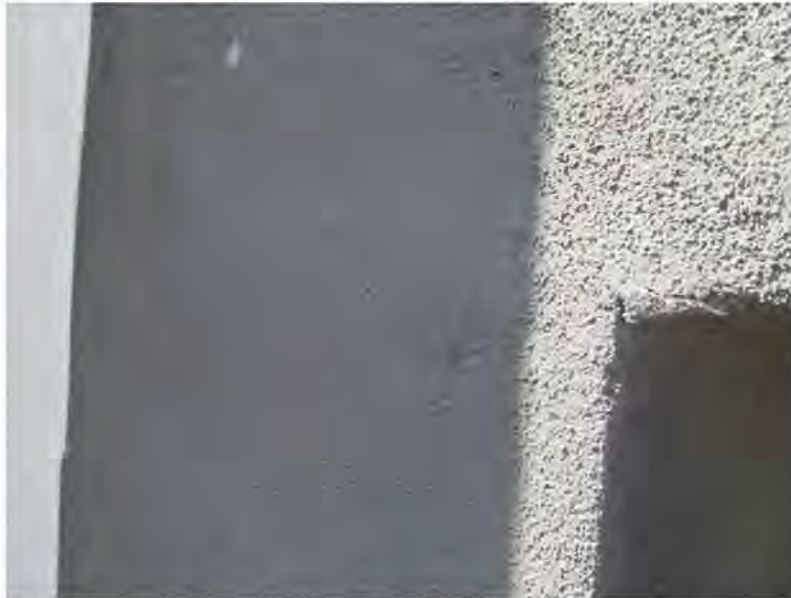
March 10, 2021, Disc IT7, Photograph 97, JFF, Building D, missing control joint and horizontal crack in stucco at floorline.

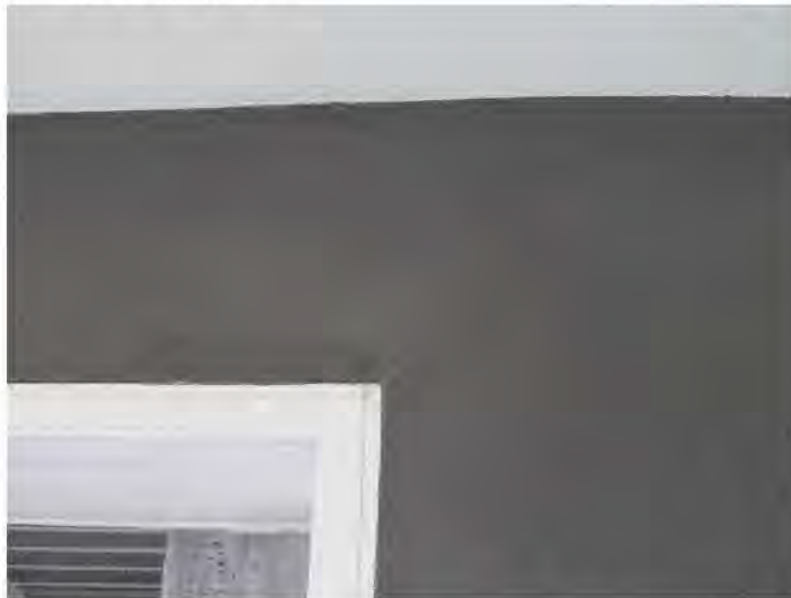
March 9, 2021, Disc IT5, Photograph 3, JJF, Building A, missing flashing at sliding door head.

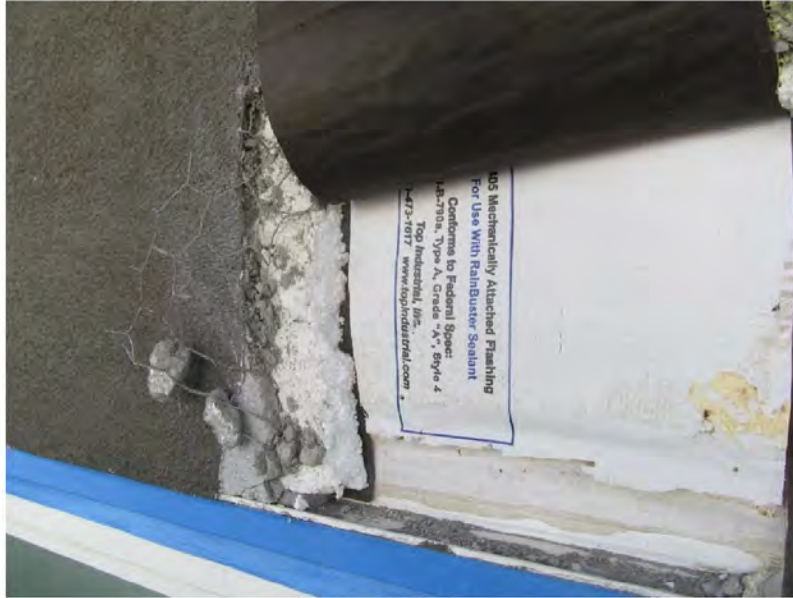
March 9, 2021, Disc IT6, Photograph 286, SSR, Building A, missing flashing at sliding door head.

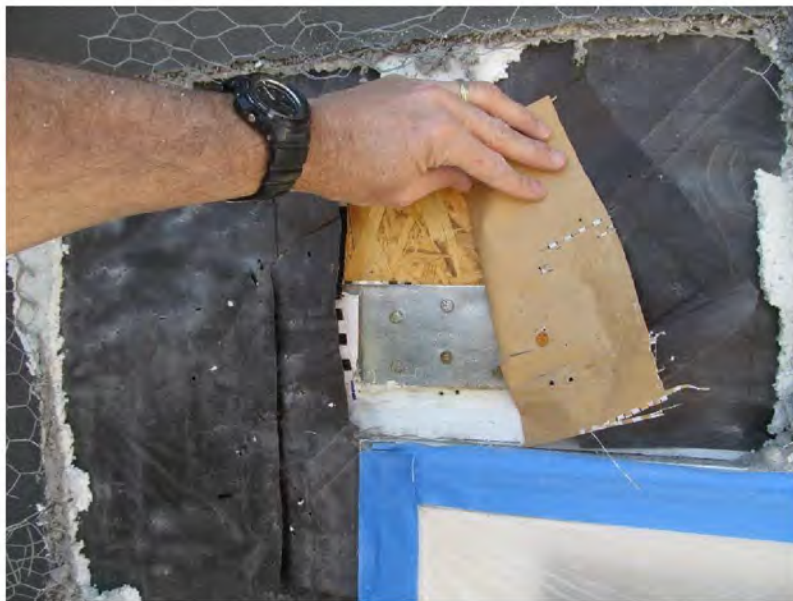
March 10, 2021, Disc IT7, Photograph 139, JJF, Building D, missing flashing at sliding door head.

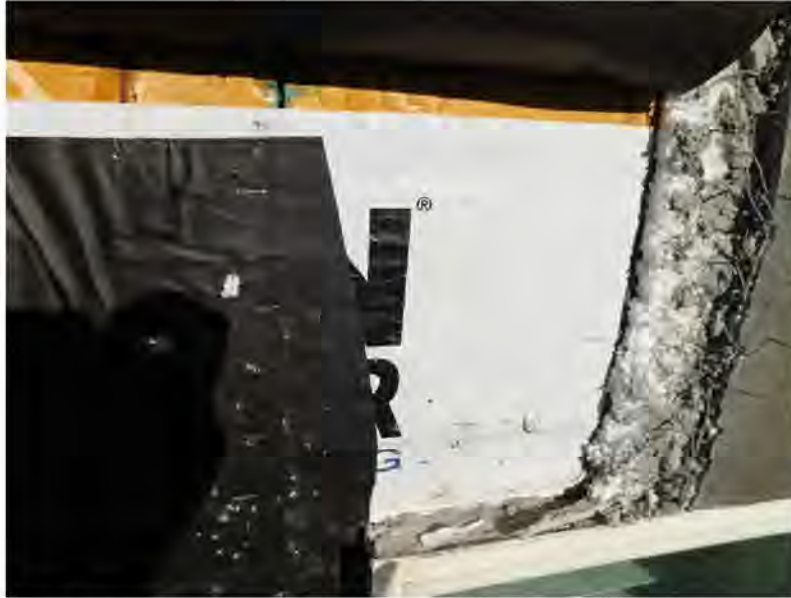
March 10, 2021, Disc IT9, Photograph 269, PER, Building C, missing flashing at window head.

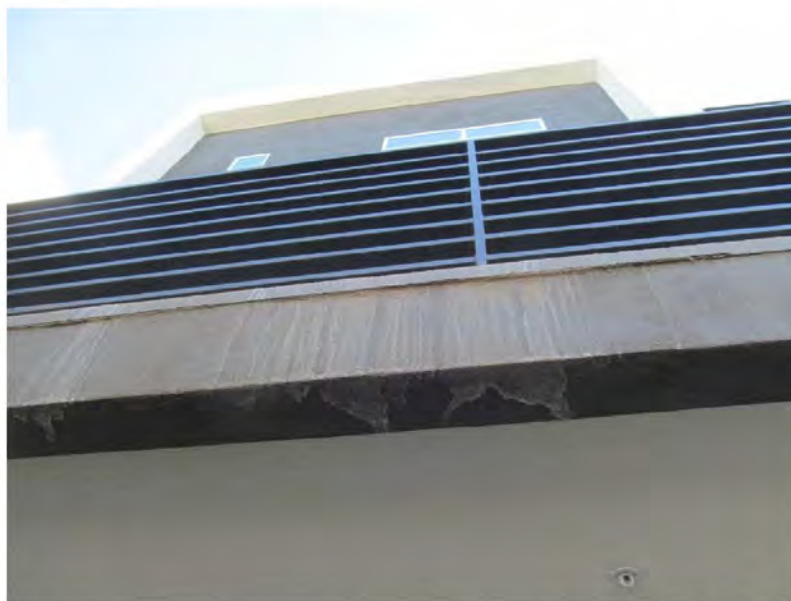
October 14, 2019, Disc OBS2, Photograph 125, SSR, Building B, deck edge flashing inset at stucco and stains visible.

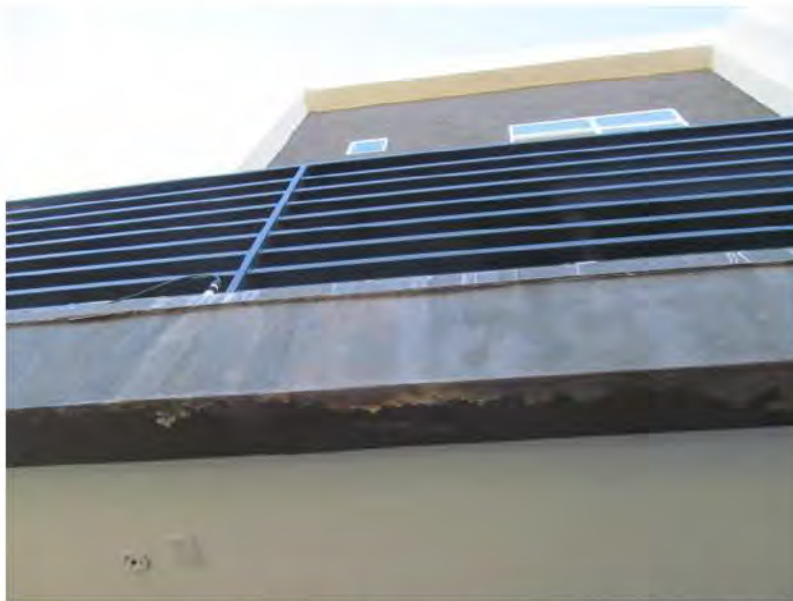
October 14, 2019, Disc OBS3, Photograph 389, SSR, Building D, deck edge flashing inset at stucco and stains visible.

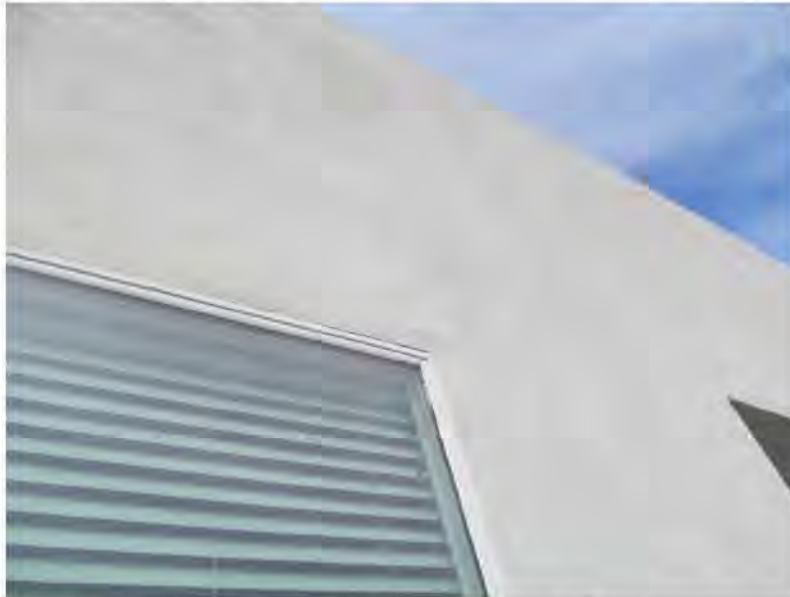
March 9, 2021, Disc IT6, Photograph 12, SSR, Building A, non-compliant isolation joint at window to stucco interface with a diagonal crack at top right corner of window.

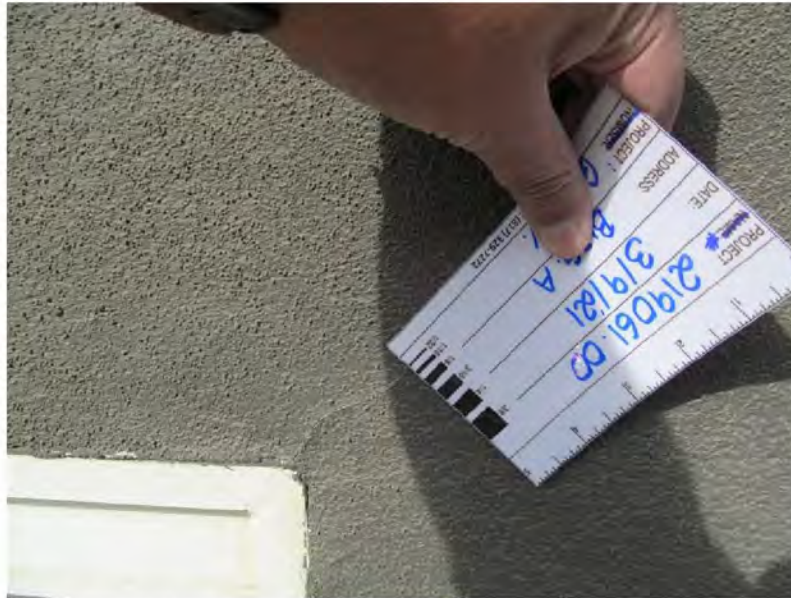
March 9, 2021, Disc IT6, Photograph 39, SSR, Building A, non-compliant isolation joint at sliding door to stucco interface with a diagonal crack at top right corner of sliding door.

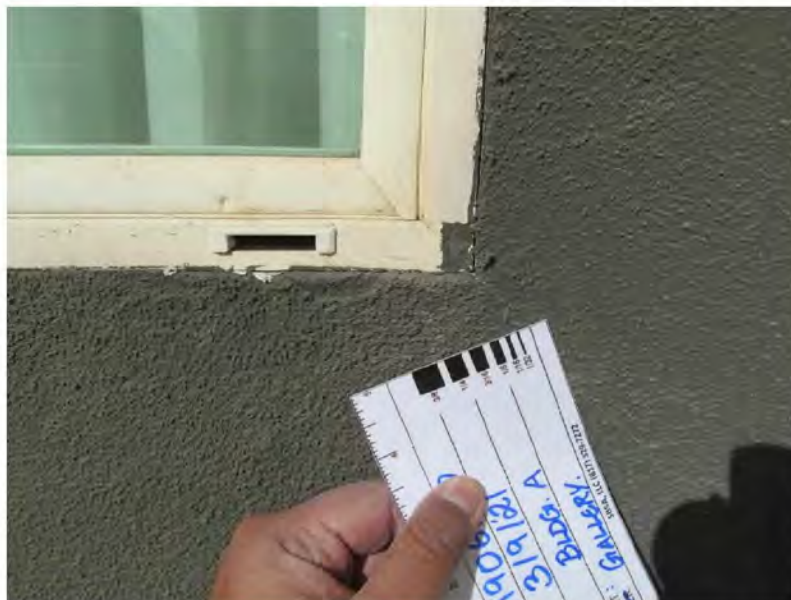
March 9, 2021, Disc IT6, Photograph 81, SSR, Building A, non-compliant isolation joint at window to stucco interface with a diagonal crack at bottom right corner of window.

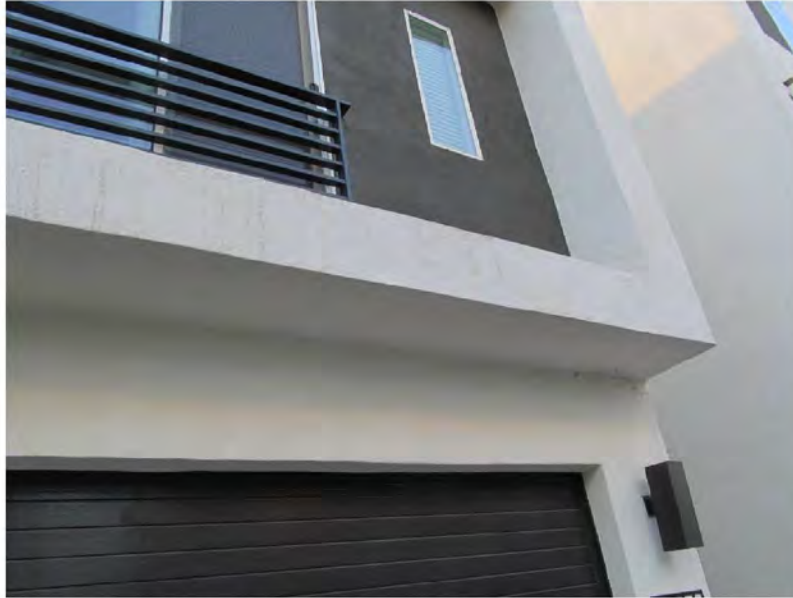
March 10, 2021, Disc OBS5, Photograph 72, SSR, Building B, missing isolation joint at stucco siding to stucco soffit

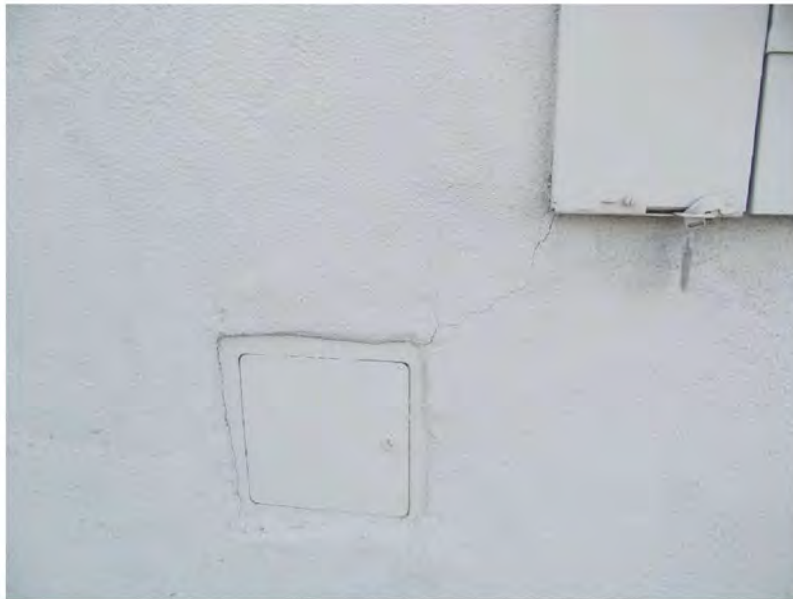
March 10, 2021, Disc OBS5, Photograph 91, SSR, Building B, non-compliant isolation joint at utility box to stucco with diagonal stucco racks.

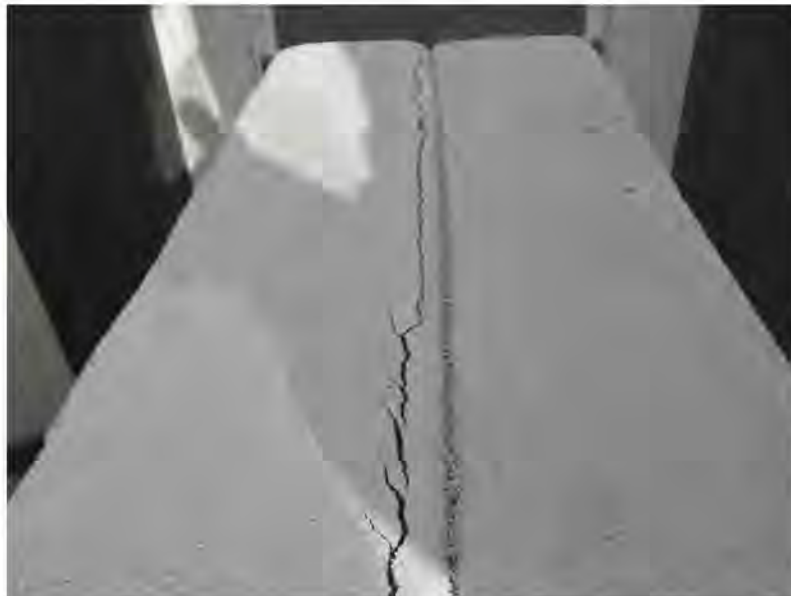
March 11, 2021, Disc OBS6, Photograph 28, JBF, stairs between Buildings C and D, cracking and separation of stair wall. SBSA understands builder performed repairs at this location.

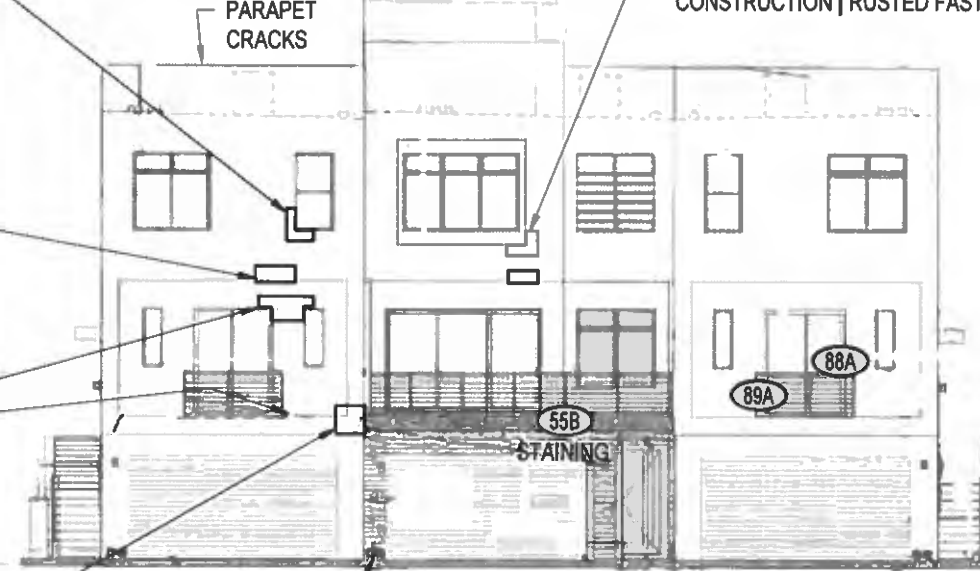
3E-4E
FRONT ELEVATION

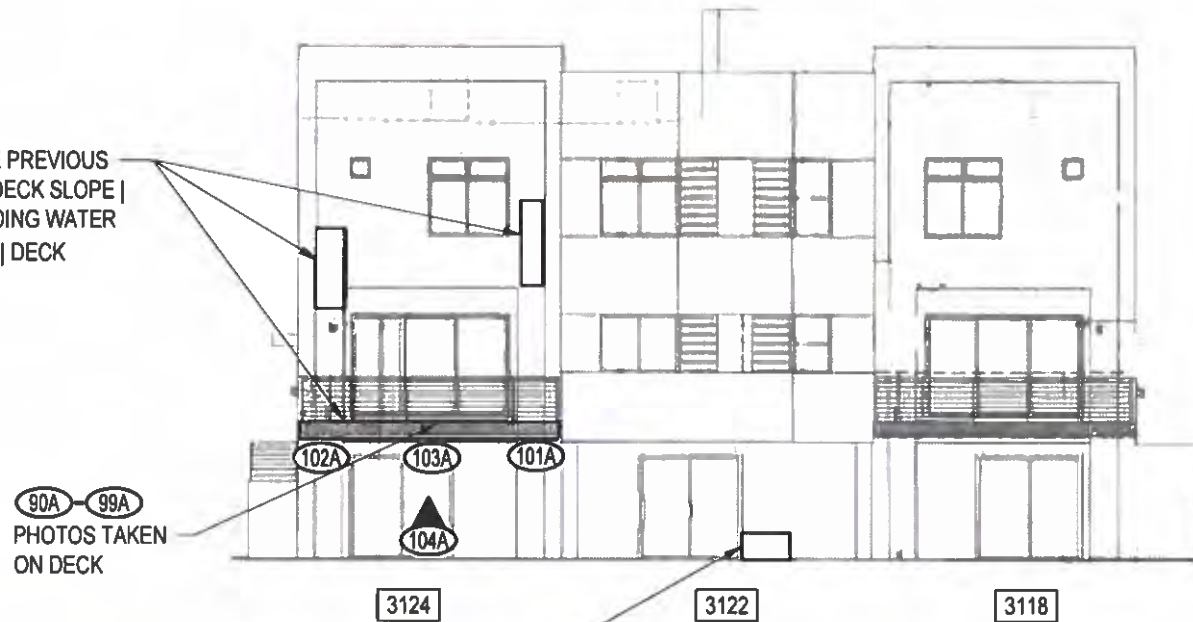
90A-99A
PHOTOS TAKEN ON DECK

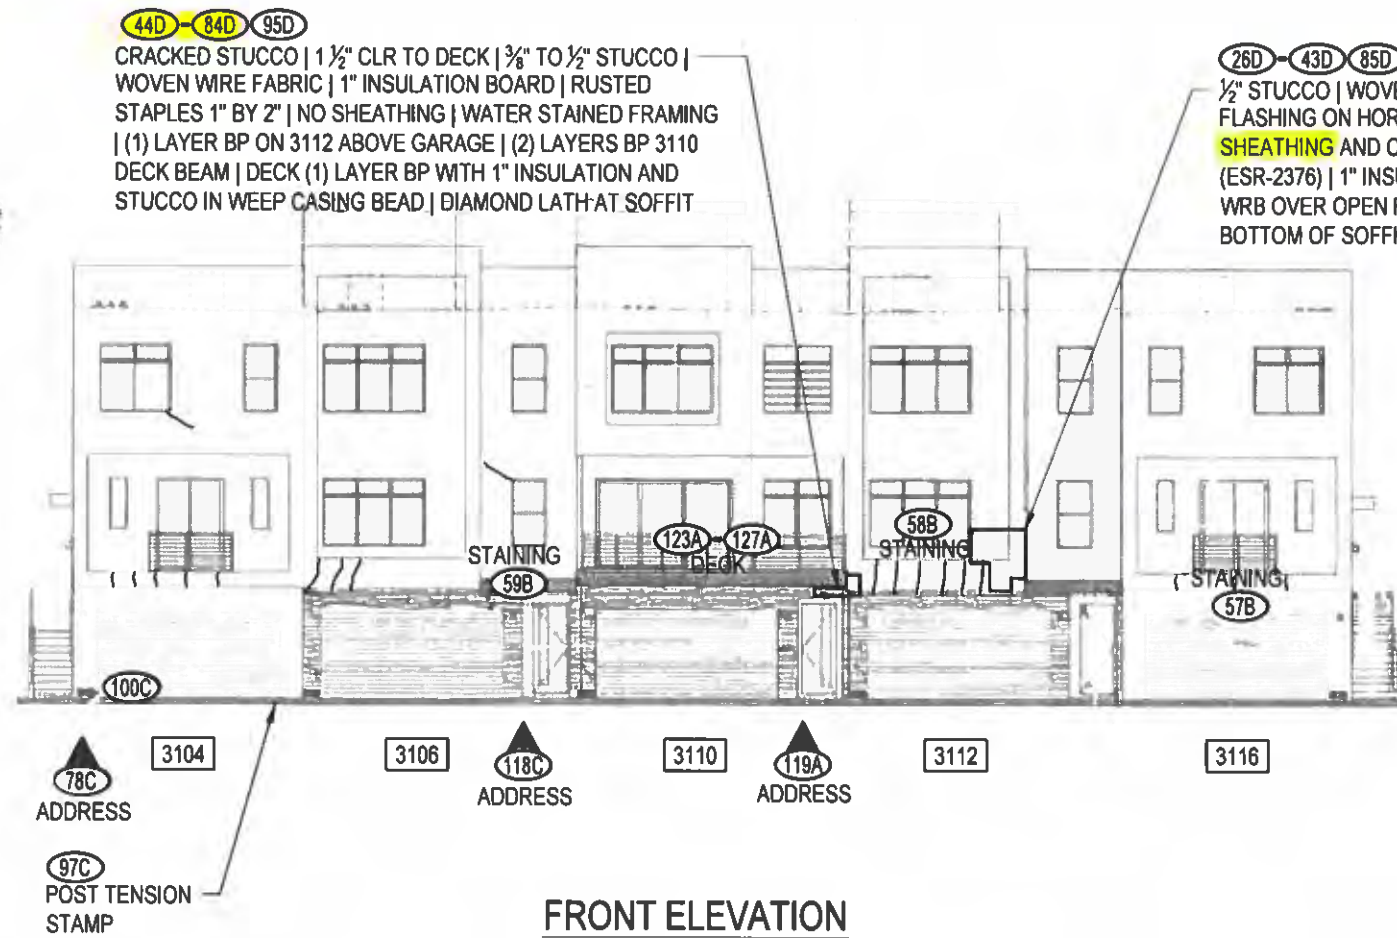
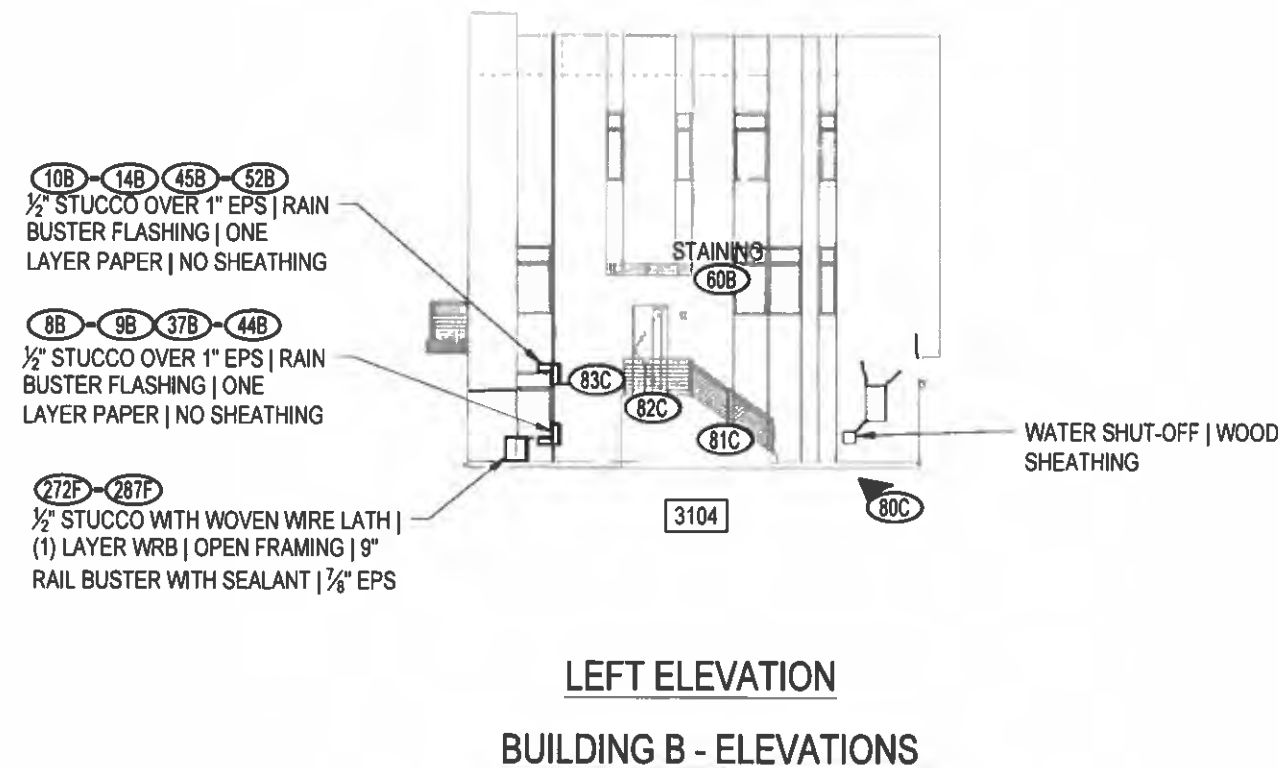
289G
 UNIT 3110:
 ROOF LEAK AND REPAIR | CEILING DRYWALL
 | STAIN FROM LEAK LOCATED AT UPPER
 LEVEL BED | HOME OWNER REPORTS NEW
 DRAIN COVER AT MAIN AND OVERFLOW
 DRAIN | 4" TEAR IN ROOF SURFACE COAT |
 ROOF SLOPE AT CRICKET 0.9% - 1.9% | AT
 ACCESS DOOR FRAMING UNDER JAMB IS
 EXPOSED | STUCCO STOPS SHORT OF JAMB
 | 5" CLR FRAMING TO ROOF

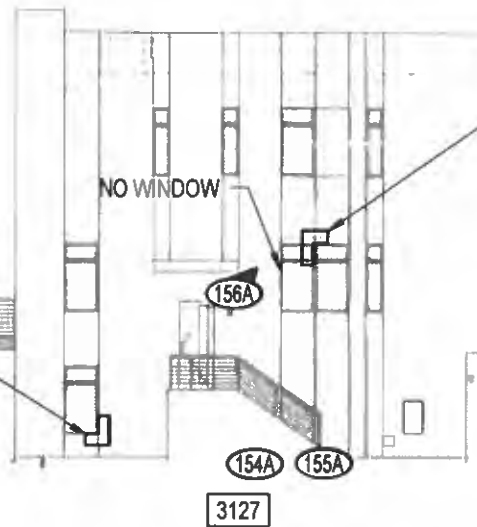
139-140-147-156
 $\frac{1}{2}$ " STUCCO | 1" EPS | RAIN BUSTER FLASHING AT JAMB AND SILL | ONE LAYER PAPER | NO SHEATHING

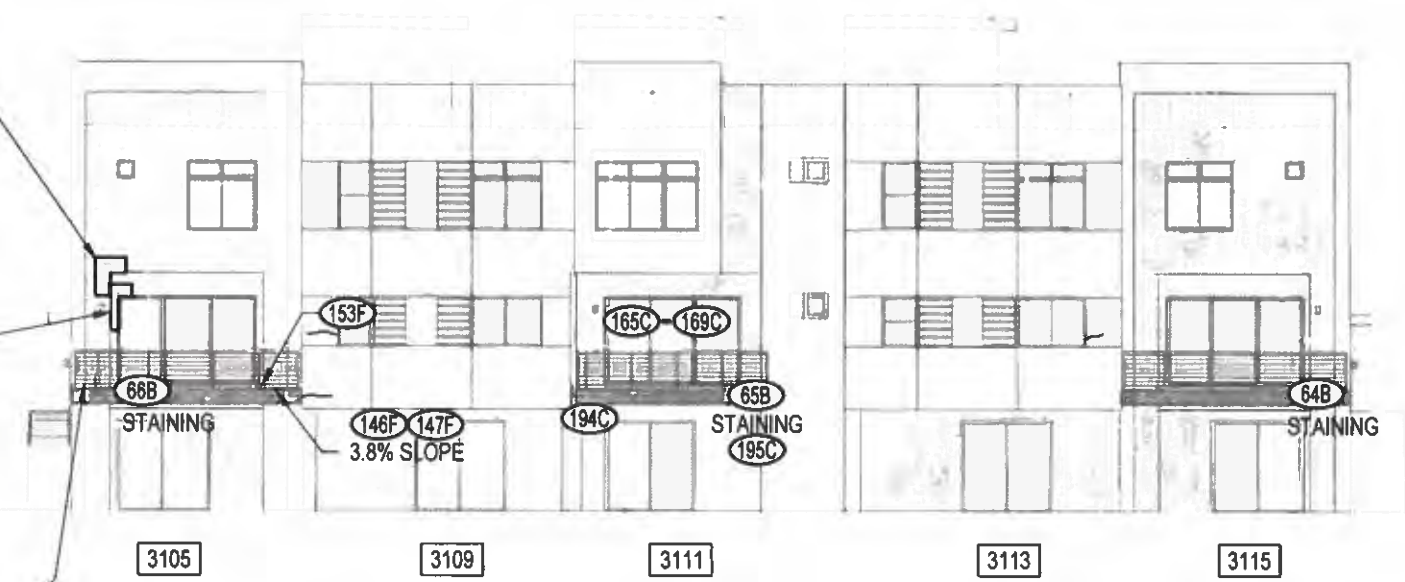
148F-152F-154F-155F
4" CLR TO SMF | UNDER WINDOW / DOOR

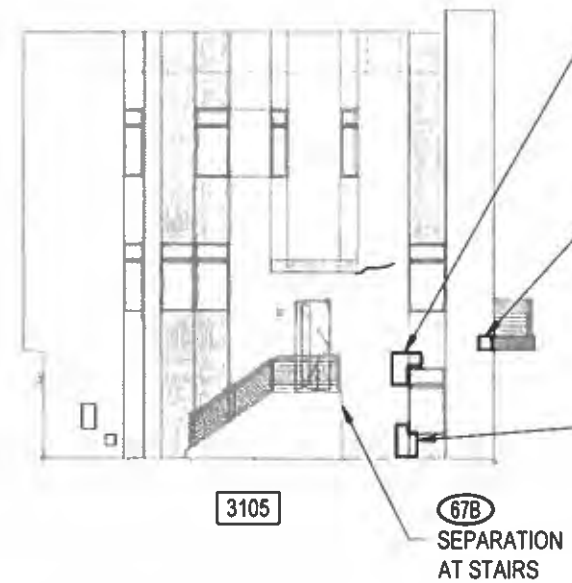
8F-14F-33F-50F-62F
NO ISO JT (TYP) | WINDOW SEPARATION | WOVEN WIRE LATH | (1) LAYER WRB | (RAIN BUSTER) | OPEN FRAMING | 9" WIDE LOOSE WINDOW FLASHING | SEALANT | 3/8" TO 1/2" STUCCO THICKNESS
