Project Number: 219061.00 (030)
Project Name: Gallery
Location: 3104-3127 North 71st Street
Scottsdale, Arizona 85251

Subject: Supplemental Construction and Design Compliance Report

Per your request, SBSA, LLC, A Charles Taylor Company (SBSA), provided a Construction and Design Compliance Report (SBSA CDC Report) dated June 23, 2021 to document findings based on observations of the buildings at the Gallery Townhomes site (Gallery) in Scottsdale, Arizona. This supplemental report provides additional findings based on a visual observation on August 23, 2021 and disclosed photographs.

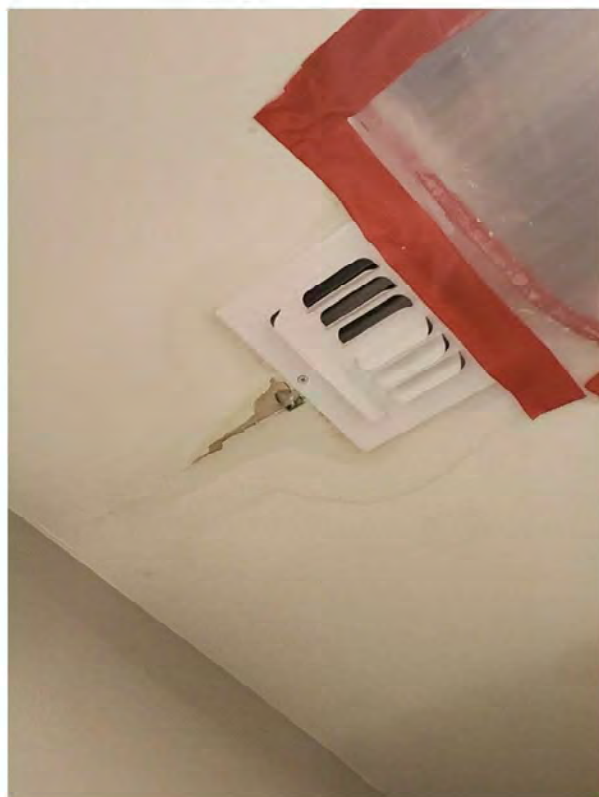
The homeowner's insurance representative removed the ceiling gypsum sheathing to observe damage in the ceiling space in the third floor bedroom and laundry room of Unit 3106. The water-damaged gypsum sheathing was retained, covered with plastic, and stored in the homeowner's garage.

At Unit 3106, the preformed roof drain sump is supported over wood blocking and wood roof trusses along the perimeter. There are rusted fasteners and water stains on the roof framing and blocking at the perimeter of the drain sump, indicating water intrusion. The roof coating transitions from the SPF to the recessed drain sump. The drain sump is flexible and is susceptible to vertical movement when any downward force is applied. Some of the units have roof access and are used as roof decks for the occupants. The transition from the SPF to the perimeter of the roof drain sump had been temporarily repaired at the time of SBSA's observation. Nautilus applied water on the roof and allowed it to drain. SBSA did not observe water intrusion into the roof space below at the roof drain sump, and the temporary repair at the perimeter of the roof drain sump appears to have fixed the leaks. It is more likely than not that the waterproofing failed at the transition of the SPF to the roof drain sump.

August 14, 2021, Homeowner-provided photograph, Unit 3106, upper floor laundry room, water leak near location of roof drain.

- Prepare the existing waterproofing system for installation of reinforcing fabric at transition from the SPF and the perimeter of the roof drain sump at all units of Building B.
- Apply waterproofing coating per manufacturer's instructions.
- At the Unit 3106 AC unit pad, provide a permanent roof repair and coordinate with repairs for C.3.a in SBSA's CDC Report.
- At Unit 3104, reinstall front light to electrical box and apply a compliant sealant joint. Coordinate with repairs recommended in SBSA's CDC Report.

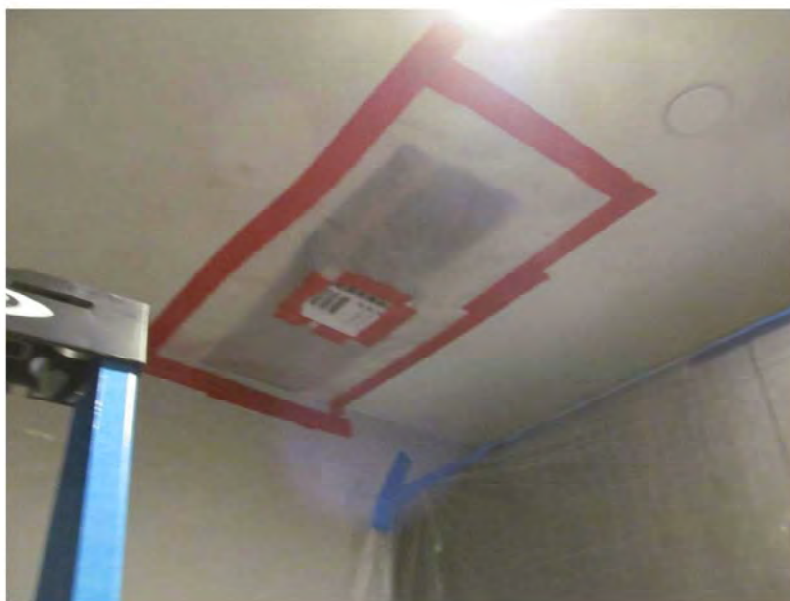
August 23, 2021, Disc OBS8, Photograph 54, JJF, Unit 3106, laundry room, portion of ceiling drywall removed by others.

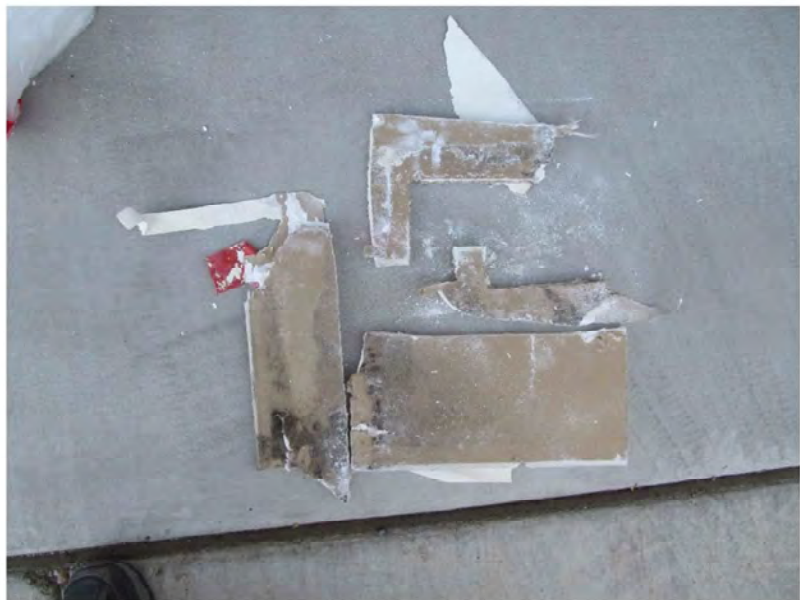
August 23, 2021, Disc OBS8, Photograph 48, JJF, Unit 3106, laundry room ceiling, water-damaged ceiling drywall around vent. Refer to photograph above.

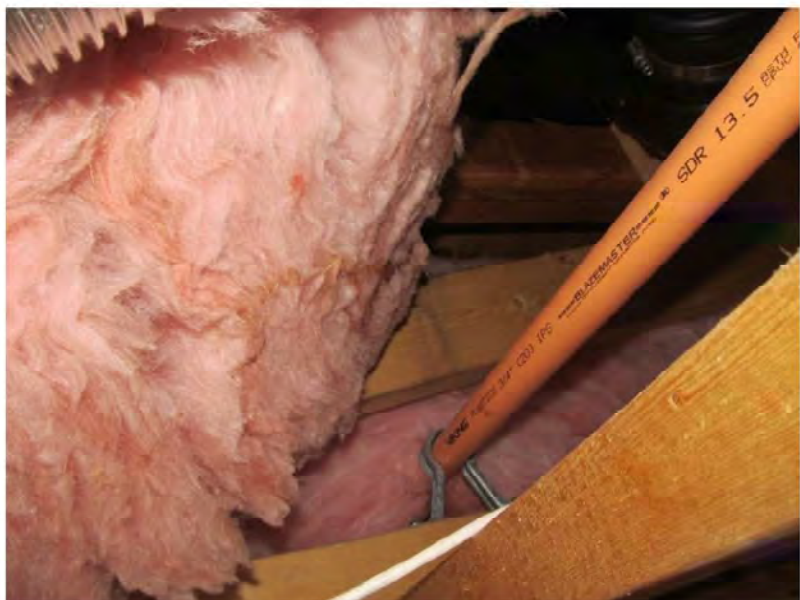
August 23, 2021, Disc OBS8, Photograph 76, JJF, Unit 3106, laundry room, water-stained batt insulation.

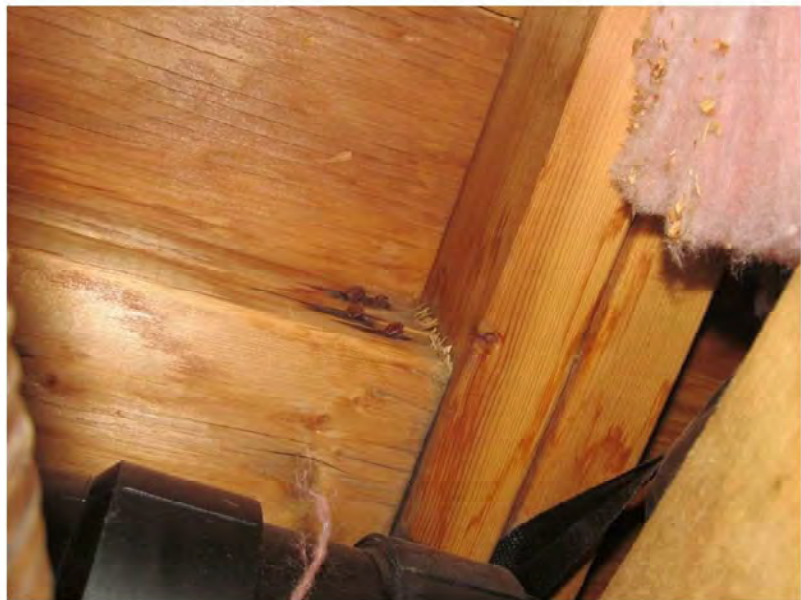
August 23, 2021, Disc OBS8, Photograph 84, JJF, Unit 3106, laundry room, rusted nails and water-stained wood blocking and top chord of roof truss.

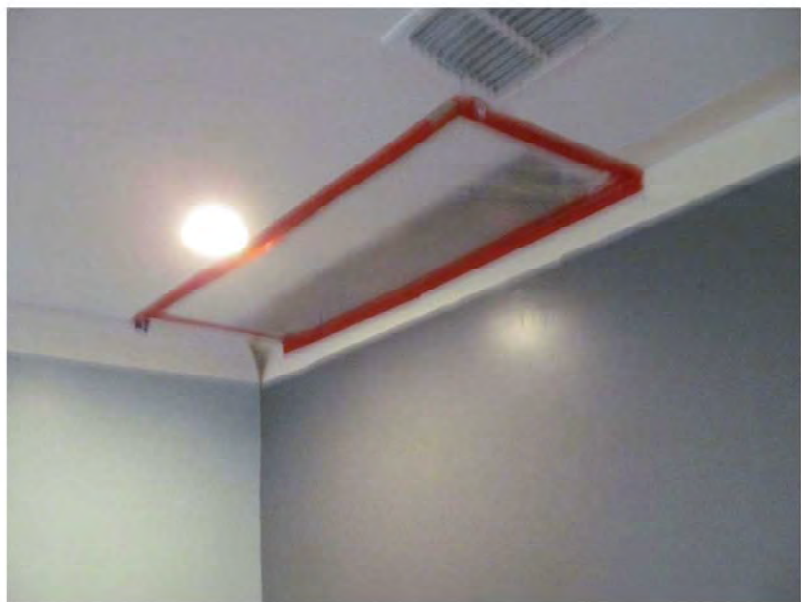
August 23, 2021, Disc OBS8, Photograph 60, JJF, Unit 3106, bedroom, portion of ceiling drywall removed by others.

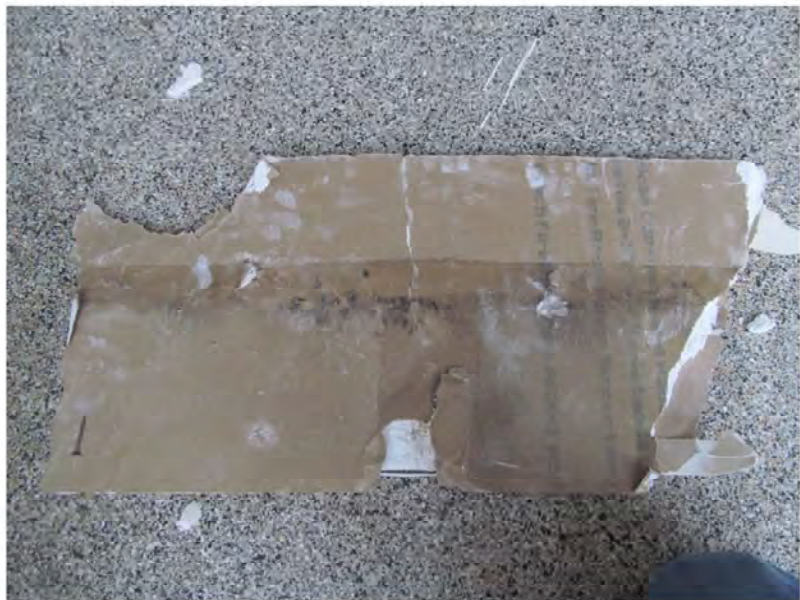
August 23, 2021, Disc OBS8, Photograph 51, JJF, Unit 3106, bedroom ceiling, water-damaged ceiling drywall. Refer to photograph above.

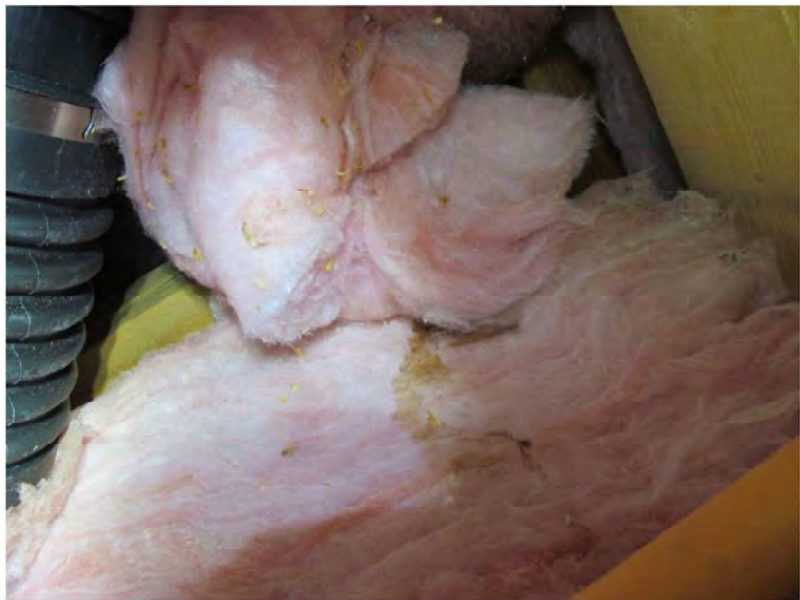
August 23, 2021, Disc OBS8, Photograph 65, JJF, Unit 3106, bedroom, water-stained batt insulation.

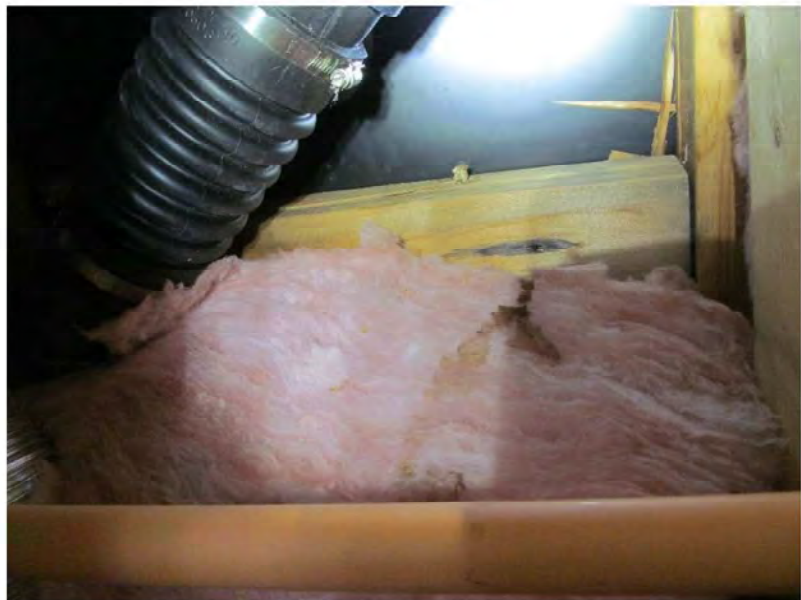
August 23, 2021, Disc OBS8, Photograph 68, JJF, Unit 3106, bedroom, water-stained batt insulation under nail.

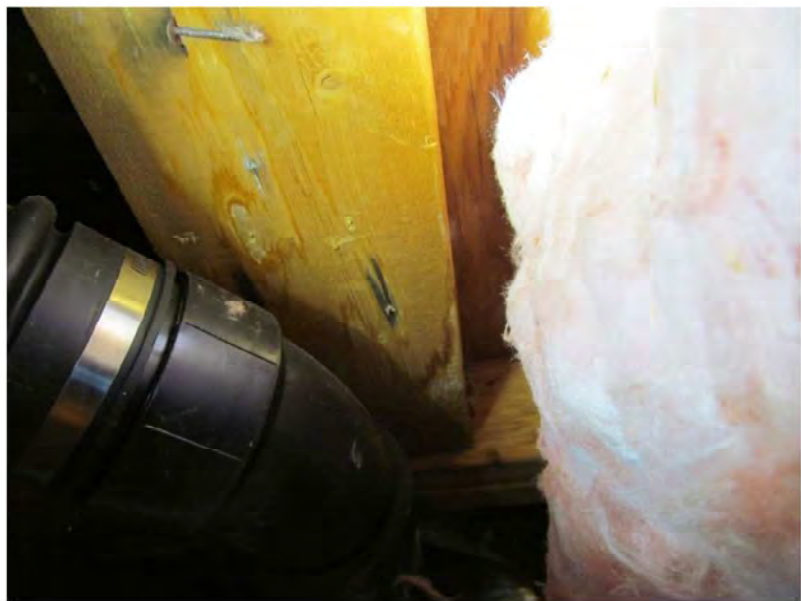
August 23, 2021, Disc OBS8, Photograph 70, JJF, Unit 3106, bedroom, water-stained wood blocking under perimeter edge of preformed drain pan farthest from parapet wall.

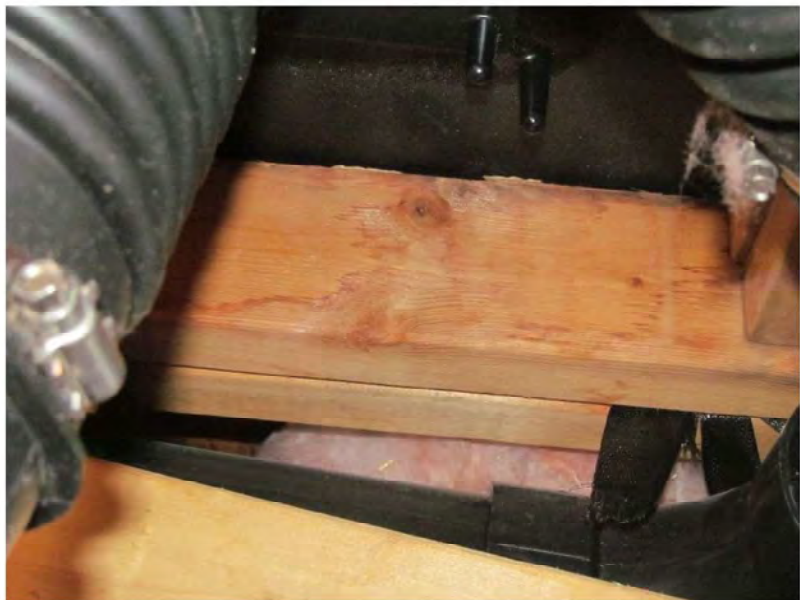
August 23, 2021, Disc OBS8, Photograph 72, JJF, Unit 3106, bedroom, water-stained wood blocking under perimeter edge of preformed drain sump nearest to parapet wall.

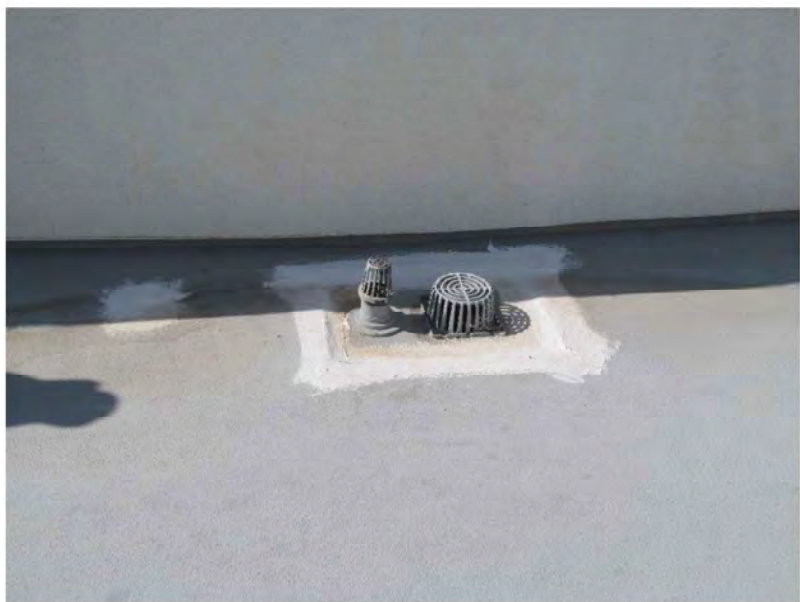
August 23, 2021, Disc OBS8, Photograph 86, JJF, Unit 3106, roof, temporary repair at perimeter of roof drain sump.

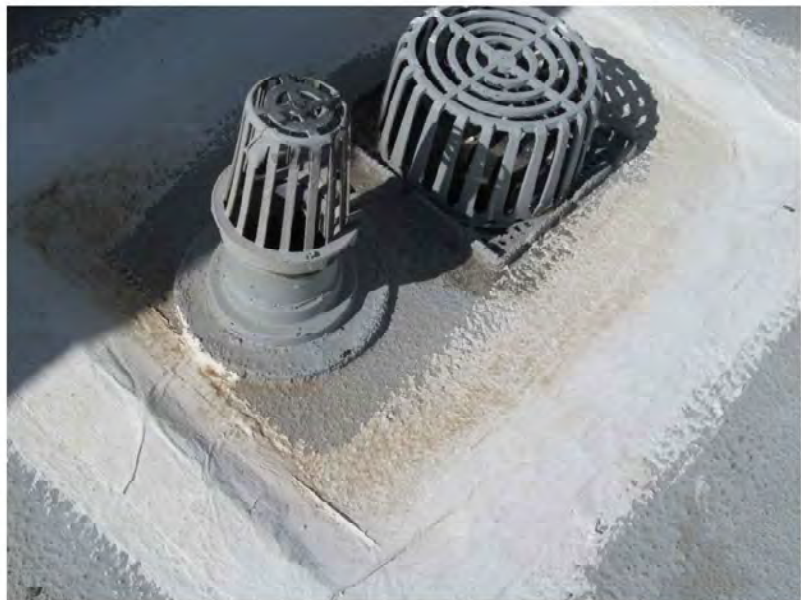
August 23, 2021, Disc OBS8, Photograph 88, JFF, Unit 3106, roof, temporary repair at perimeter of roof drain sump.

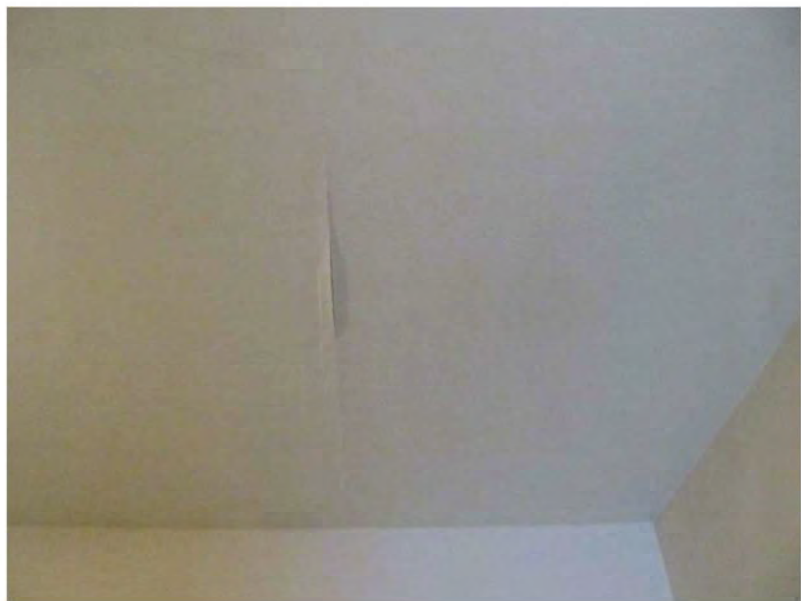
At Unit 3104, the homeowner reported roof leaks at the third floor back bedroom and hallway and at the front door light switch. The roof leak at the back bedroom is near the roof drain sump above. The roof membrane has locations of cuts and holes. SBSA understands that the roof cuts and holes have been repaired by Nautilus. The front door light was not sealed and protruded from the stucco with openings around the perimeter. Nautilus applied sealant around the front entry light base as a temporary repair.

August 23, 2021, Disc OBS8, Photograph 107, JFF, Unit 3104, back bedroom, ceiling damage near location of roof drain above.

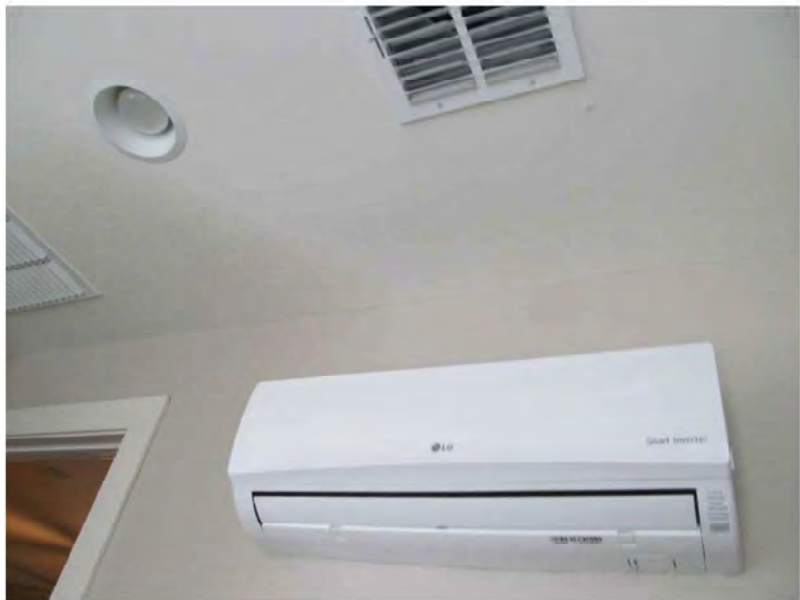
August 23, 2021, Disc OBS8, Photograph 108, JJJ, Unit 3104, hallway, ceiling stain and damage at bottom right of vent.

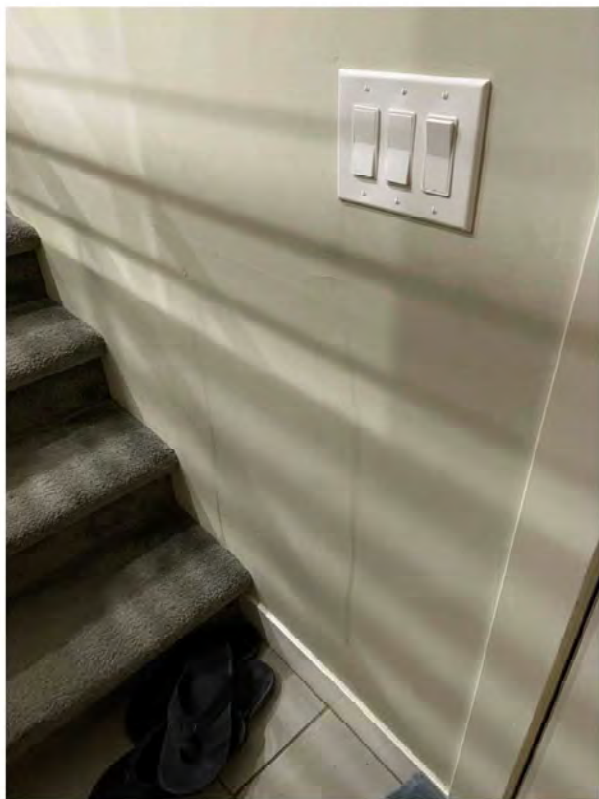
Burg Simpson provided photograph, Bates Number GALLERY-JONES_3104-000010, Unit 3104, water leak at front door light switch and hole in interior drywall.

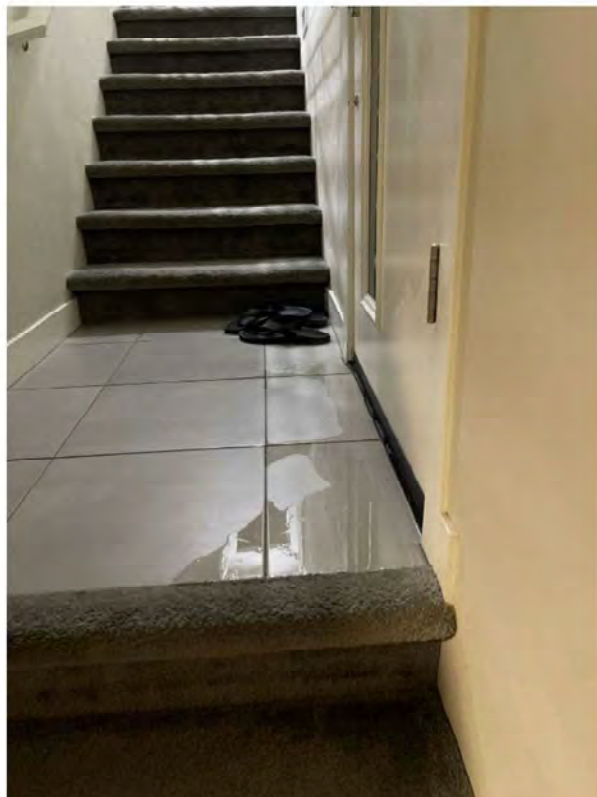
Burg Simpson provided photograph, Bates Number GALLERY-JONES_3104-000012, Unit 3104, water leak at from front door light switch and hole in interior drywall. Water pooling on floor.

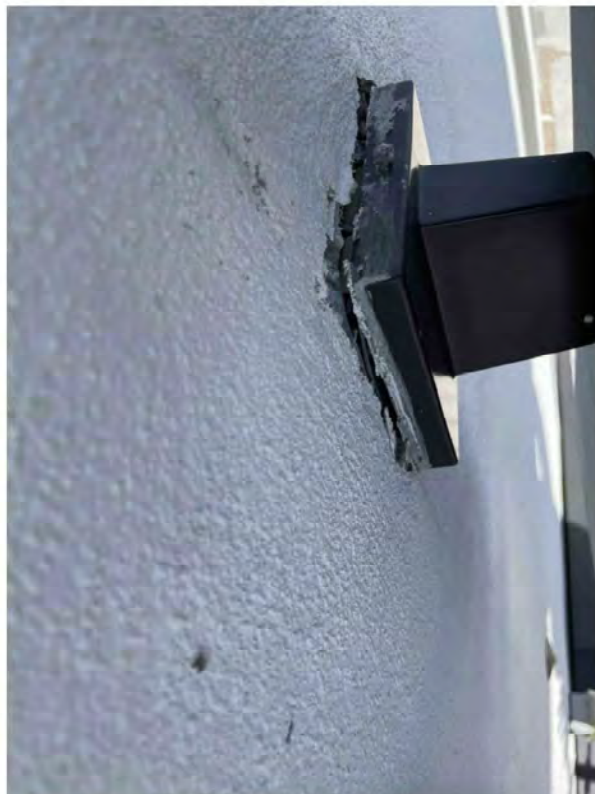
Nautilus-provided photograph, Bates Number GALLERY-NBC_004992, Unit 3104, light fixture protruding from stucco with openings around the perimeter.

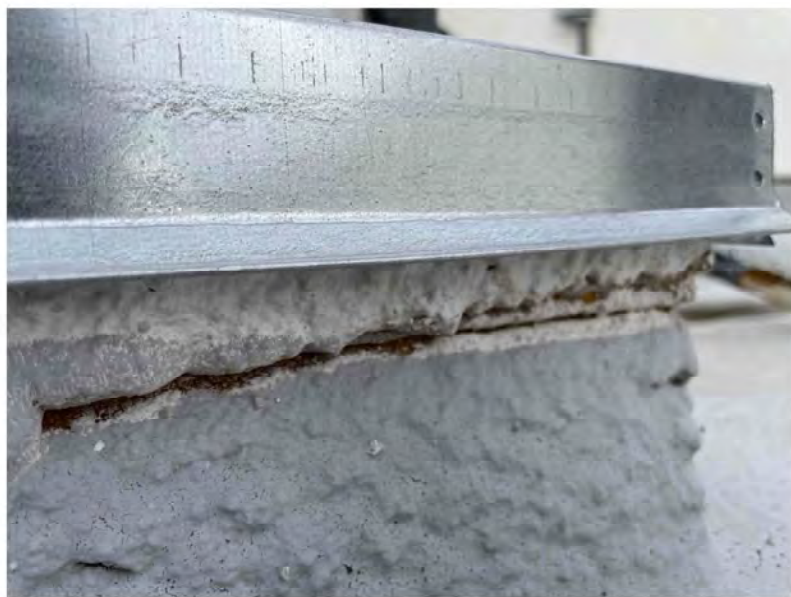
Also, the homeowner at Unit 3112 reported a roof leak near an AC unit. SBSA understands that the pad under the AC unit was repaired by the contractor. This repair failed because there are numerous openings and seams of the roof covering, allowing water intrusion. Nautilus provided a repair at the openings and seams of the AC unit pad.

Nautilus-provided photograph, Bates Number GALLERY-NBC_005052, Unit 3112, previous repair failed to seal openings in the roof membrane.

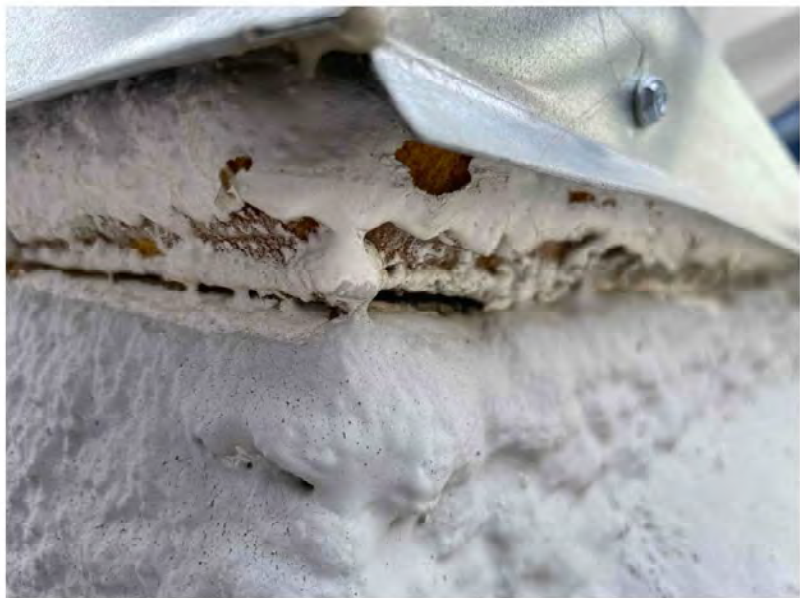
Nautilus-provided photograph, Bates Number GALLERY-NBC_005058, Unit 3112, previous repair failed to seal openings in the roof membrane.

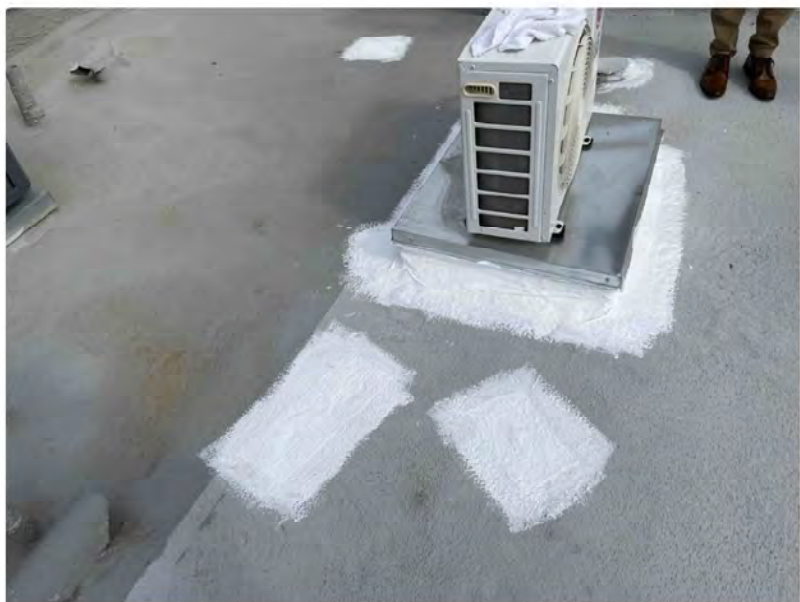
Nautilus-provided photograph, Bates Number GALLERY-NBC_005059, Unit 3112, Nautilus roof repair.

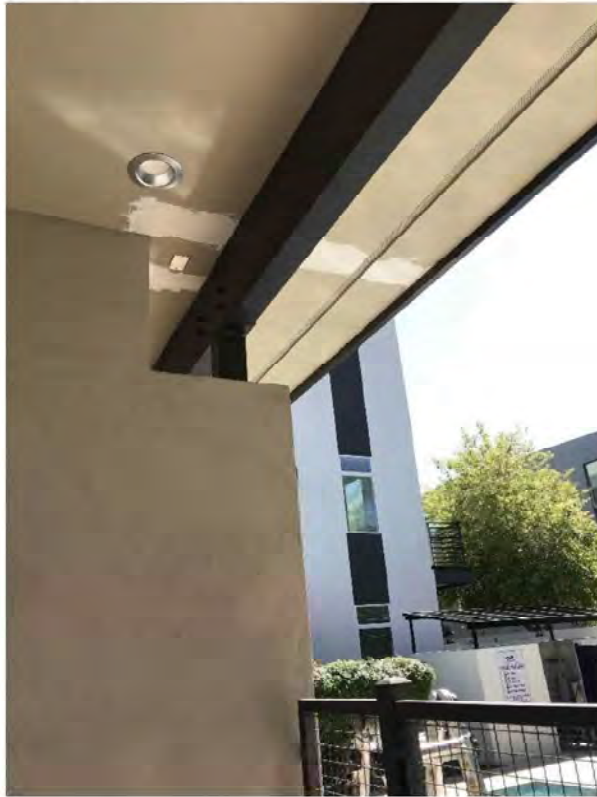
There are areas of the pool cabana ceiling that are cracked and have peeling paint. A previous repair by the original contractor was performed on the ceiling area near the area of the damaged ceiling per the disclosed Nautilus photographs.

The standing seam metal roof panels of the cabana are riveted at the overlap with the metal drip edge. At the standing seam metal roof panels and drip edge interface, there are openings and at one location there are no rivets. The openings allow water to enter between the drip edge and roof panels. The disclosed photographs of the previous repair show that the repair does not appear to have addressed the underlying issue that caused the damage.

Nautilus-provided photograph, previous repair of pool cabana ceiling.

- Remove existing rivets at the downhill side of the roof.
- Install sheet metal flashing under the existing standing seam metal roof. Extend the leg of the sheet metal flashing under the standing seam metal panels and under the roof underlayment a minimum of 4-inches. Extend the edge of the sheet metal flashing 1/4-inch past the edge of the fascia. Color to match existing roof and sheet metal drip edge.
- Drill a pilot hole through the new sheet metal flashing at the existing rivet holes and apply heat-resistant silicone sealant in the existing rivet holes.
- Attach standing seam metal roof with screws and neoprene washers at the location of the existing rivets.
- Crimp the ends of the standing seam metal roofs.
- Fix damaged drywall ceiling and paint to match.

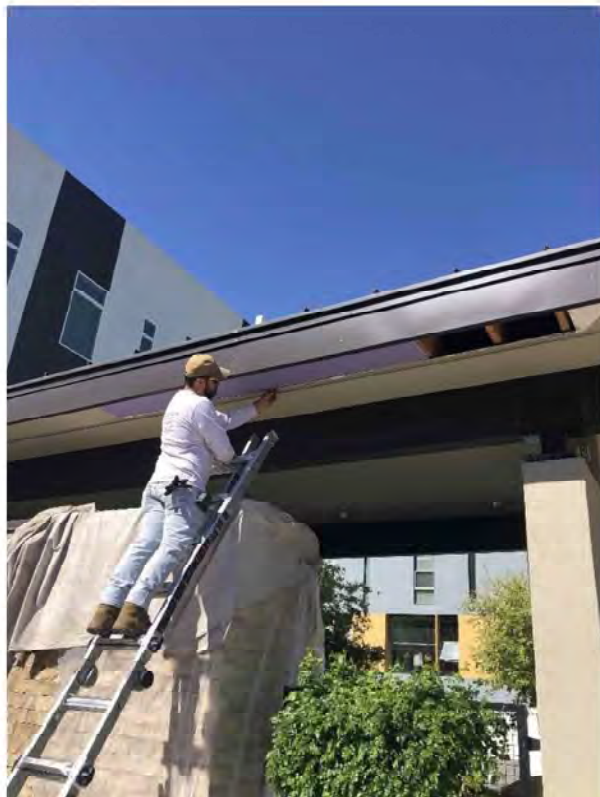
Nautilus-provided photograph, previous repair of pool cabana ceiling.

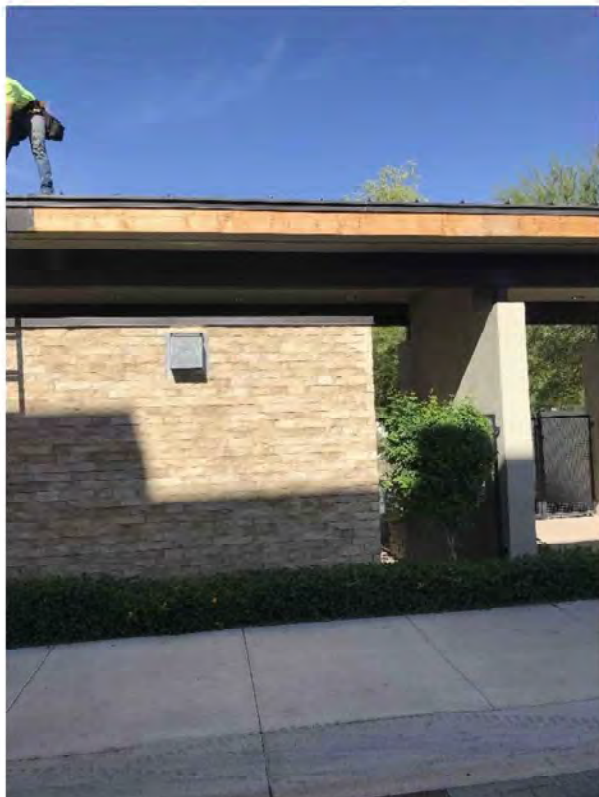
Nautilus-provided photograph, previous repair of pool cabana ceiling.

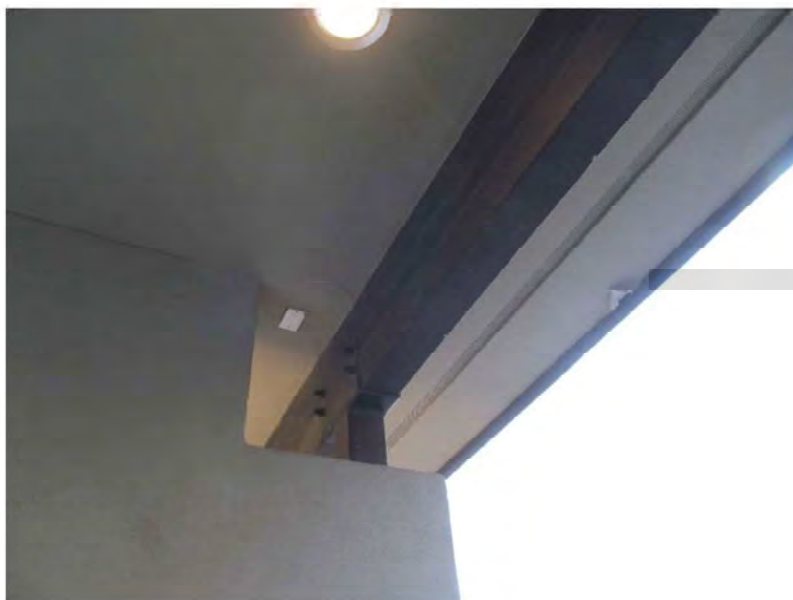
August 23, 2021, Disc OBS8, Photograph 2, JJF, pool cabana, peeling paint and cracked ceiling finish.

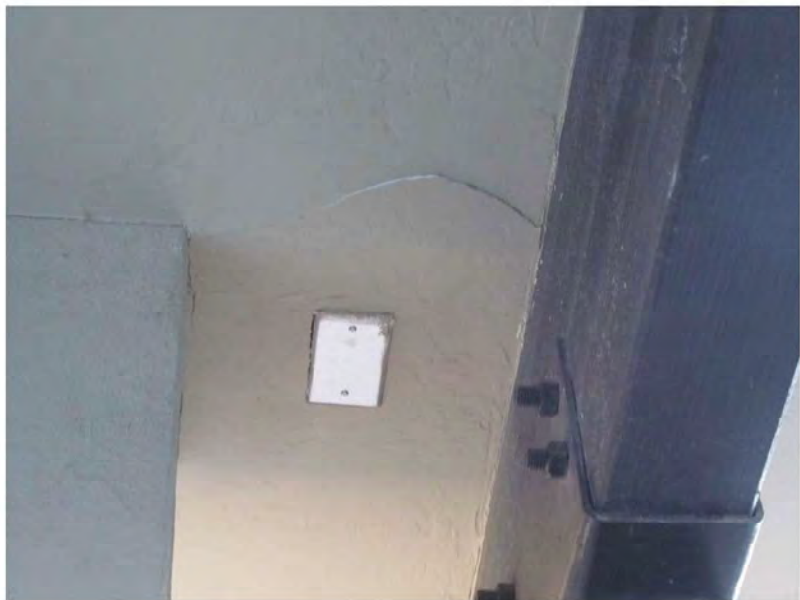
August 23, 2021, Disc OBS8, Photograph 3, JJF, pool cabana, cracked ceiling finish.

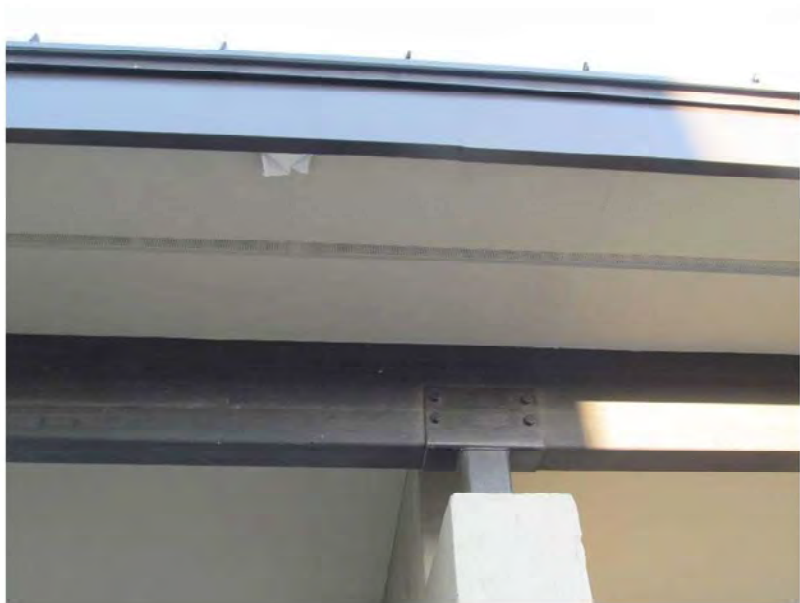
August 23, 2021, Disc OBS8, Photograph 10, JJF, pool cabana, peeling paint and cracked ceiling finish.

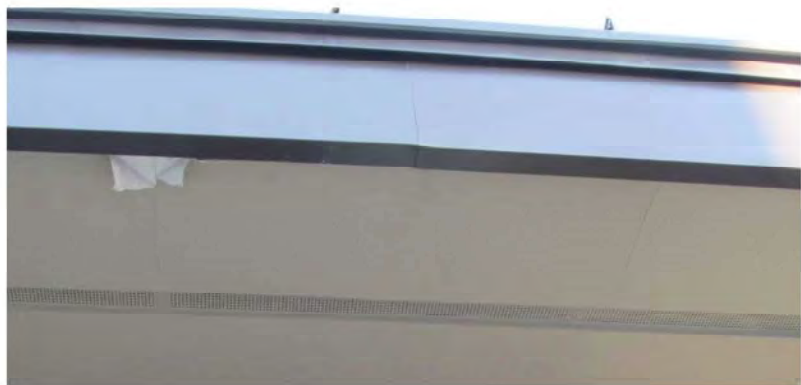
August 23, 2021, Disc OBS8, Photograph 10 (Enlarged), JJF, pool cabana, peeling paint and cracked ceiling finish. Zoomed in from photograph above.

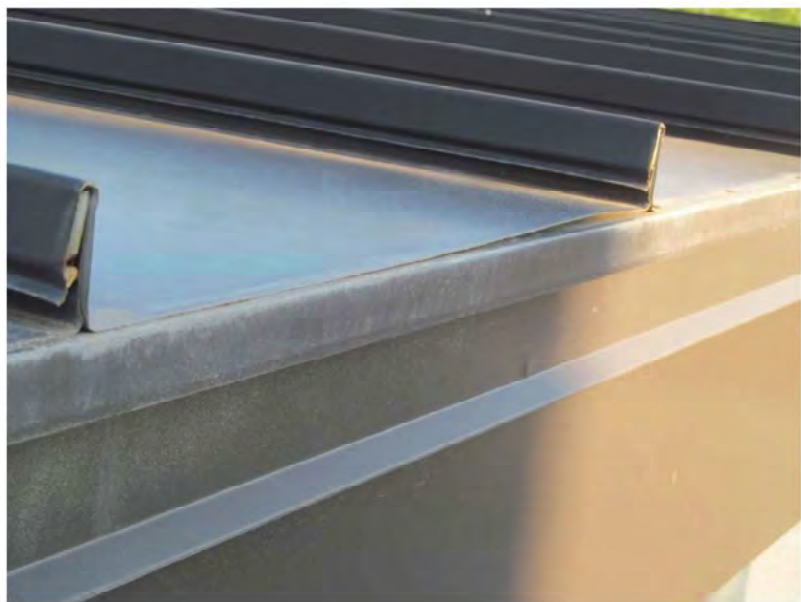
August 23, 2021, Disc OBS8, Photograph 13, JJF, standing seam metal panel is bulged at location where it is not riveted at leading edge.

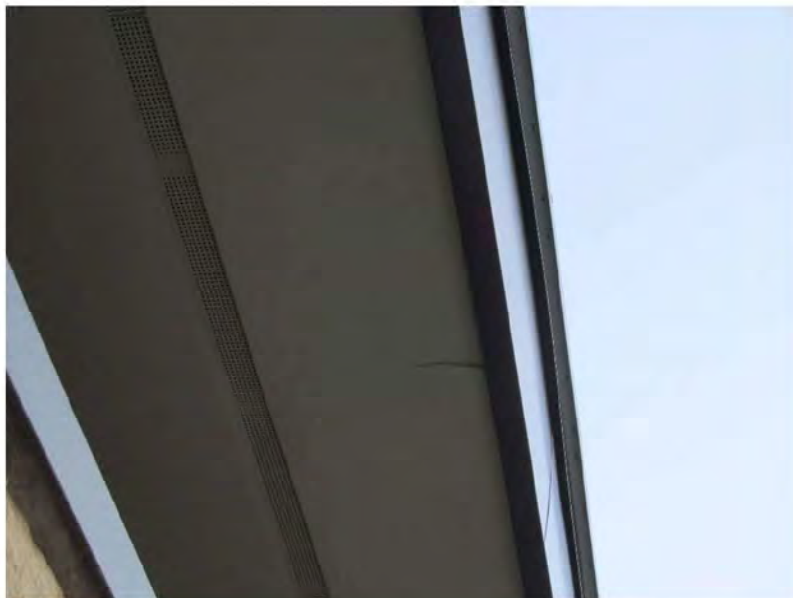
August 23, 2021, Disc OBS8, Photograph 9, JFF, pool cabana, cracked ceiling finish.

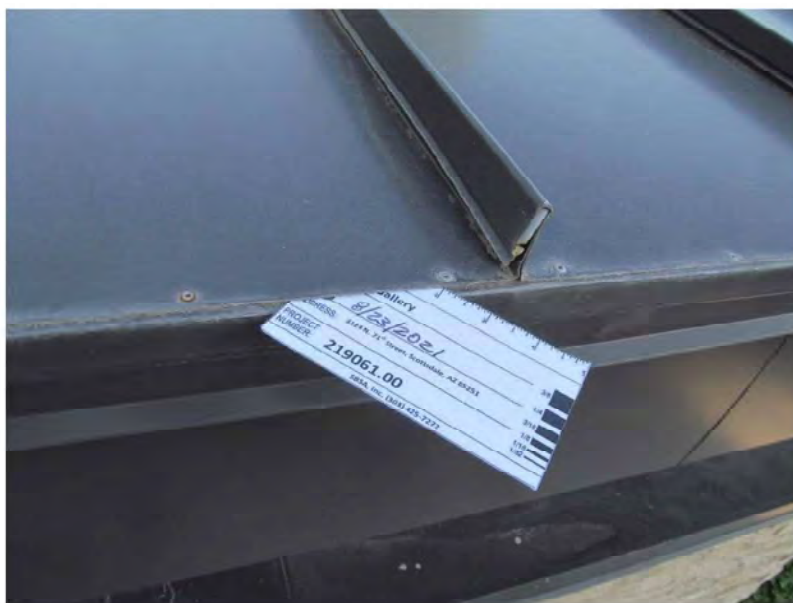
August 23, 2021, Disc OBS8, Photograph 16, JFF, pool cabana, unsealed edge.

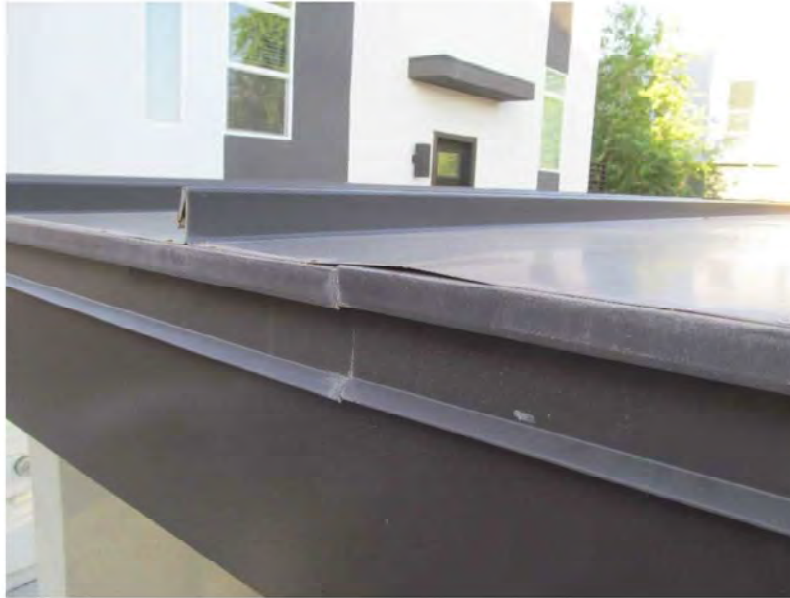
August 23, 2021, Disc OBS8, Photograph 18, JJF, pool cabana, unsealed and bulging edge.

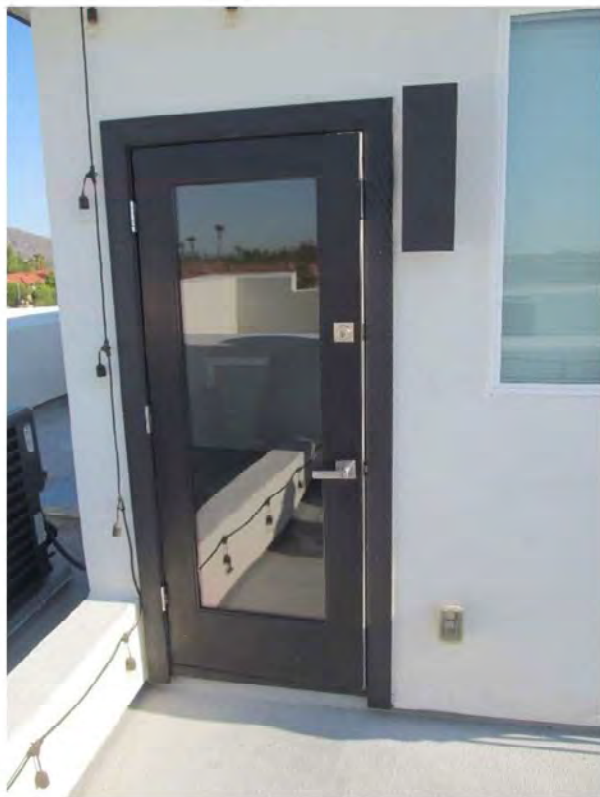
The homeowners at Unit 3106 reported that the penthouse door trim is damaged and there is water intrusion. The interior door trim extends below the tile floor finish and is swollen and paint is peeled.

August 23, 2021, Disc OBS8, Photograph 23, JJF, Unit 3106, overview of roof access door.

- Apply sealant at the interface of the door jambs to the door threshold at Units 3106 and 3123.

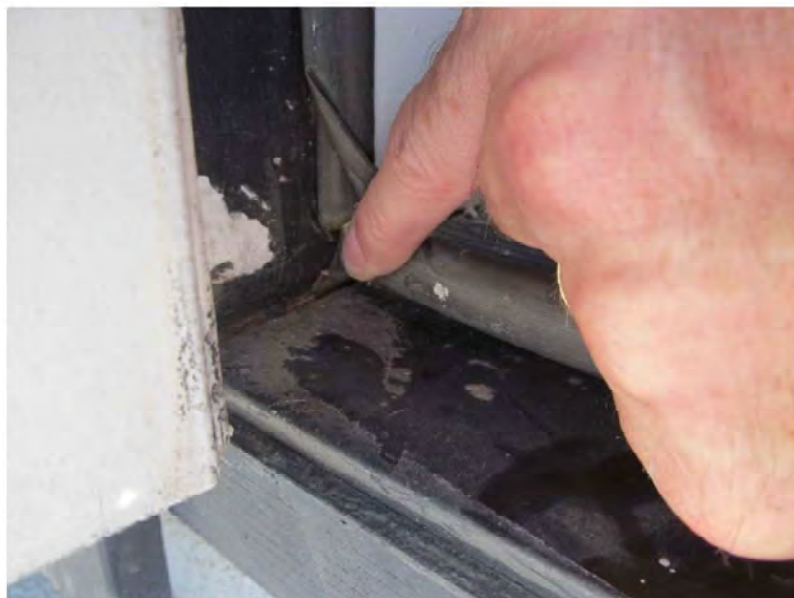
At the intersection of the door jambs to the door threshold, the joints are unsealed. Water is allowed to enter at the openings and travel below the tile floor covering to the wood floor sheathing. The door trim is in contact with the water and has wicked up, resulting in peeled paint and swollen trim. Nautilus sprayed water on the door to determine if water leaked at the door jamb location. SBSA determined water had entered at the buried door trim below the tile floor covering.

August 23, 2021, Disc OBS8, Photograph 29, JJF, Unit 3106, roof penthouse door, unsealed joint at door threshold to jamb.

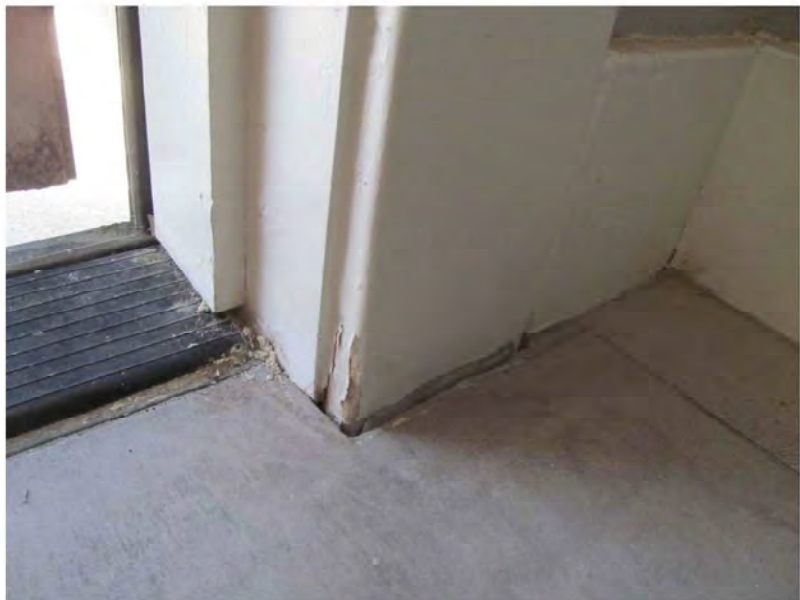
August 23, 2021, Disc OBS8, Photograph 27, JJF, Unit 3106, roof penthouse door, trim damage adjacent to door jamb.

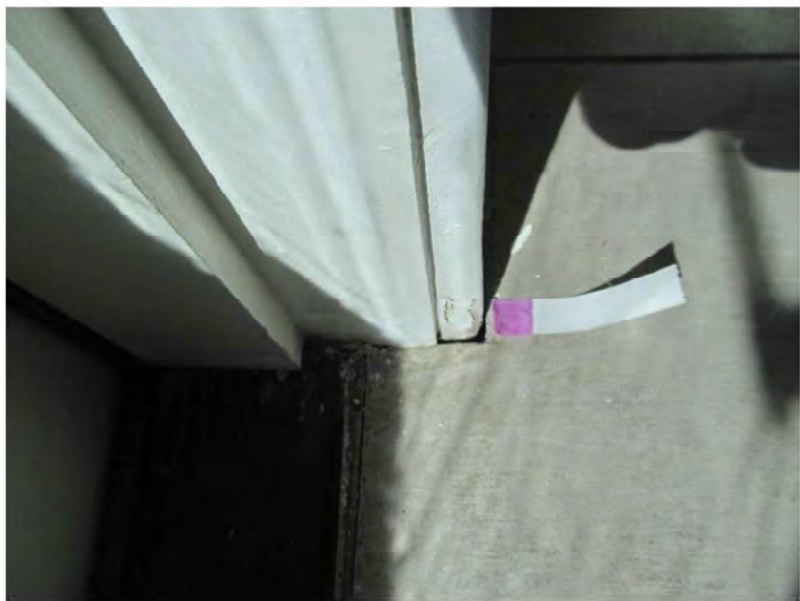
August 23, 2021, Disc OBS8, Photograph 101, JJF, Unit 3106, roof penthouse door, water infiltration under floor tile.

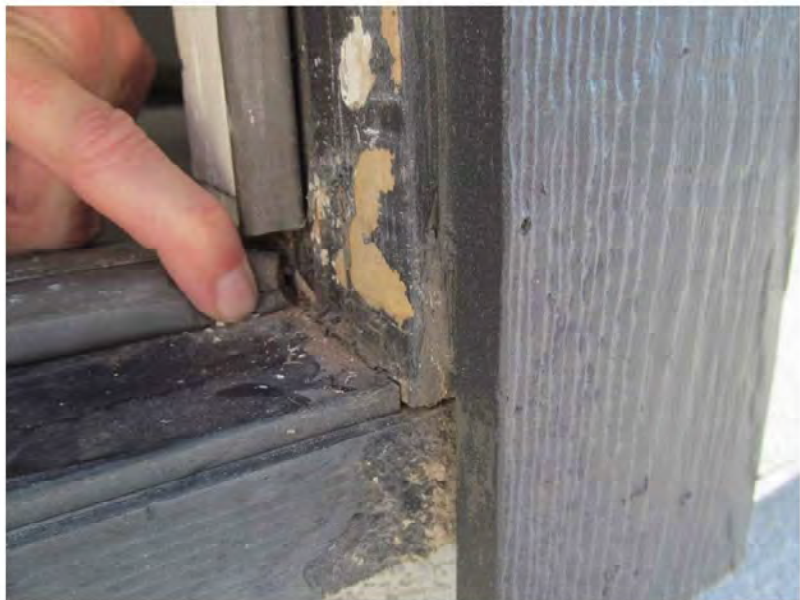
August 23, 2021, Disc OBS8, Photograph 34, JFF, Unit 3106, roof penthouse door, unsealed joint at door threshold to jamb. Paint delamination consistent with wetting and drying.

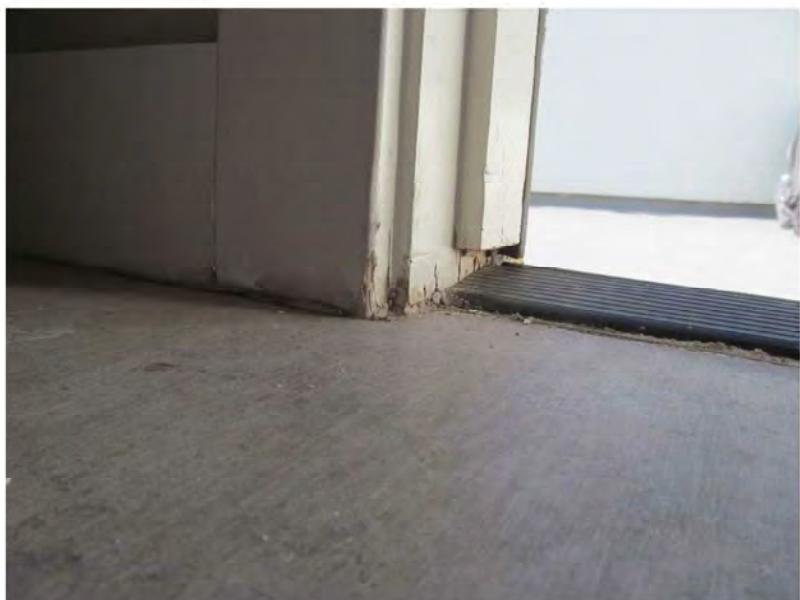
August 23, 2021, Disc OBS8, Photograph 32, JFF, Unit 3106, roof penthouse door, trim damage adjacent to door jamb.

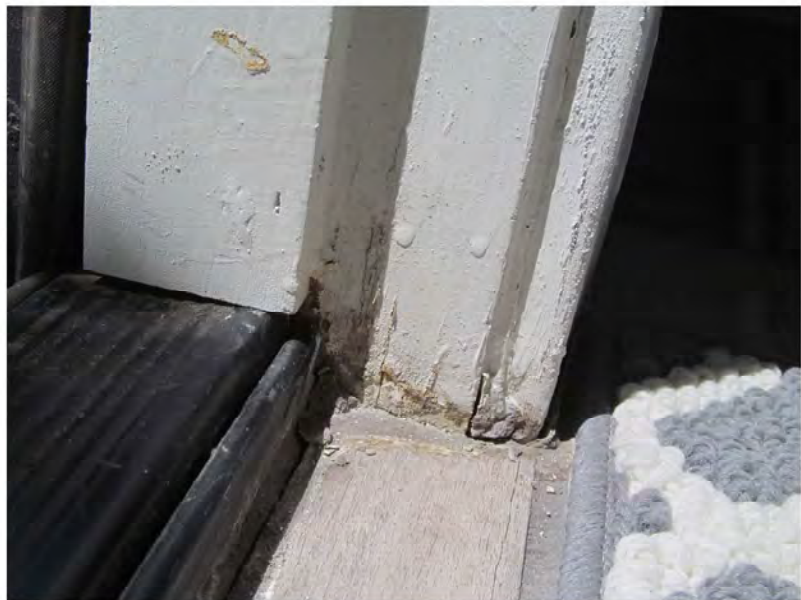
At Unit 3123, the penthouse door trim is damaged and there is water intrusion. The interior door trim extends below the floor finish and is swollen, and paint is peeled.

August 23, 2021, Disc OBS8, Photograph 188, JJF, Unit 3123, roof penthouse door, trim damage adjacent to door jamb.

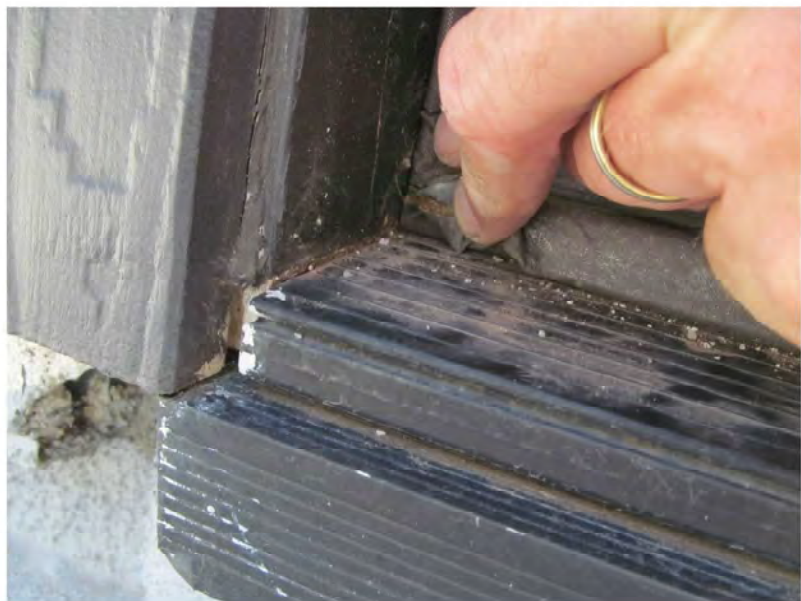
August 23, 2021, Disc OBS8, Photograph 187, JJF, Unit 3123, roof penthouse door, unsealed joint at door threshold to jamb.

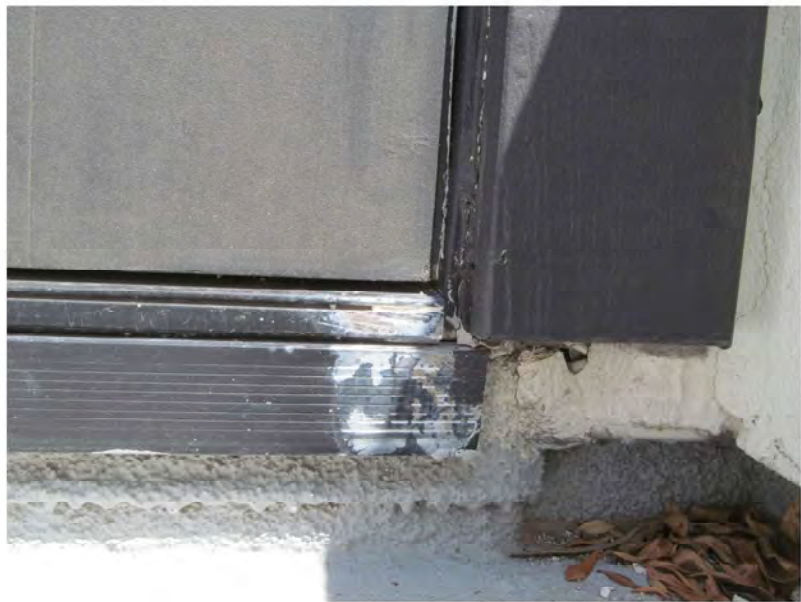
August 23, 2021, Disc OBS8, Photograph 180, JJF, Unit 3123, roof penthouse door, openings at door jamb.
