1 **BURG SIMPSON ELDREDGE**
2 **HERSH & JARDINE P.C.**

3 8310 South Valley Highway, Suite 270
4 Englewood, CO 80112
5 Phone: (303) 792-5595
6 Fax: (303) 708-0527
7 Craig S. Nuss – 033839
8 Penny J. Manship – 034985
9 pmanship@burgsimpson.com

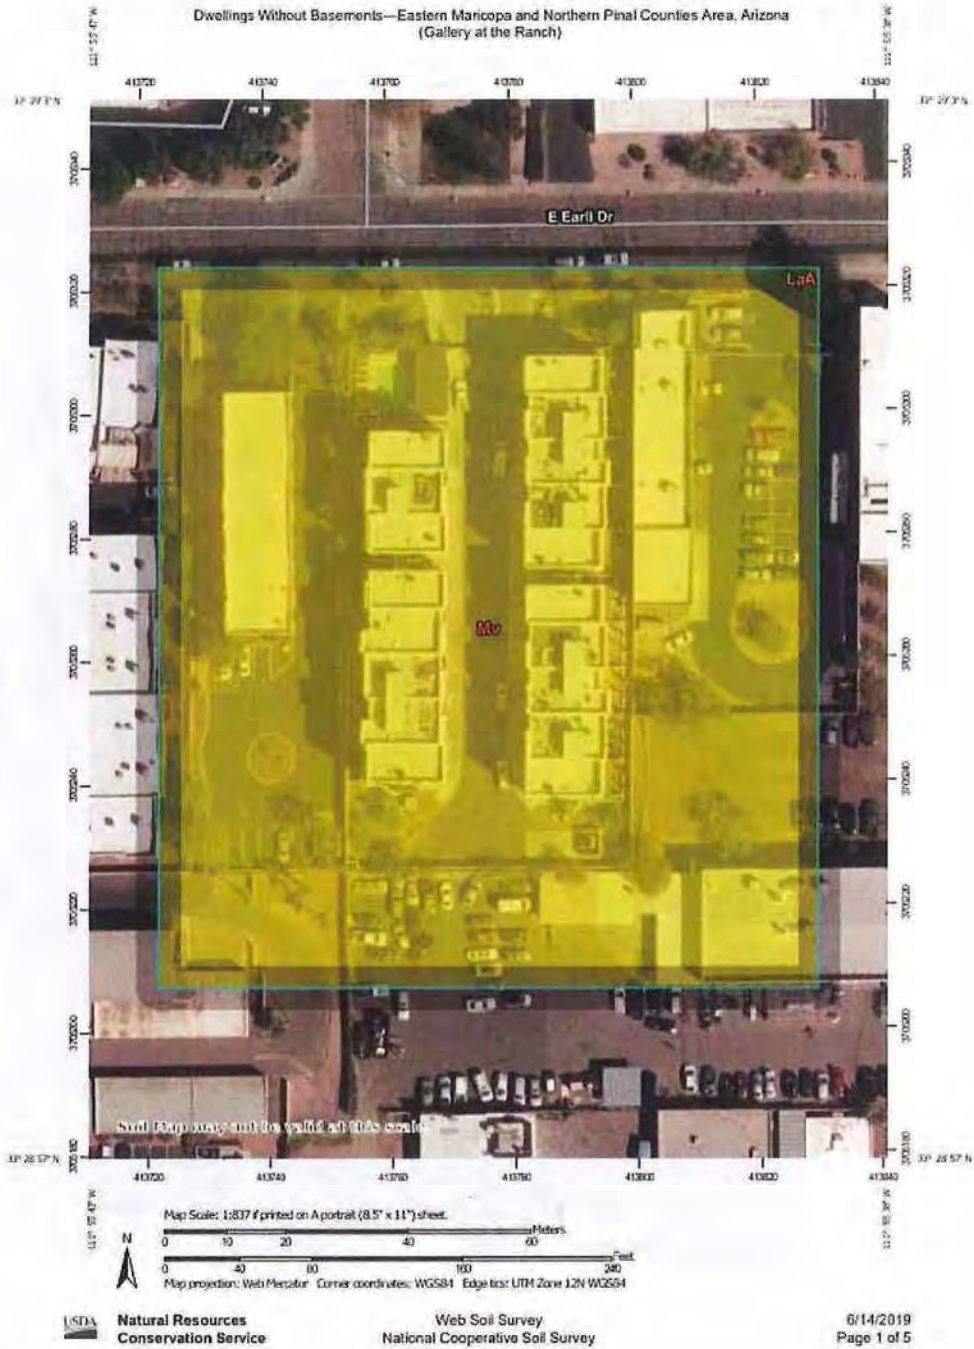
For roadway and streets, the site is considered limited due to the low strength of the on-site soils (rated at 1.00) and, to a lesser degree, the shrink swell associated with the loam.

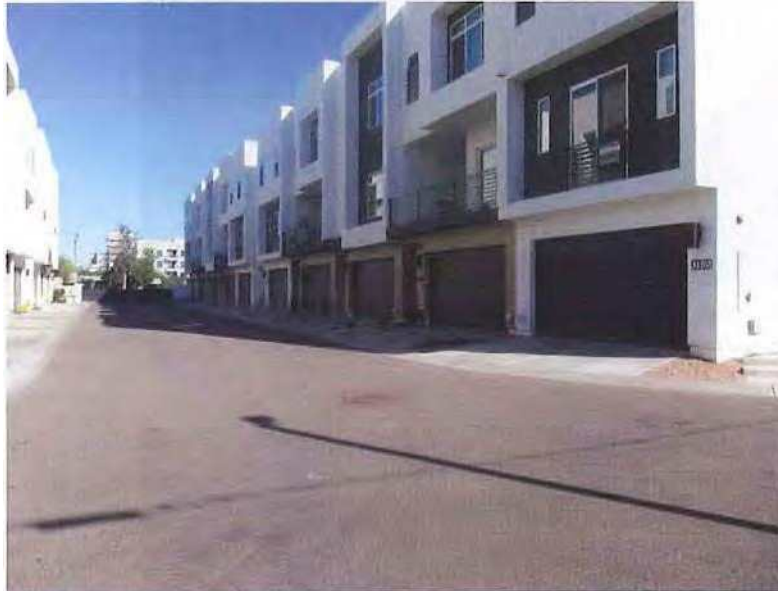
December 19, 2018, Photo 14, OBS1, JBF, overview of the elevation showing limited panel size available for LFRS.

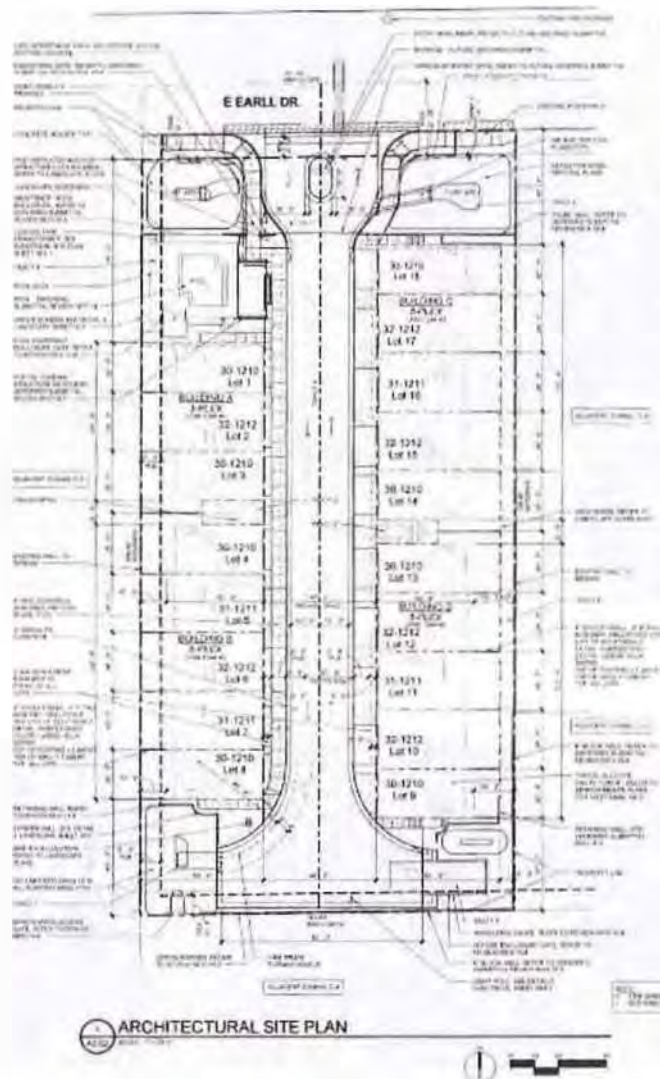
The road slopes from a high point in the center roadway to the east and west. The overall site generally slopes from the north toward the south.

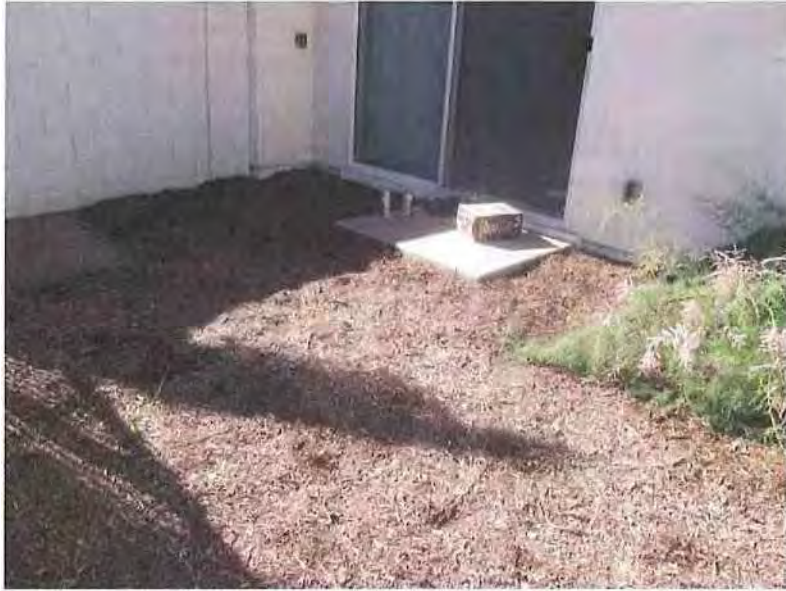
December 19, 2018, Disc OBS1, Photograph 80, JBF, east elevation of Building D - Unit 3111, poor slope of grade away from foundation.

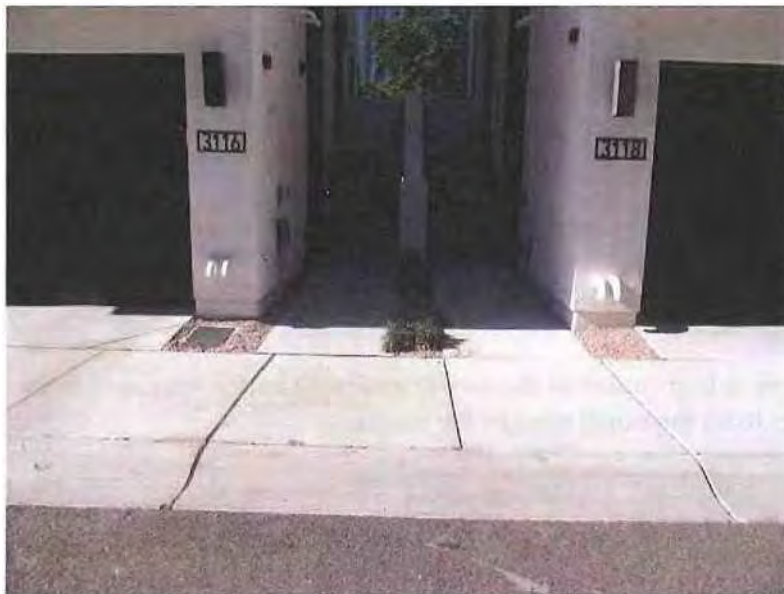
December 19, 2018, Disc OBS1, Photograph 156, JBF, west elevation between Buildings C and D, poor slope of grade between buildings.

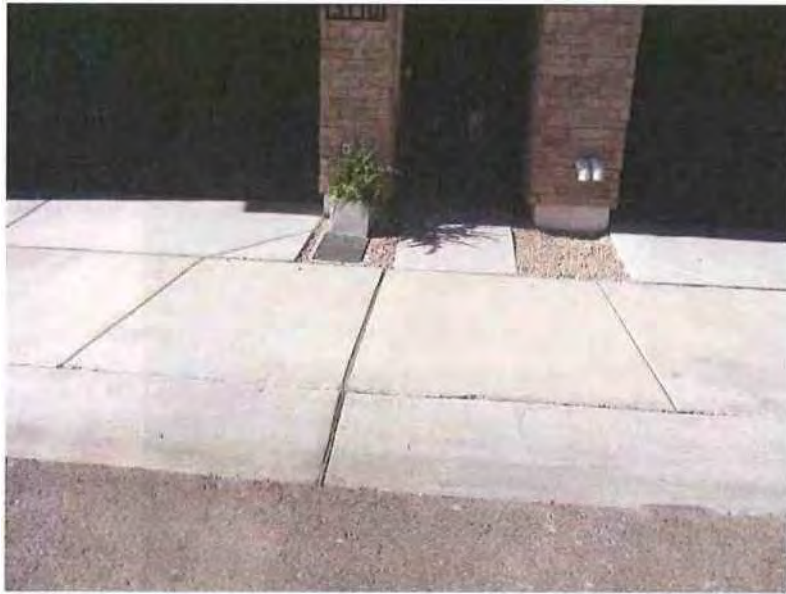
December 19, 2018, Disc OBS1, Photograph 154, JBF, east elevation of Building B, drainage adjacent to foundation bound by concrete flatwork.

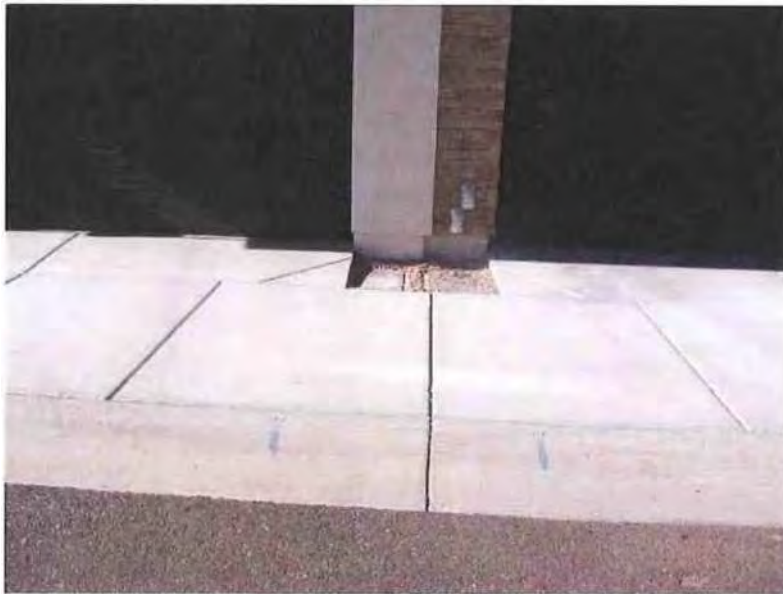
December 19, 2018, Disc OBS1, Photograph 157, JBF, east elevation of Building A, condensate from high efficiency units drain water adjacent to foundation bound by concrete flatwork into the electrical vault.

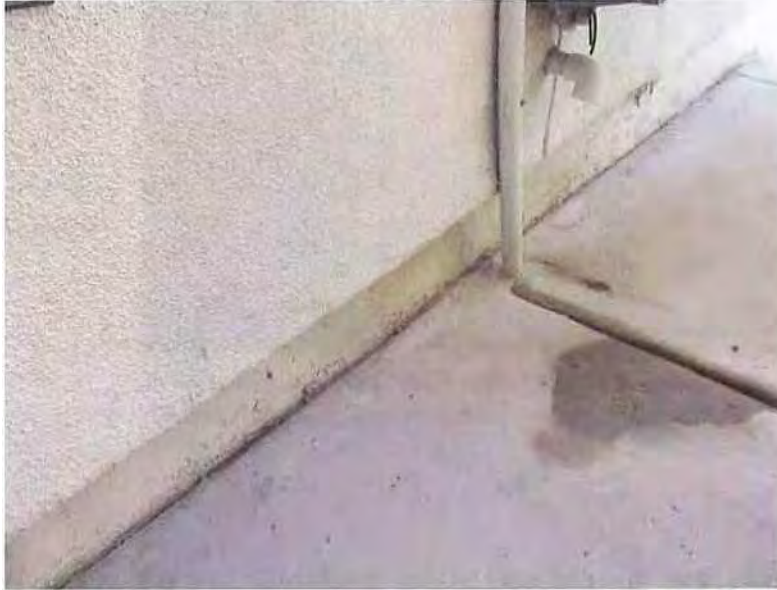
December 19, 2018, Disc OBS1, Photograph 136, JBF, south elevation of Building A - Unit 3118, no isolation joint between concrete flatwork and structural foundation.

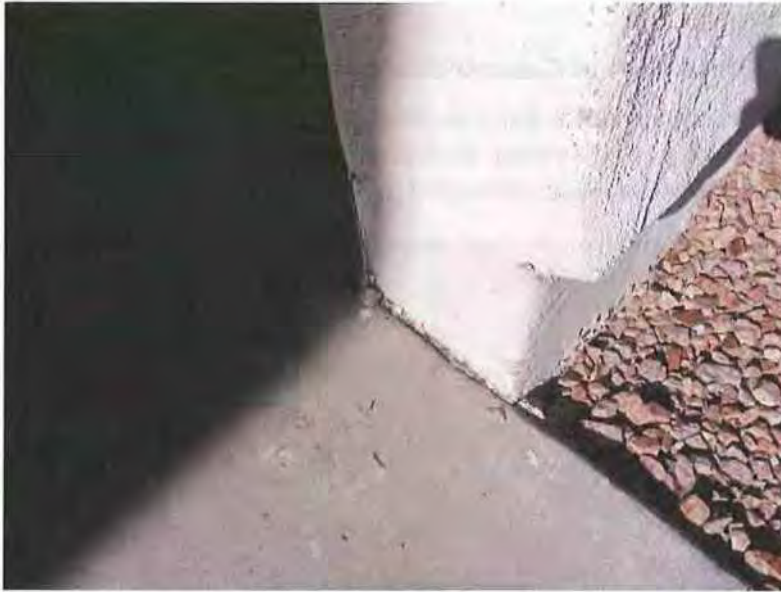
December 19, 2018, Disc OBS1, Photograph 137, JBF, east elevation of Building B - Unit 3116, no isolation joint between concrete flatwork and structural foundation.

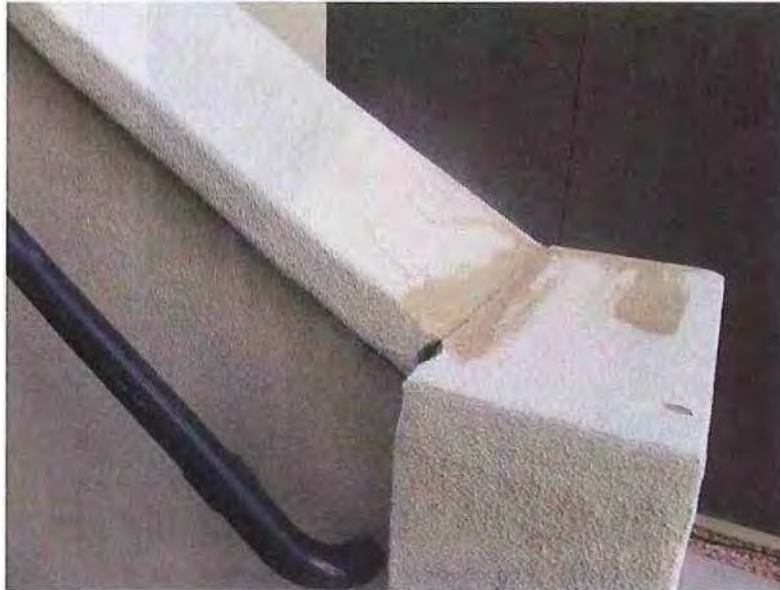
December 19, 2018, Disc OBS1, Photograph 45, JBF, east stairs between Buildings C and D, cracking and separation of stair wall indicative of differential movement.

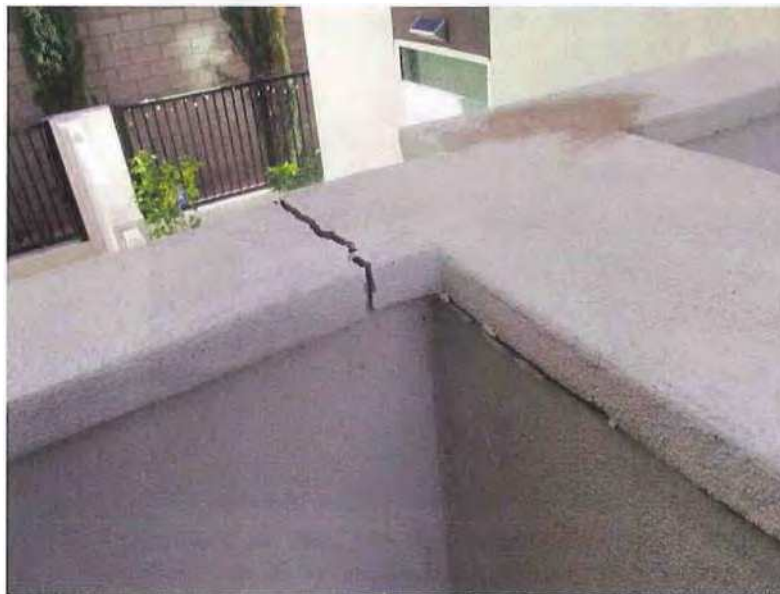
December 19, 2018, Disc OBS1, Photograph 47, JBF, east stairs between Buildings C and D, cracking and separation of stair wall indicative of differential movement.

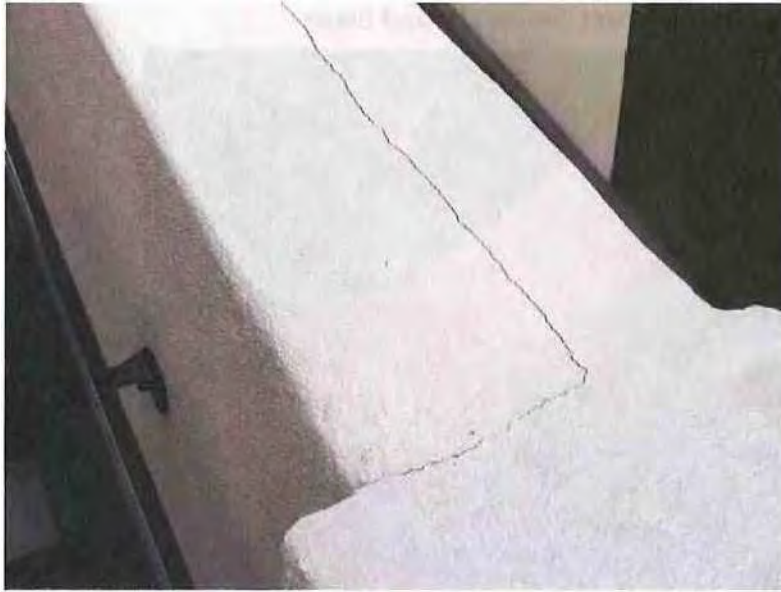
December 19, 2018, Disc OBS1, Photograph 132, JBF, west stairs between Buildings A and B, cracking and separation of stair wall.

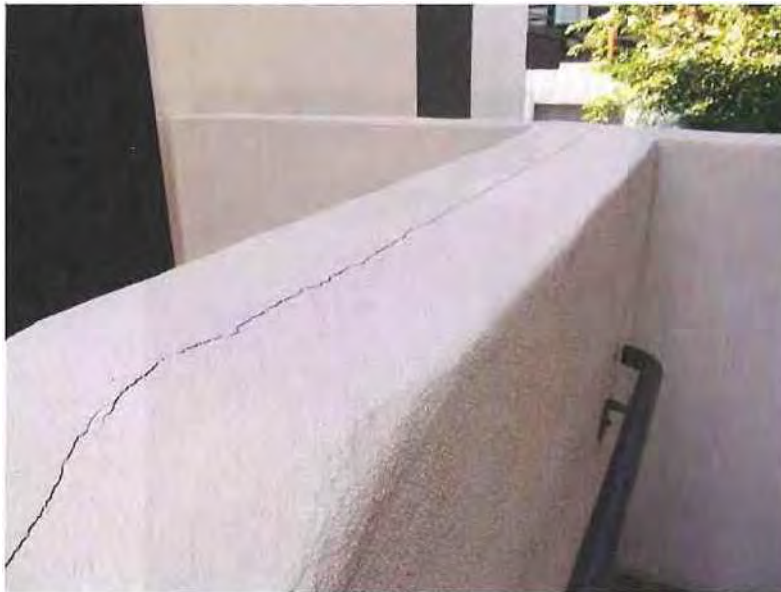
December 19, 2018, Disc OBS1, Photograph 134, JBF, west stairs between Buildings A and B, cracking and separation of stair wall indicative of differential movement.

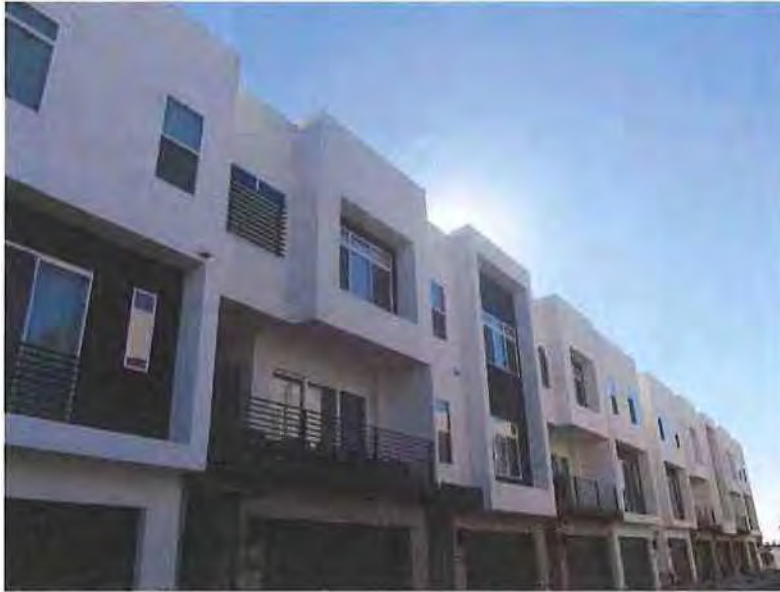
December 19, 2018, Disc OBS1, Photograph 5, JBF, west elevation of Buildings C and D, no control/movement joints provided.

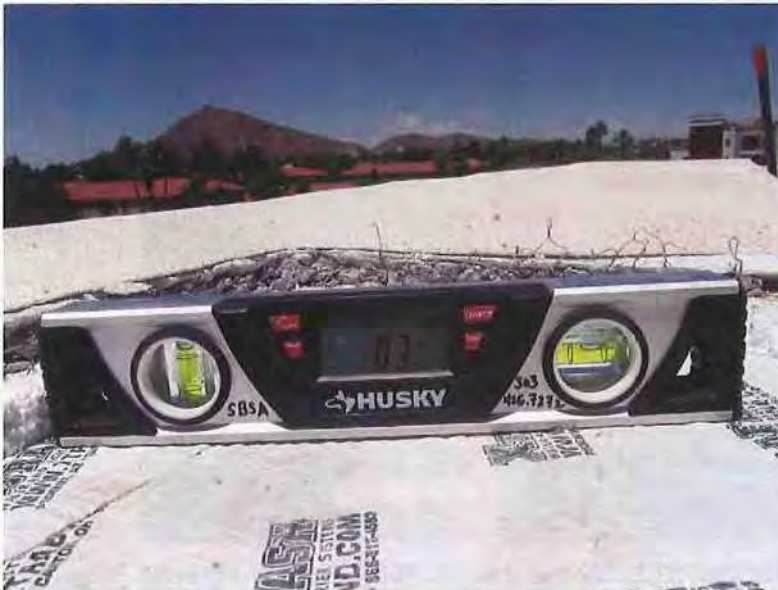
May 13, 2019, Disc IT1, Photograph 98, JBF, Building C - Unit 3125, stucco does not slope at parapet cap.

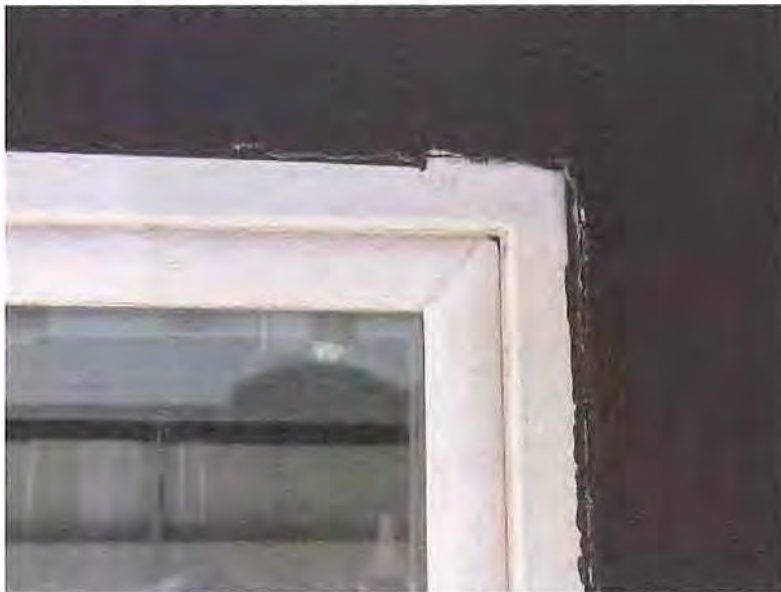
May 13, 2019, Disc IT2, Photograph 33, ELF, west elevation of Building D – Unit 3115, no expansion joints provided between stucco and window. Cracking is present at this interface.

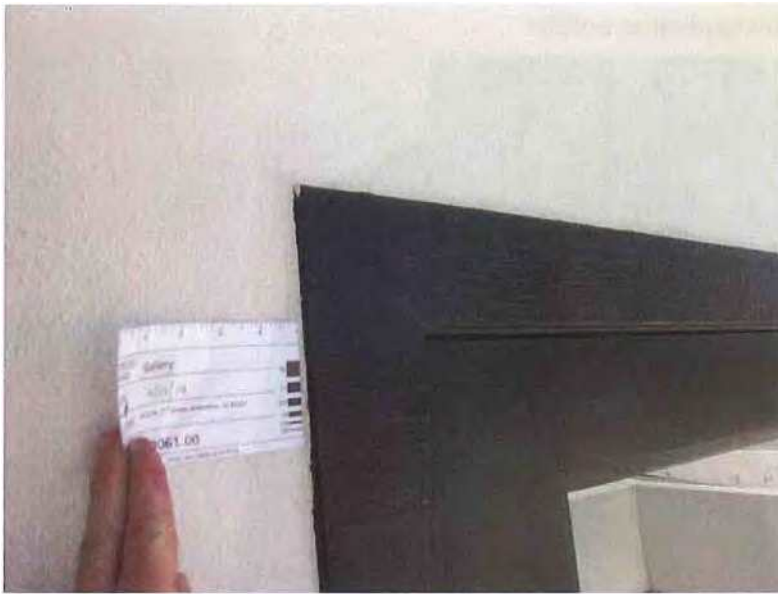
May 13, 2019, Disc IT2, Photograph 50, ELF, Building A - Unit 3122, no expansion joints provided between stucco and wood trim.

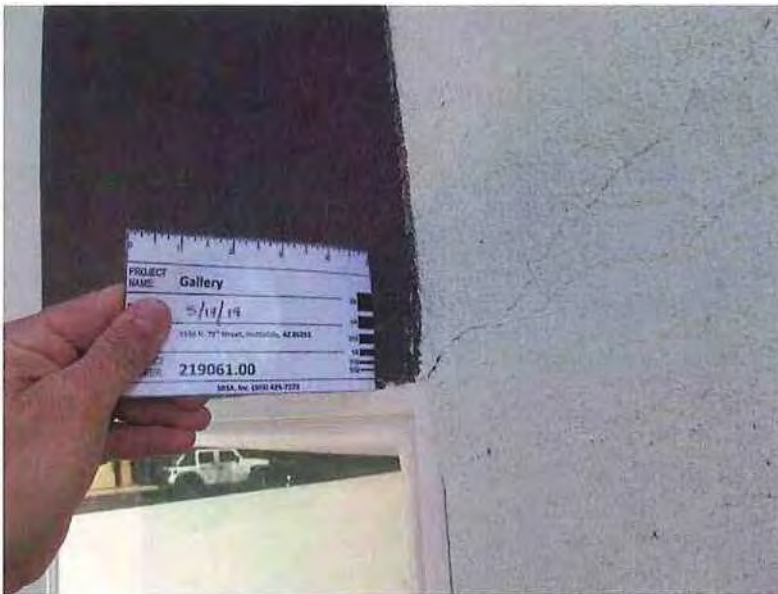
May 14, 2019, Disc IT3, Photograph 12, JBF, south elevation of Building B - Unit 3104, no expansion joints provided between stucco and window. A diagonal stucco crack is present at this location.

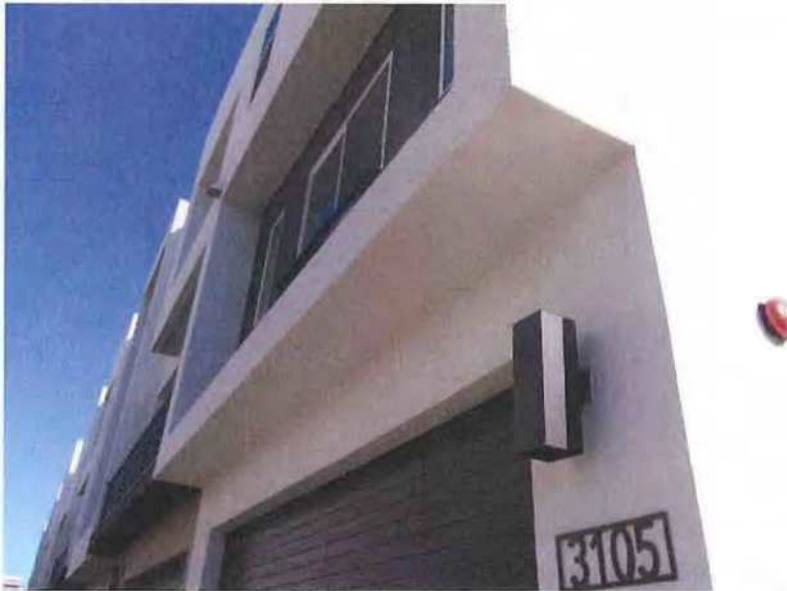
December 19, 2018, Disc OBS1, Photograph 18, JBF, west elevation of Building D - Unit 3105, no weep mechanism at base of stucco at soffit.

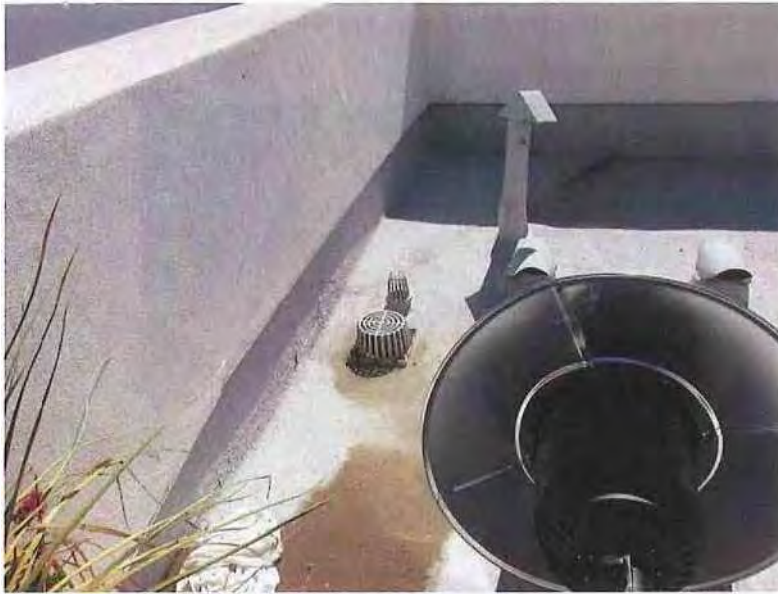
May 14, 2019, Disc IT4, Photograph 58, ELF, Building D - Unit 3113, insufficient slope of roof at drain resulting in ponding water.

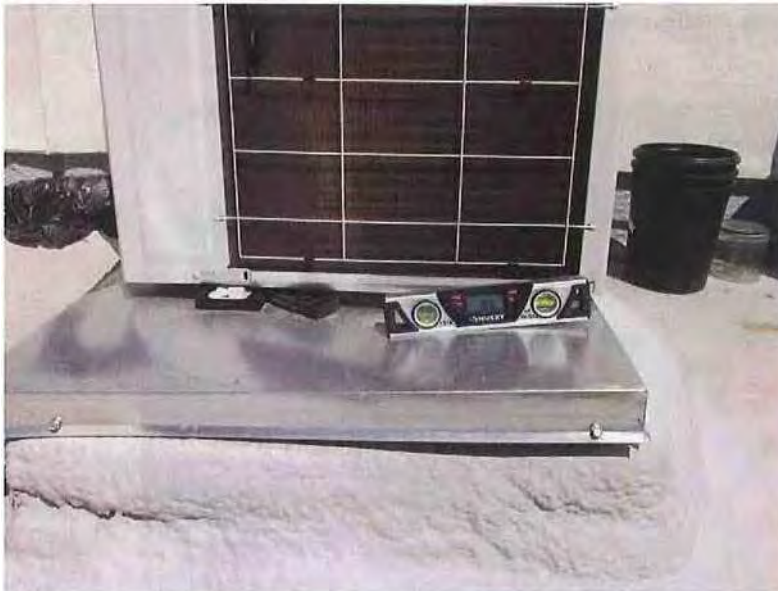
May 13, 2019, Disc IT2, Photograph 146, ELF, Building B - Unit 3110, roof built-up and flashing provided to accommodate additional air conditioner after original construction. Surface is uneven and inadequate for support of air conditioner unit.

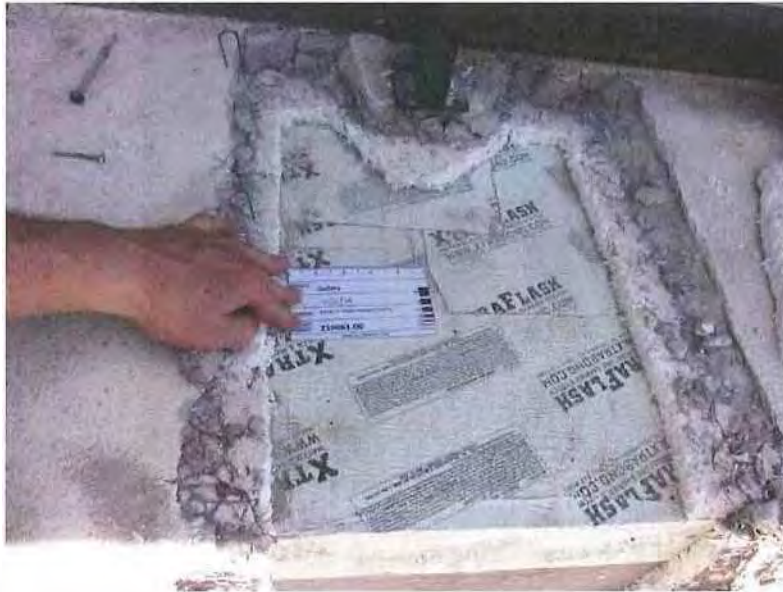
May 13, 2019, Disc II2, Photograph 21, ELF, west elevation of Building D - Unit 3115, XtraFlash membrane under stucco. Stain through holes in membrane.

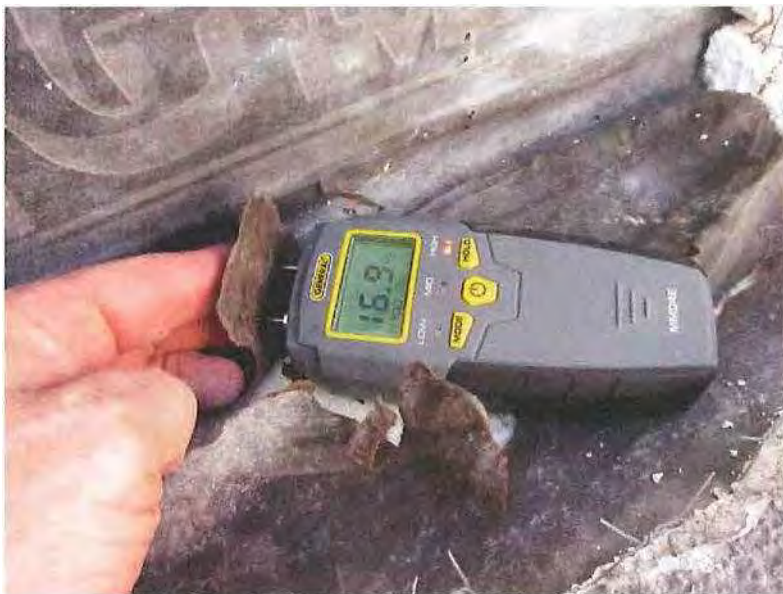
May 14, 2019, Disc II4, Photograph 13, ELF, west elevation of Building C - Unit 3123, high moisture content in building paper below stucco over self-adhered membrane.

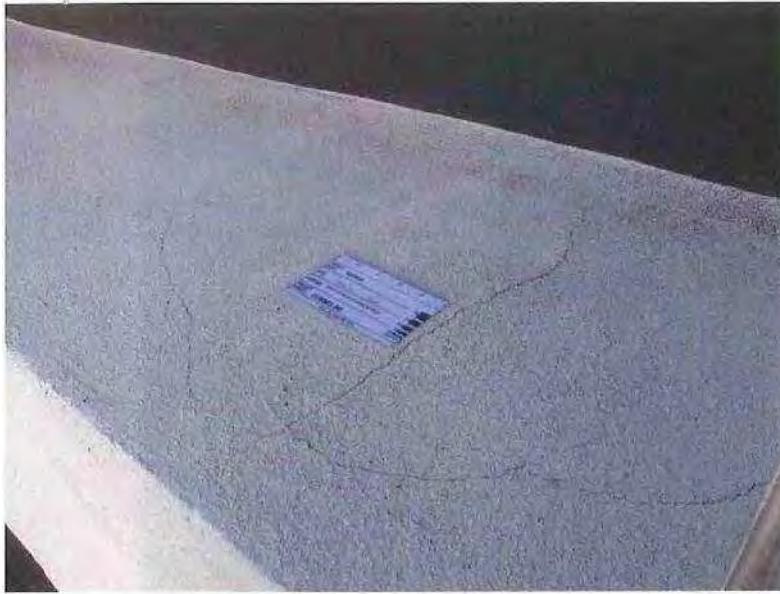
May 14, 2019, Disc IT4, Photograph 26, ELF, west elevation of Building C - Unit 3125, cracking of stucco on window shelf indicative of water entrapment.
