ORAL DEPOSITION OF
EVAN JAMES MARSHALL
August 30, 2022
(REPORTED REMOTELY)

Defense Response Report

August 11, 2021

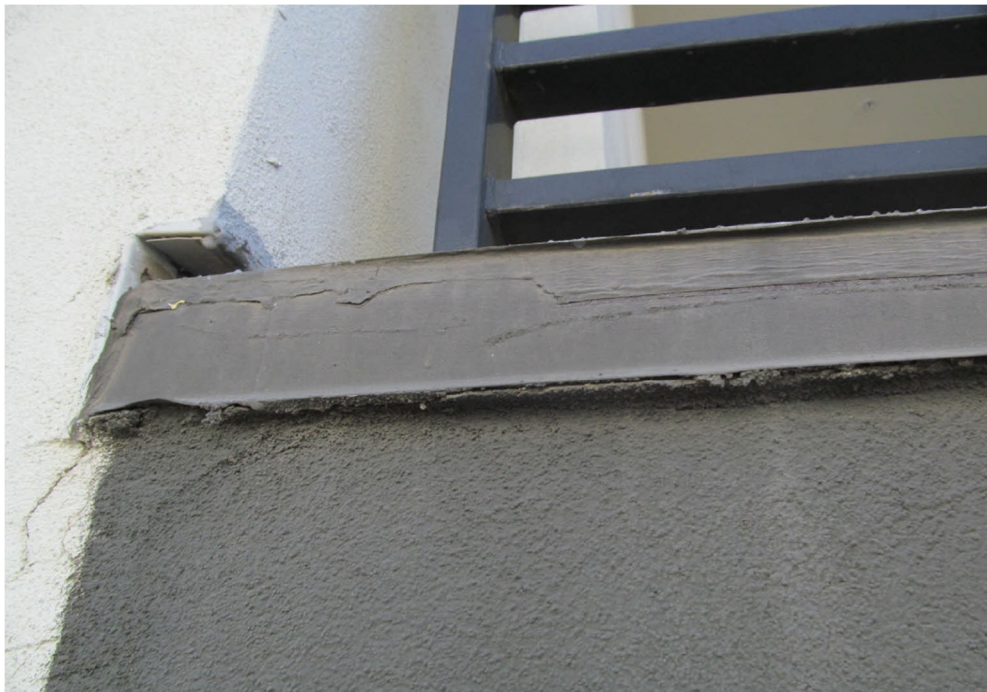
GALLERY-SBSA 001856

- MC did observe an improper junction of the stucco and deck edge metal at some, but not all conditions, but plaintiff has not provided evidence of leaks or damages attributable to the deck edge metal installation.

Deck metal properly installed over stucco

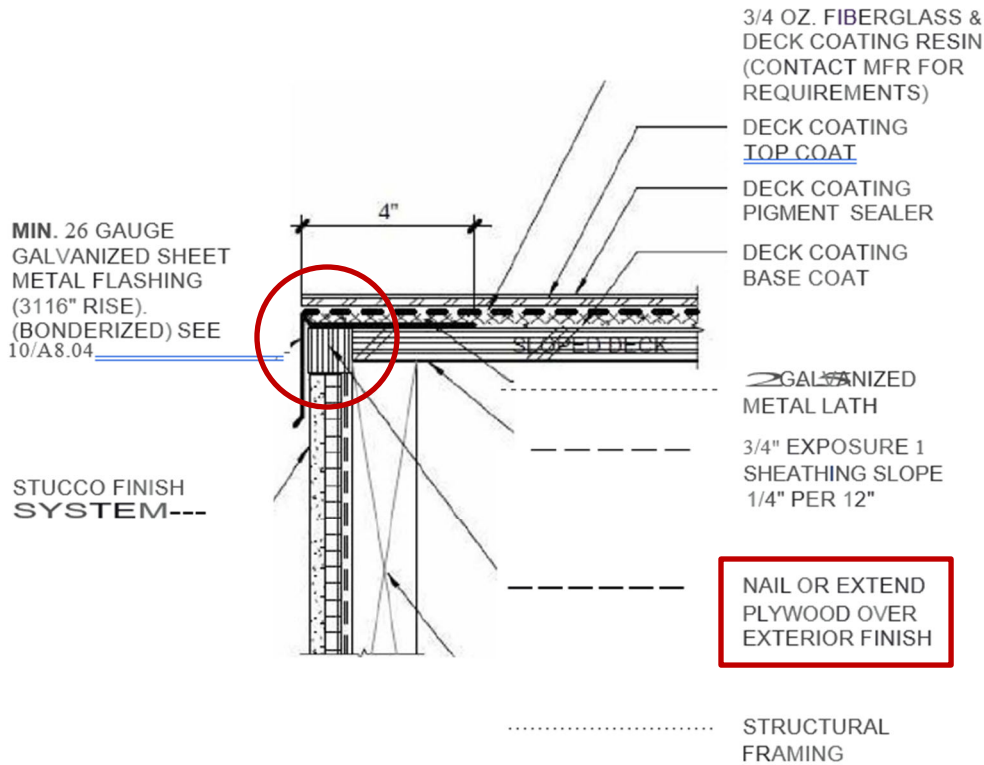
Detail 5/AS.04

- In detail 5/AS.04 Deck Perimeter Flashing (above), Note the wood block at the end of the deck 9 (circled). This block serves three purposes:
 1. A stop for the stucco

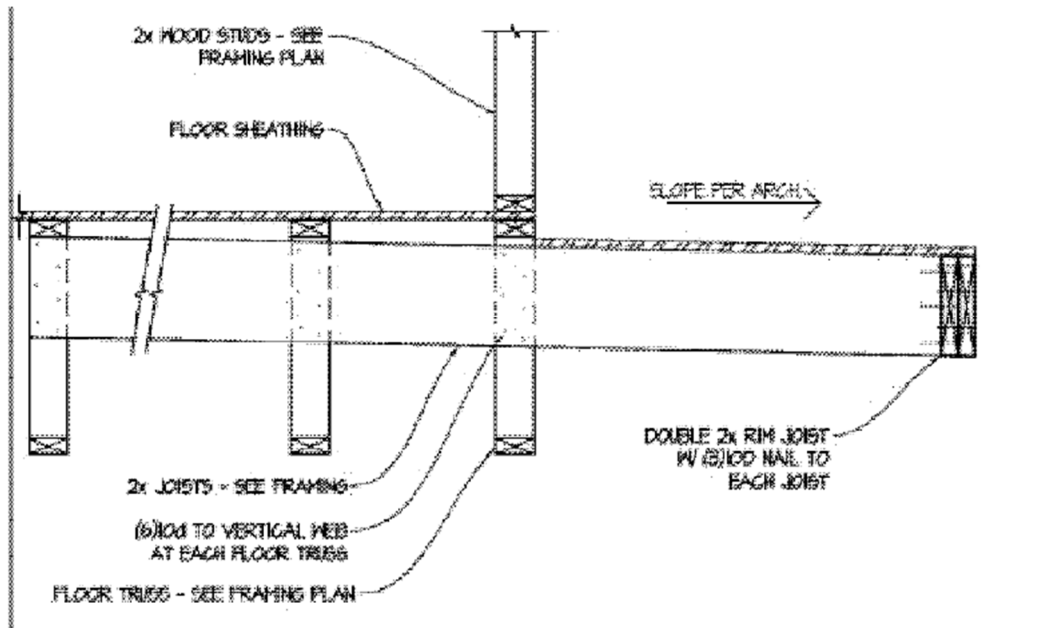
- This allegation is not relevant to client's scope of work.
- Per the plans, slope was to be provided in the framing, not the deck membrane.
- Refer to Issue 2.0 b, Detail 5/AS.04, the slope is designated in the framing.
- Additionally, slope is designated in the framing in Detail 907 (below), from the Plaintiff report.

- No repair offered.
