June 23, 2021

Craig S. Nuss
Penny J. Manship
Burg Simpson Eldredge Hersh & Jardine PC
8310 South Valley Highway, #270
Englewood, Colorado 80112

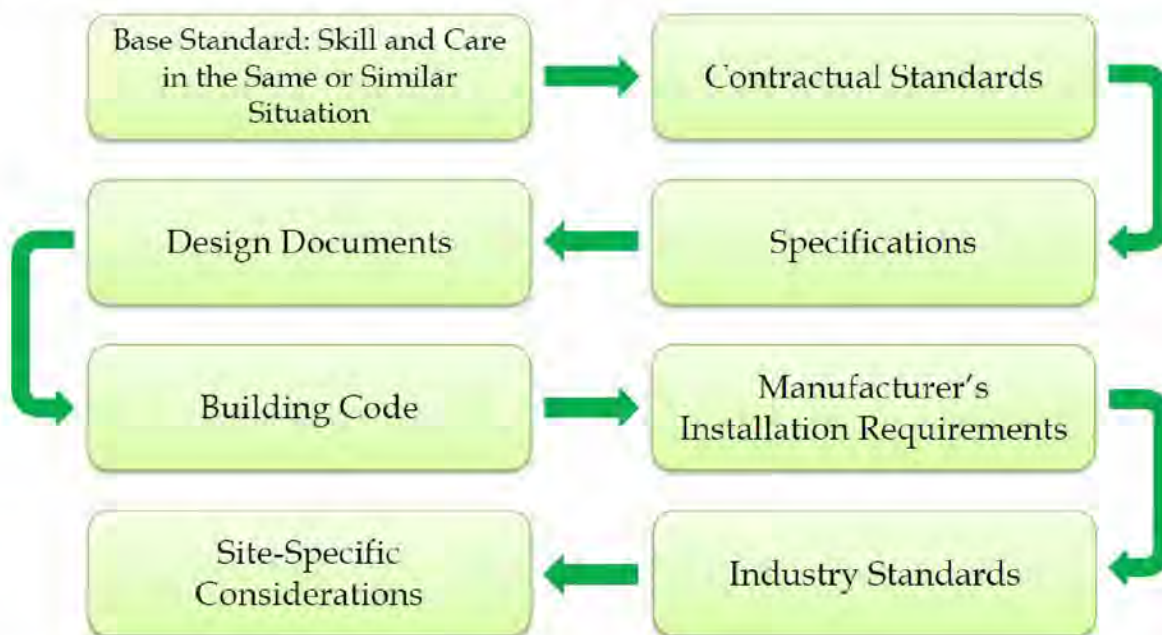
In addition, the following site-specific contract information currently disclosed was considered where possible in the evaluation of the parties' site-specific standards of care:

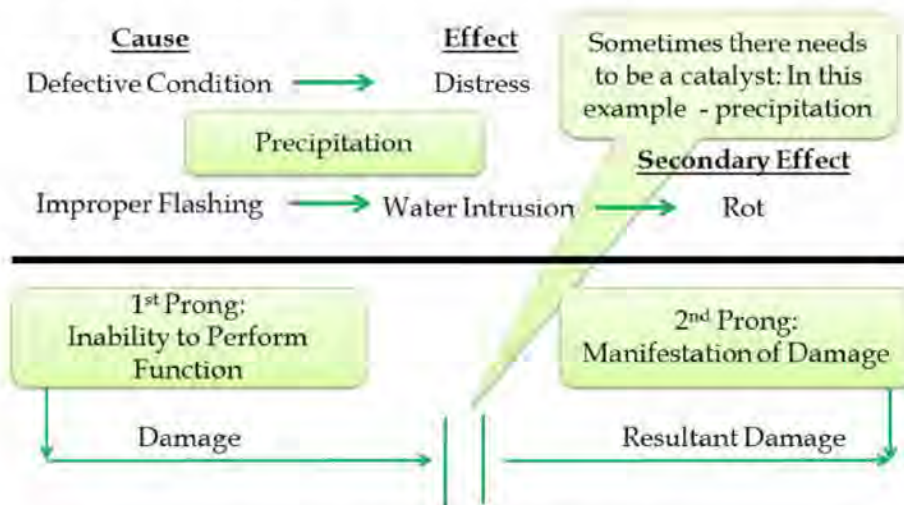
Figure 1- Manifestation Timeline

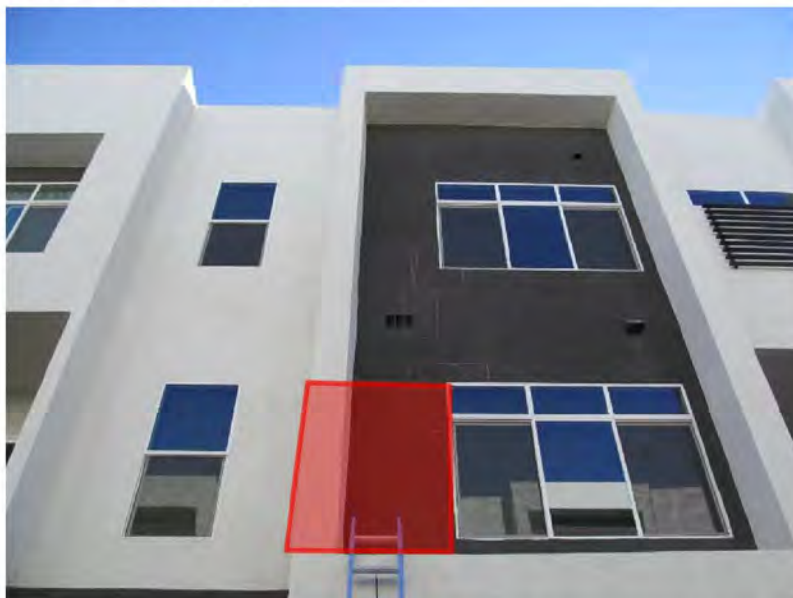
March 10, 2021, Disc IT8, Photograph 41, SSR, Building D - Unit 3111, overall view of building elevation with non-compliant LFRS. Red box outlines the approximate area within which the exterior sheathing was identified to be missing.

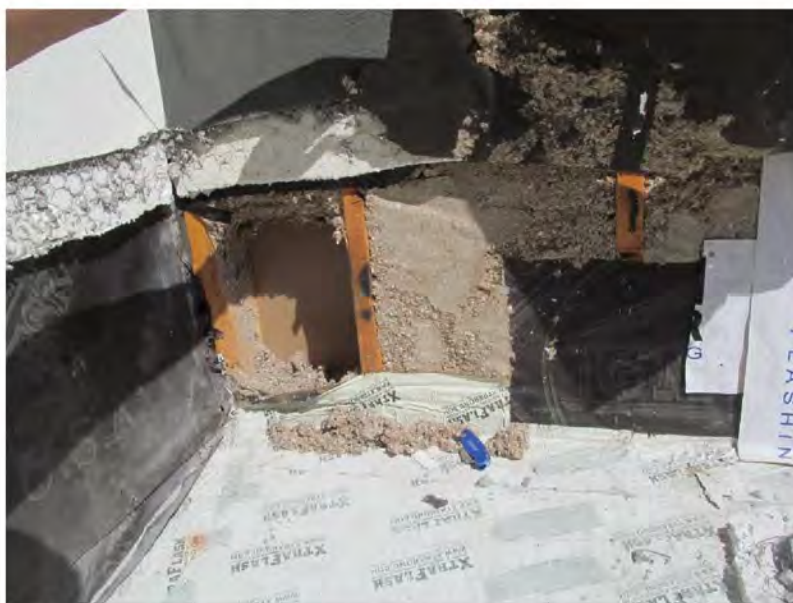
March 10, 2021, Disc IT8, Photograph 237, SSR, Building D - Unit 3111, missing OSB sheathing at existing stud framing.

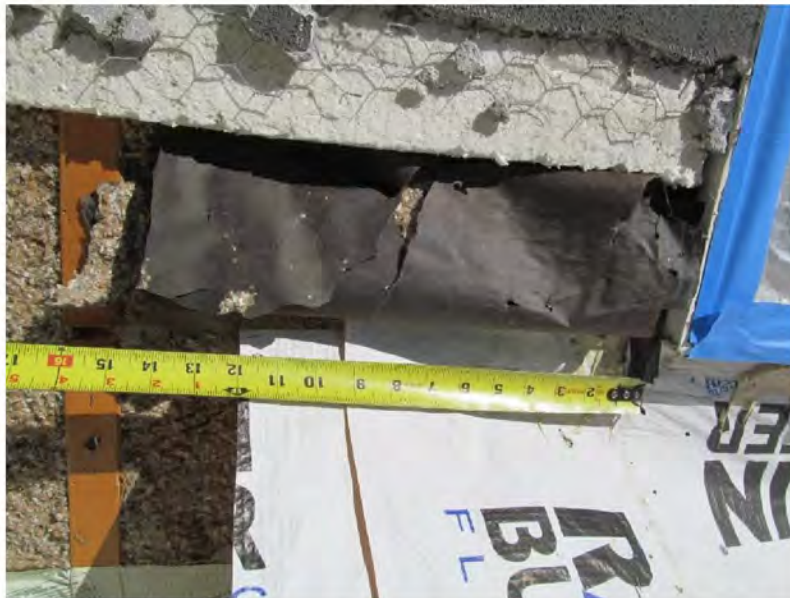
March 10, 2021, Disc IT8, Photograph 248, SSR, Building D - Unit 3111, missing OSB sheathing at existing stud framing.

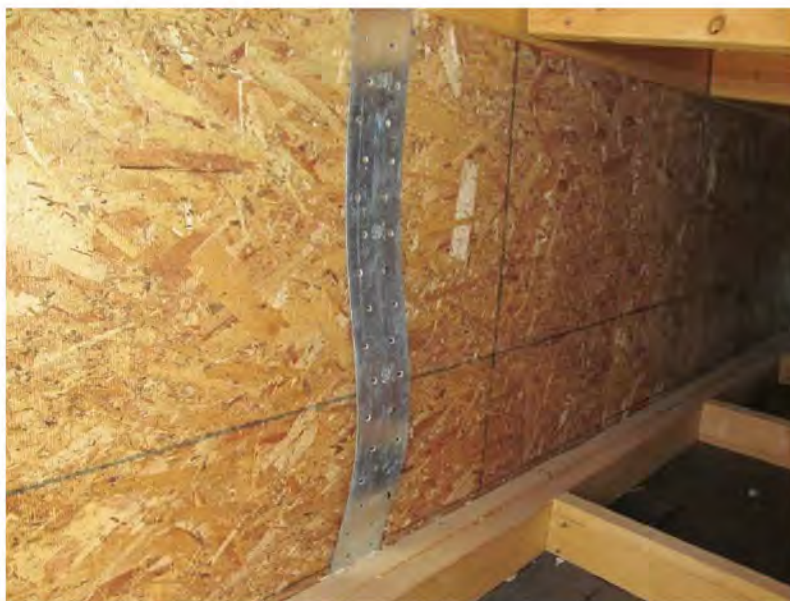
March 10, 2021, Disc IT8, Photograph 278, SSR, Building D - Unit 3111, CS-16 metal strap is disengaged and buckled.

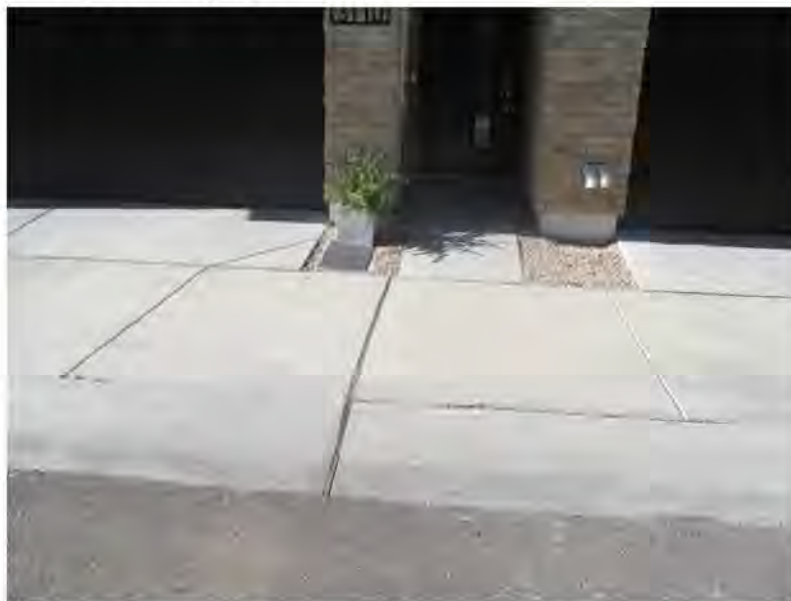
December 19, 2018, Disc. OBS1, Photograph 154, JBF, east elevation of Building B, undrained landscaped islands next to foundation are bounded by concrete flatwork. Roof drains discharge into this area also.

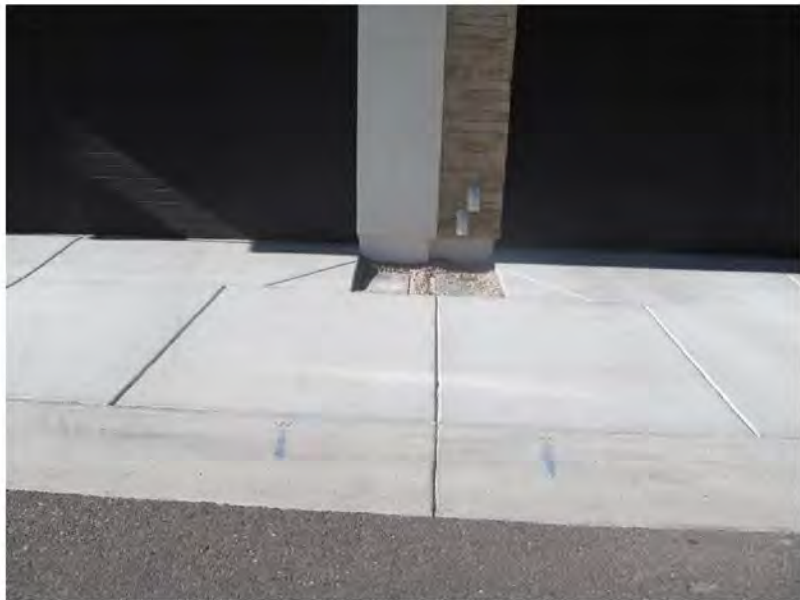
December 19, 2018, Disc OBS1, Photograph 157, JBF, east elevation of Building A, undrained landscaped islands next to foundation are bounded by concrete flatwork. Roof drains discharge into this area also and flow into the electrical vault.

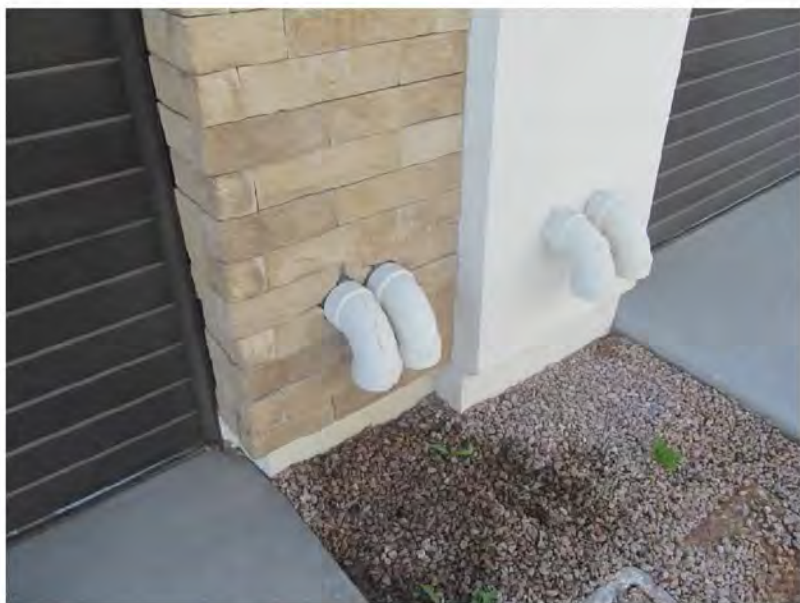
December 19, 2018, Disc OBS1, Photograph 52, JBF, Building C, condensate from high efficiency units drain water adjacent to foundation bound by concrete flatwork into the electrical vault.

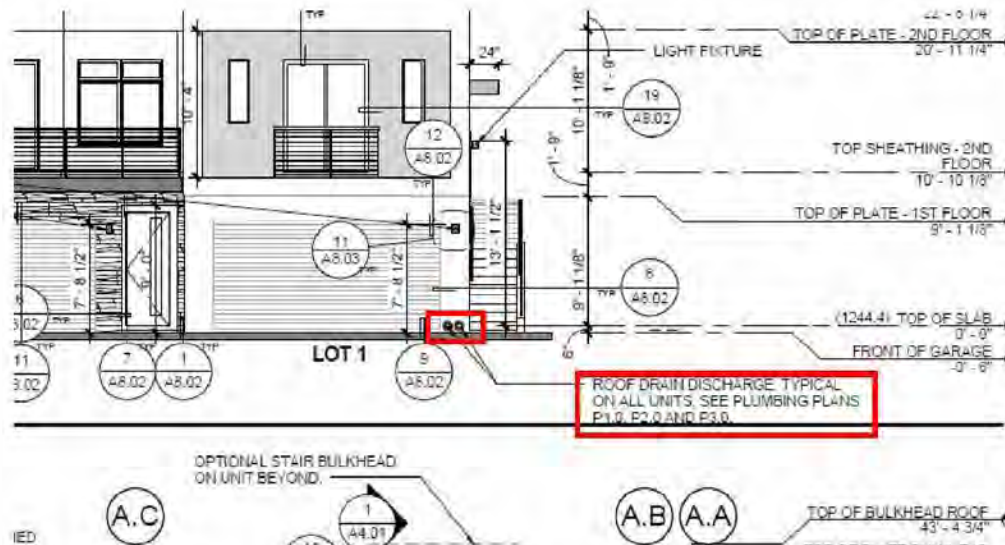
Otak, Inc., "K. Hovnanian Homes, Gallery Townhomes," revised date August 2, 2016, Exterior Elevations Building A, 3-Plex, Gallery Site #1, Sheet A3.11, showing roof drain and overflow discharging into undrained islands.

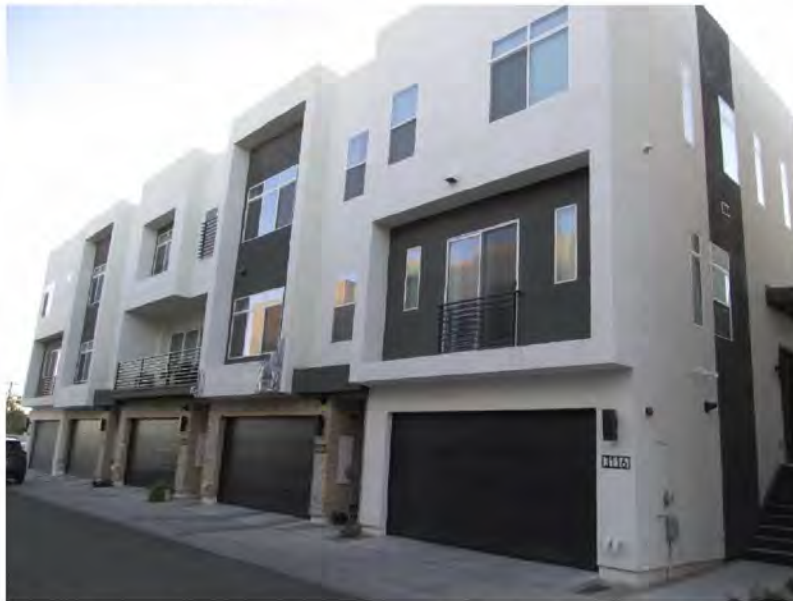
March 10, 2021, Disc OBS5, Photograph 61, SSR, Building B, east side, roof drains discharge into undrained landscaped islands next to foundation at multiple locations.

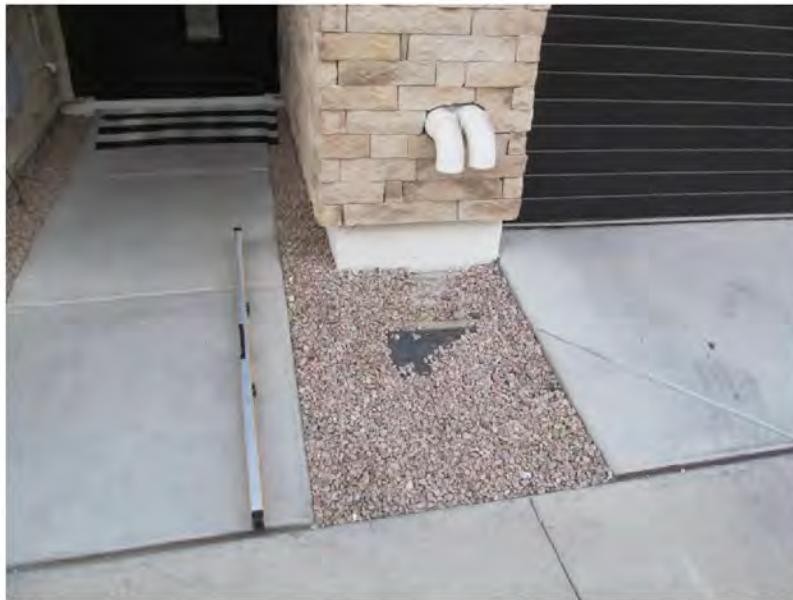
March 10, 2021, Disc OBS5, Photograph 107, SSR, Building B, east side, main and overflow roof drains discharge into undrained landscaped islands next to foundation between entrance to unit and driveway.

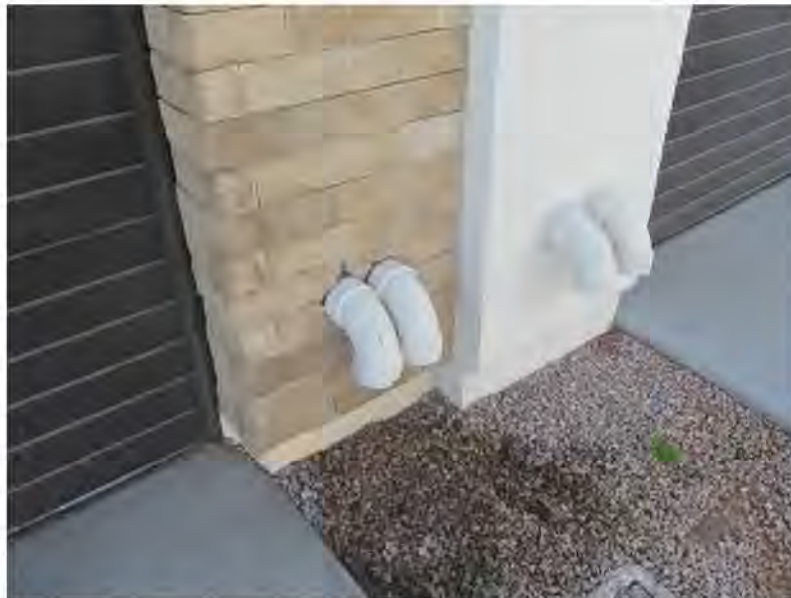
December 19, 2018, Disc OBS1, Photograph 52, JBF, Building C, roof drains from adjacent units discharge into undrained island area.

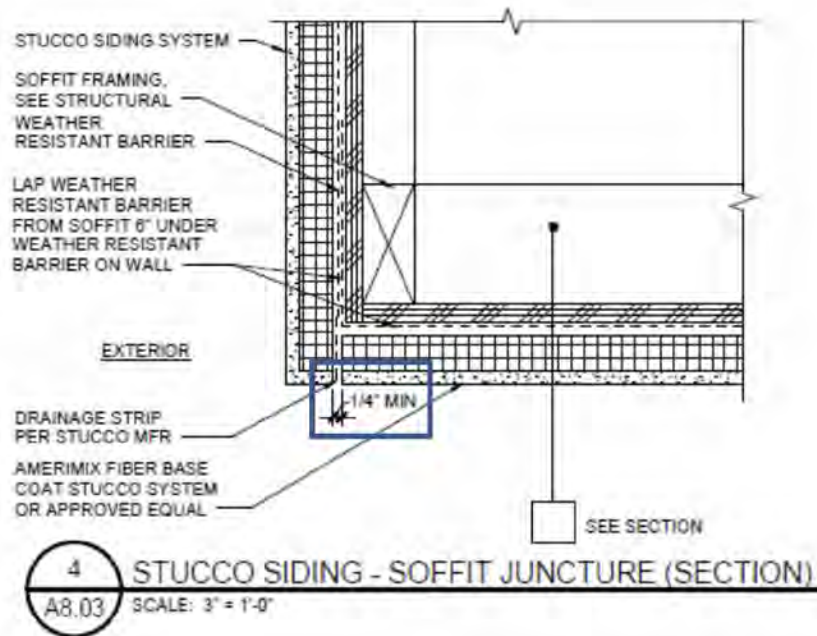
ICC Evaluation Service Report (ESR), Evaluation Report ESR-3529 "Evaluation Subject: Amerimix Fiber Base Coat Stucco," reissued February 2017, Section 4.0 "Installation," subsection 4.2 "Application over Open Framing," states the following:

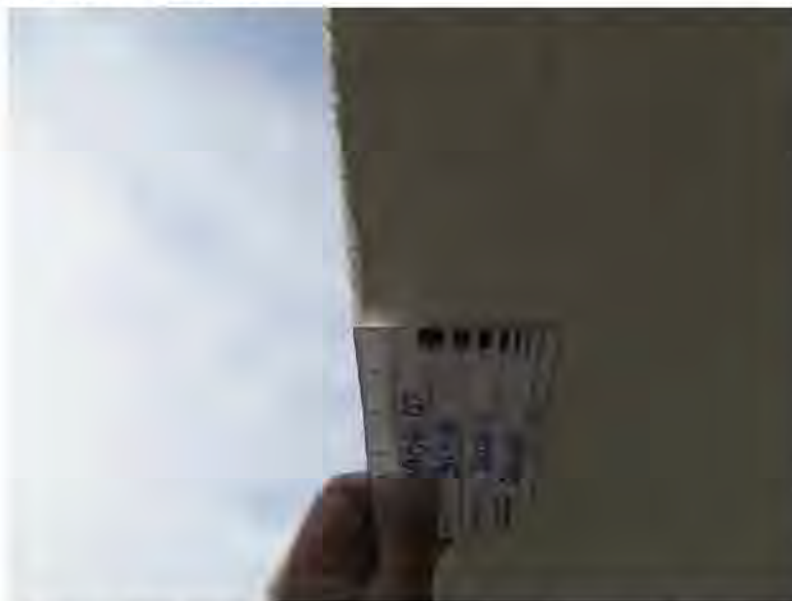
March 9, 2021, Disc IT6, Photograph 32, SSR, Building A, no weep mechanism at soffit and stucco crack along the edge.

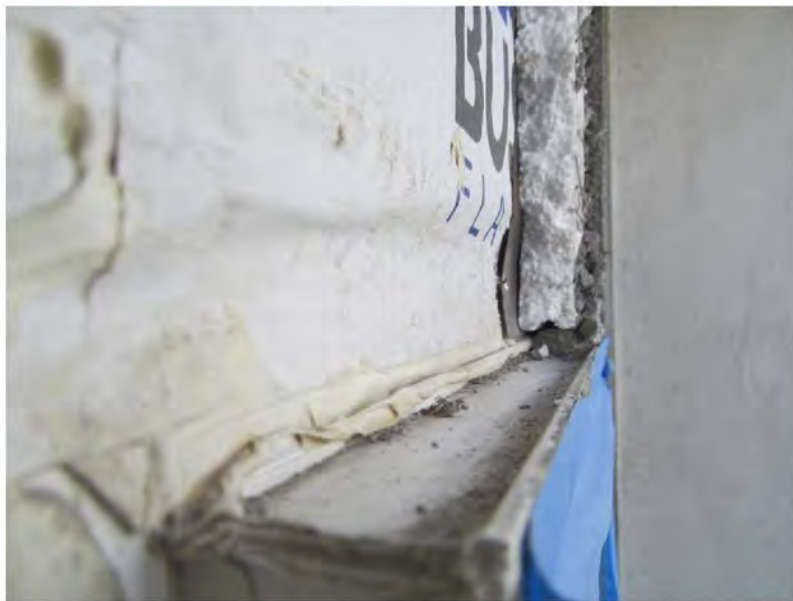
March 9, 2021, Disc IT6, Photograph 280, SSR, Building A, no weep mechanism at stucco termination above window head.

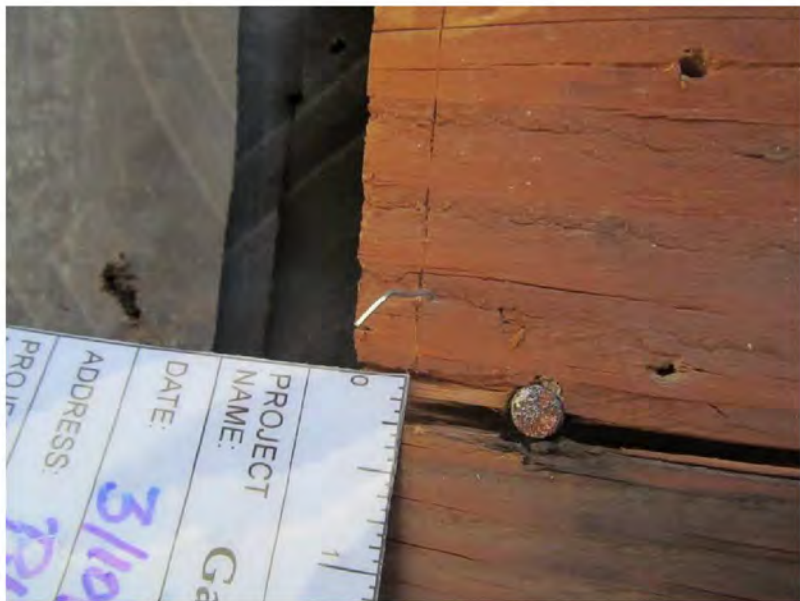
March 10, 2021, Disc IT8, Photograph 96, SSR, Building D, rusted fastener head at framing.

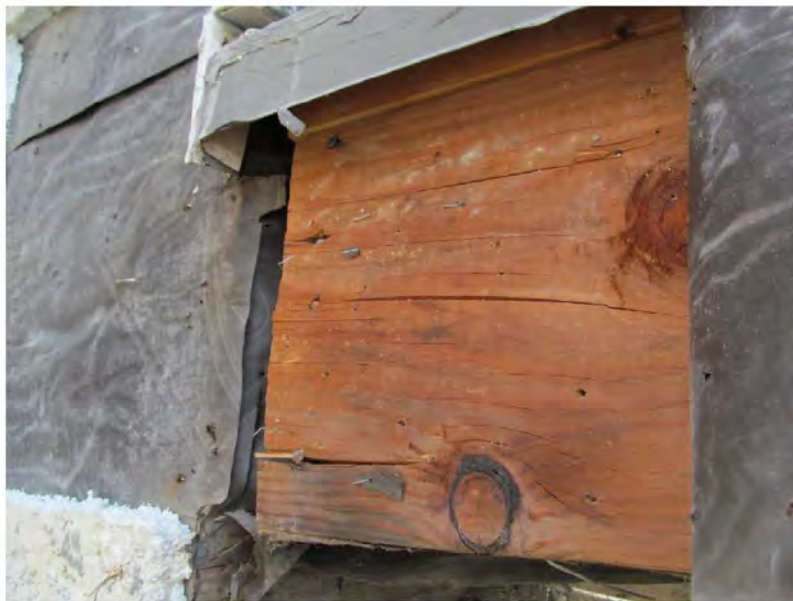
March 10, 2021, Disc IT8, Photograph 114, SSR, Building D, one layer of WRB over framing with visible stains.

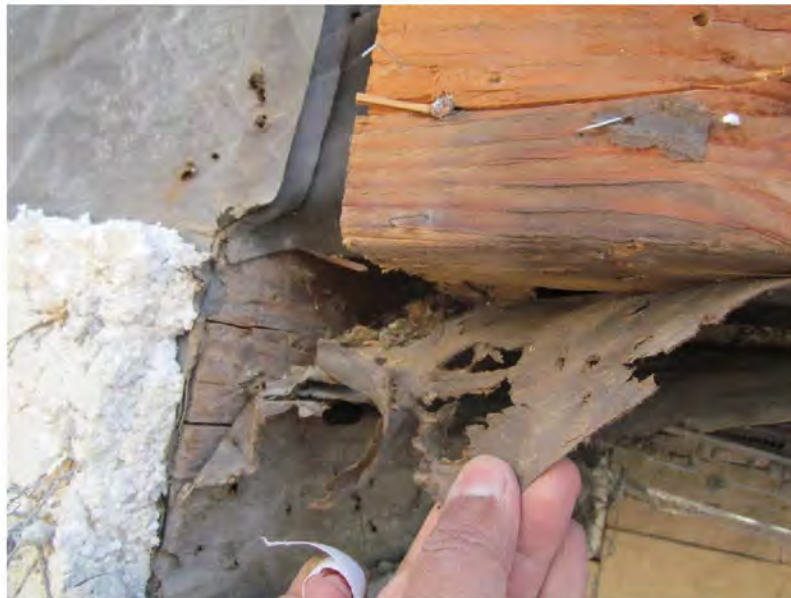
March 10, 2021, Disc IT8, Photograph 120, SSR, Building D, deteriorated WRB over framing with visible stains.

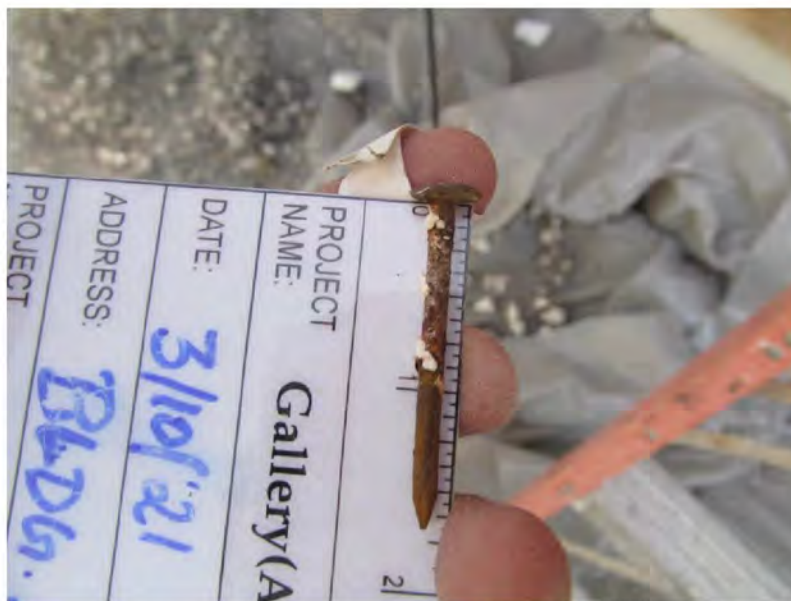
March 10, 2021, Disc IT8, Photograph 172, SSR, Building D, full-depth rusted fasteners.

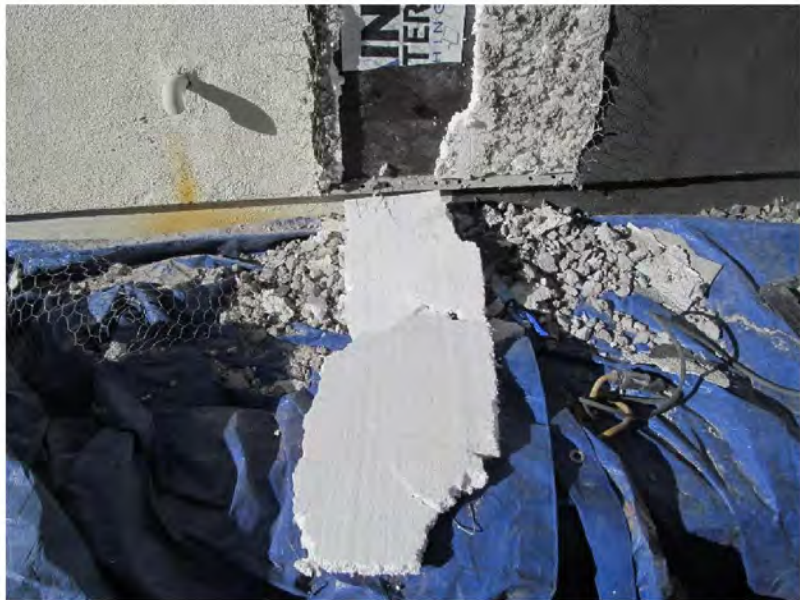
March 10, 2021, Disc IT7, Photograph 279, JJF, Building C, EPS foam board installed over WRB with vertical grooves generally missing at the back face.

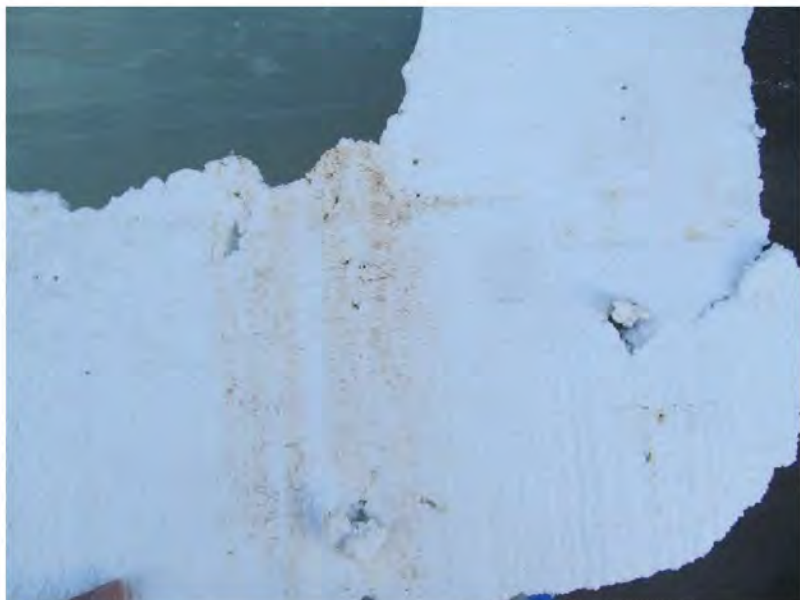
March 10, 2021, Disc IT7, Photograph 210, JJF, Building C, EPS foam board installed tight to WRB and vertical grooves generally missing at the back face.

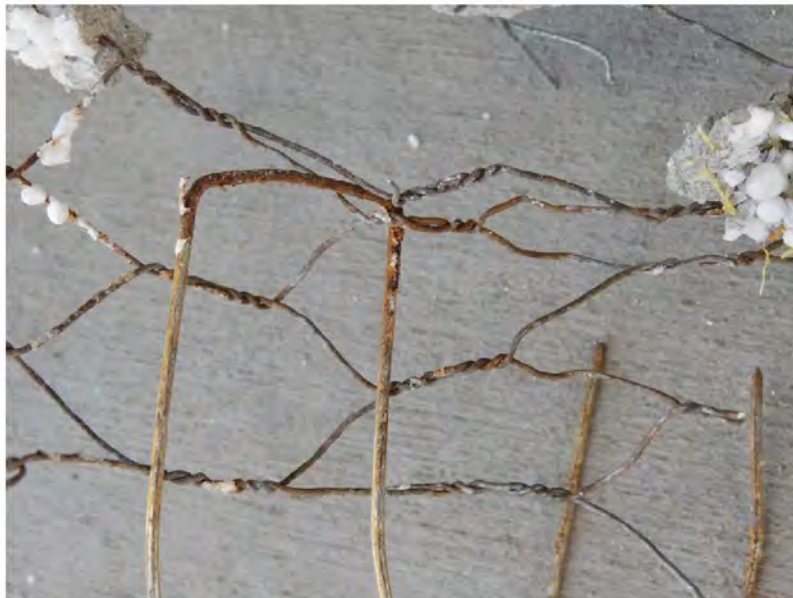
March 10, 2021, Disc IT9, Photograph 87, PER, Building C, rusted staples and lath

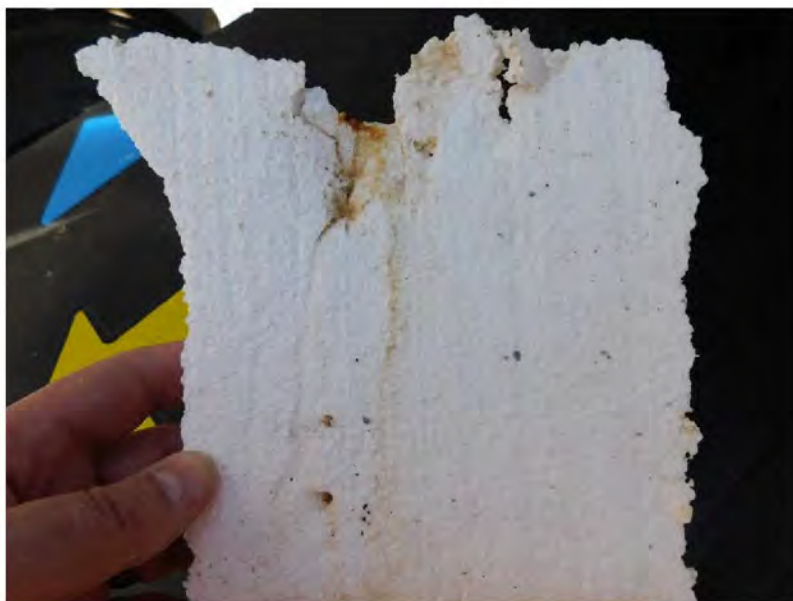
March 10, 2021, Disc IT9, Photograph 95, PER, Building C, EPS foam board installed tight to WRB and vertical grooves generally missing at the back face. Note corrosion from the nails on the EPS foam board.
