Petitioner: Tatiana Hernandez
Respondent: Barcelona Manor Association, Inc.
Case No: 26F-H012-REL

Summary of Dispute:

This matter concerns responsibility for a concealed plumbing item that failed and caused water damage to the unit below mine. The association has determined I'm responsible for the repair of the plumbing and the unit's damages; however, the facts and governing documents show that the responsibility does not lie with me.

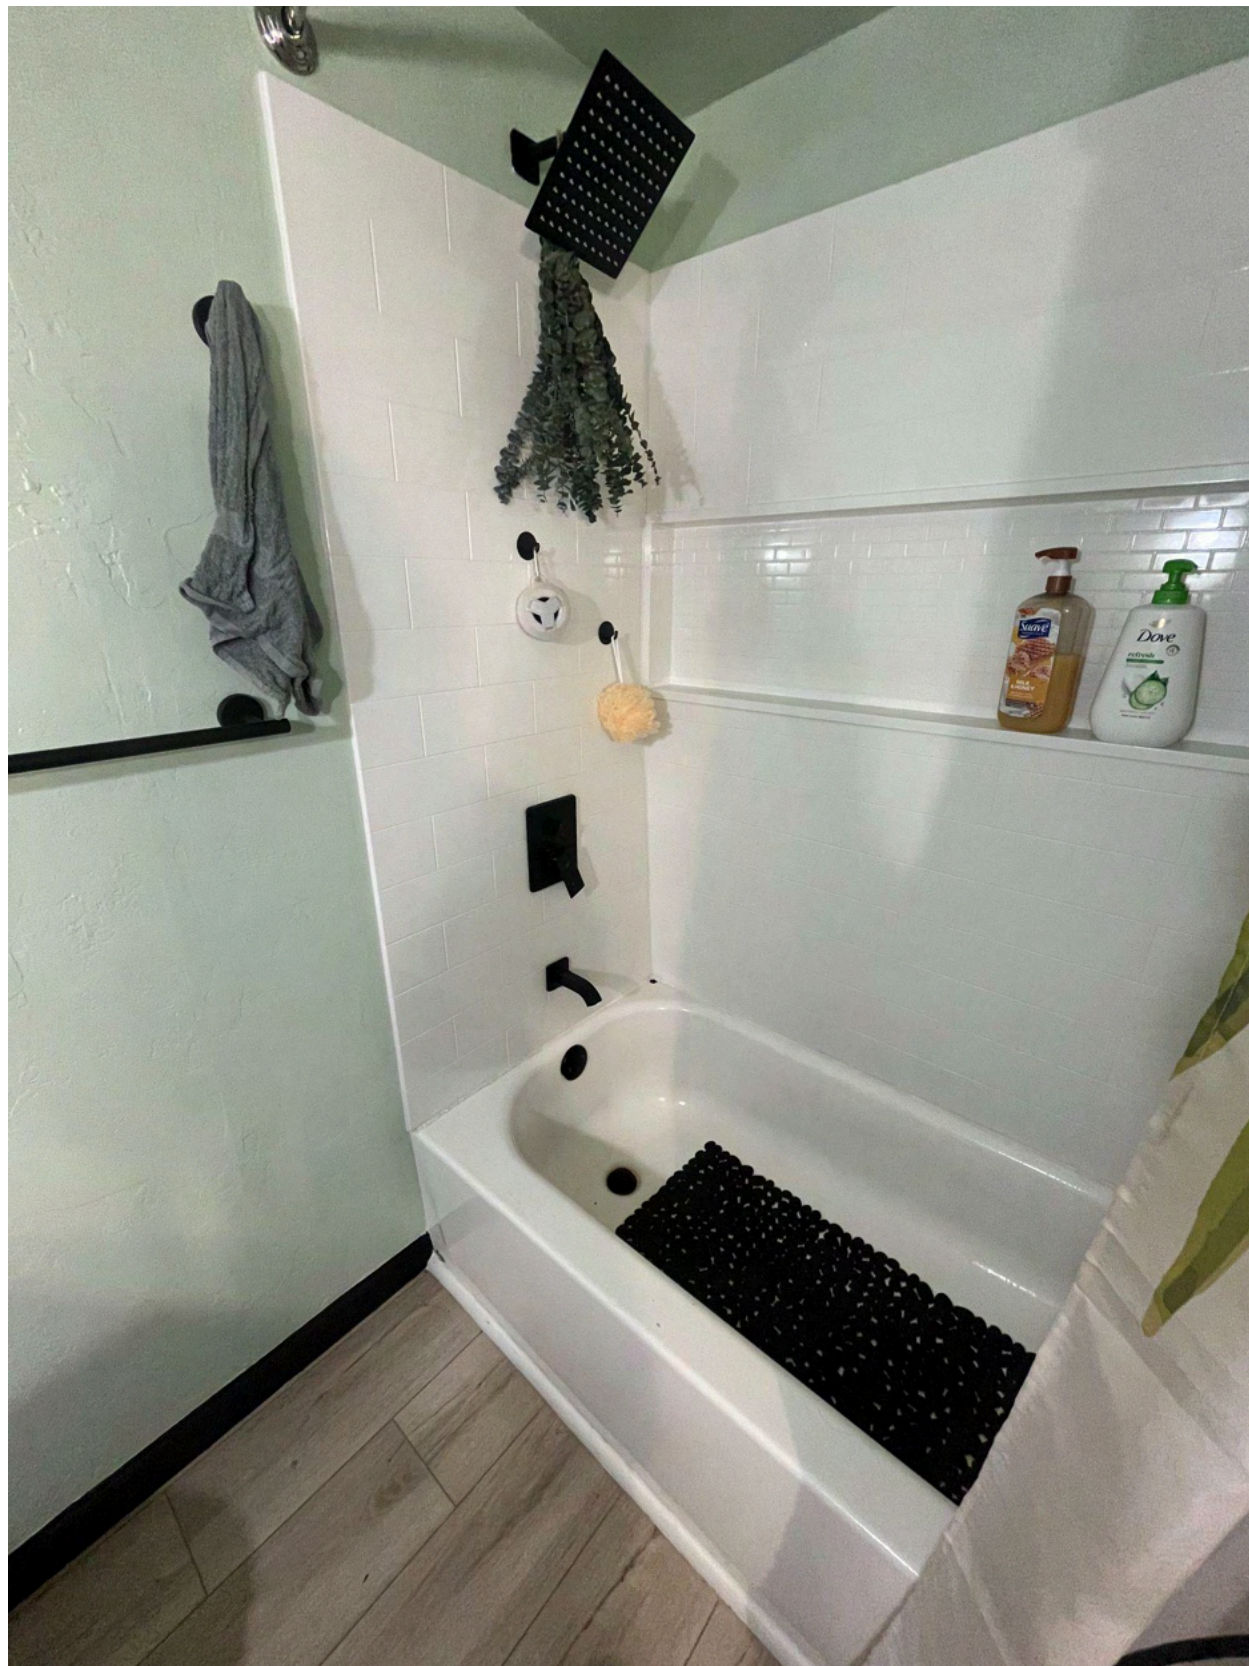
Exhibit 3. Proof of Inaccessibility

- The plumbing item (a bathtub drain/P-trap) serves my unit but is not located within my unit boundaries.
- The P-trap is fully concealed within the ceiling of the unit below and cannot be accessed, inspected, or maintained from my unit.
- I did not install, modify, or repair this plumbing and had no prior knowledge of any defect before the leak was rediscovered.
- This leak issue appears to be pre-existing and related to improper installation and component type.
