GALLERY COMMUNITY Vs. K. HOVNANIAN AT GALLERY

DEPOSITION OF
STEFEN GUSTAFSON

Date	July 23, 2021(REVISED November 08, 2021)	Preliminary ESTIMATE OF COSTS for Gallery Community Association				
I. STRUCTURAL Repair Description	Repair Quantity	Unit Type	Unit Cost	Direct Cost	Notes	
	Costs and repairs are based upon SBSA, LLC's, Construction and Design Compliance Report, dated 06/23/2021, and Supplemental Construction and Design Compliance Report, dated 10/14/2021

HCCI INVESTIGATION & PRELIMINARY REPORT

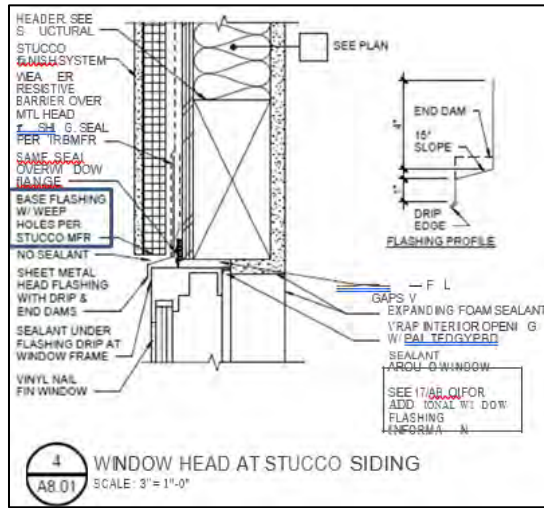
Otak Inc. “K. Hovnanian Homes, Gallery Townhomes,” revised date August 2, 2016, Sheet A8.01 “Exterior Details,” “4/A8.01 Window Head at Stucco Siding”

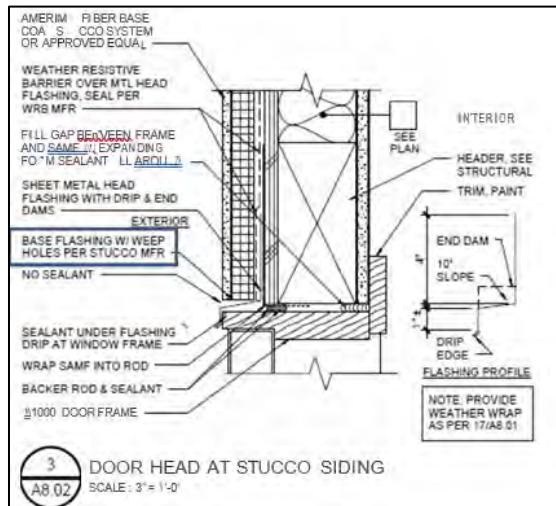
Otak Inc. “K. Hovnanian Homes, Gallery Townhomes,” revised date August 2, 2016, Sheet A8.02 “Exterior Details,” “3/A8.02 Door Head at Stucco Siding”

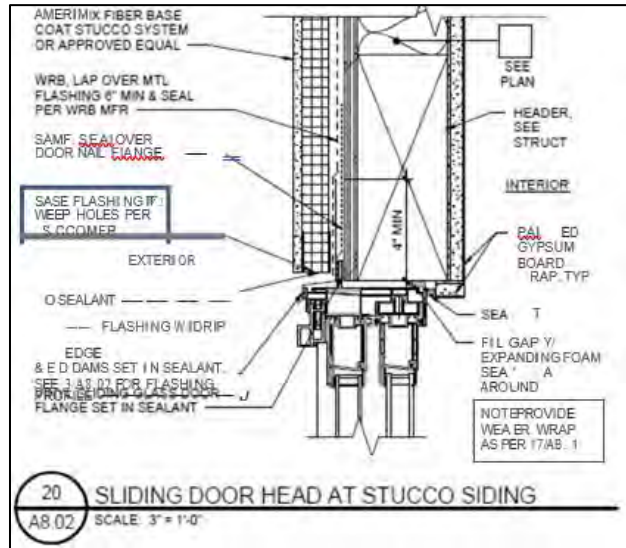
Otak Inc. “K. Hovnanian Homes, Gallery Townhomes,” revised date August 2, 2016, Sheet A8.02 “Exterior Details,” “20/A8.02 SGD Head at Stucco Siding”

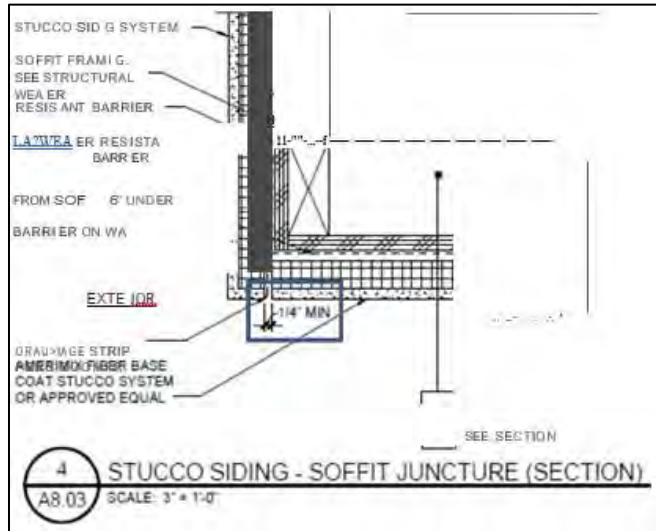
Otak Inc. “K. Hovnanian Homes, Gallery Townhomes,” revised date August 2, 2016, Sheet A8.03 “Exterior Details,” “4/A8.03 Stucco Siding – Soffit Juncture”

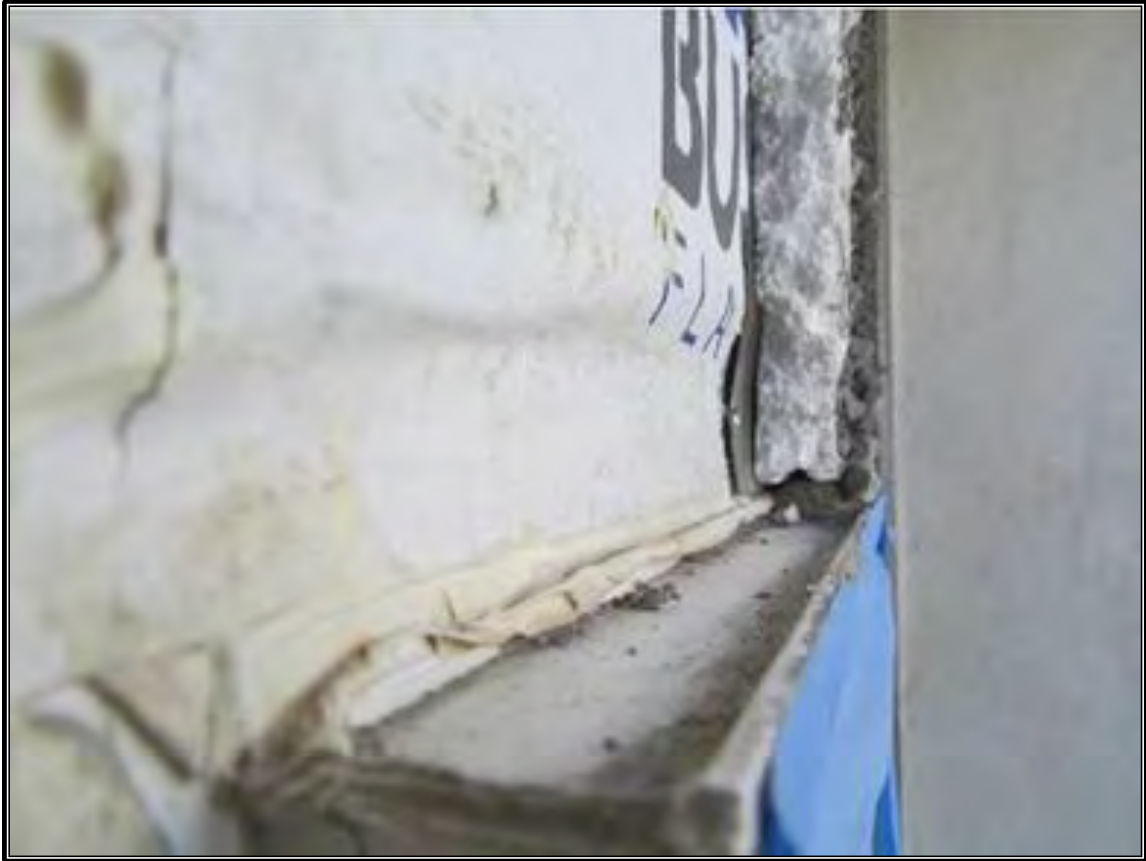
Photo #1 (Pltff Photo Disc IT6 Photo 280): Window head exposed during DT.

SBSA has asserted that weep mechanisms prescribed in the project drawings were omitted at fenestration heads, pop-outs and soffits.

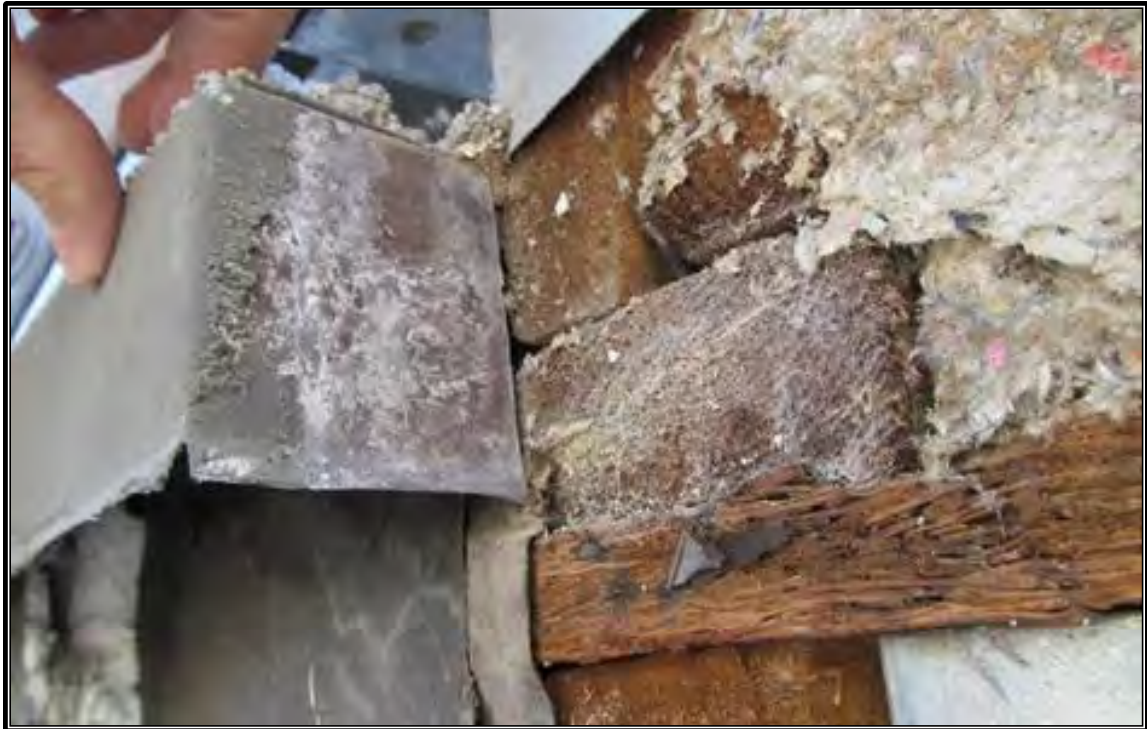
During SBSA’s destructive testing, stucco was removed at a number of wall-to-soffit transitions. At some of these locations, there was evidence of water intrusion (**Photo #2**).

Photo #2 (Pltff Photo Disc ITS Photo 73): Minor staining at exposed framing.

The degree to which this condition exists has not led to anything more than “incidental” water as defined by **ASTM 2128** (*page 1, section 3.2.1*)¹:

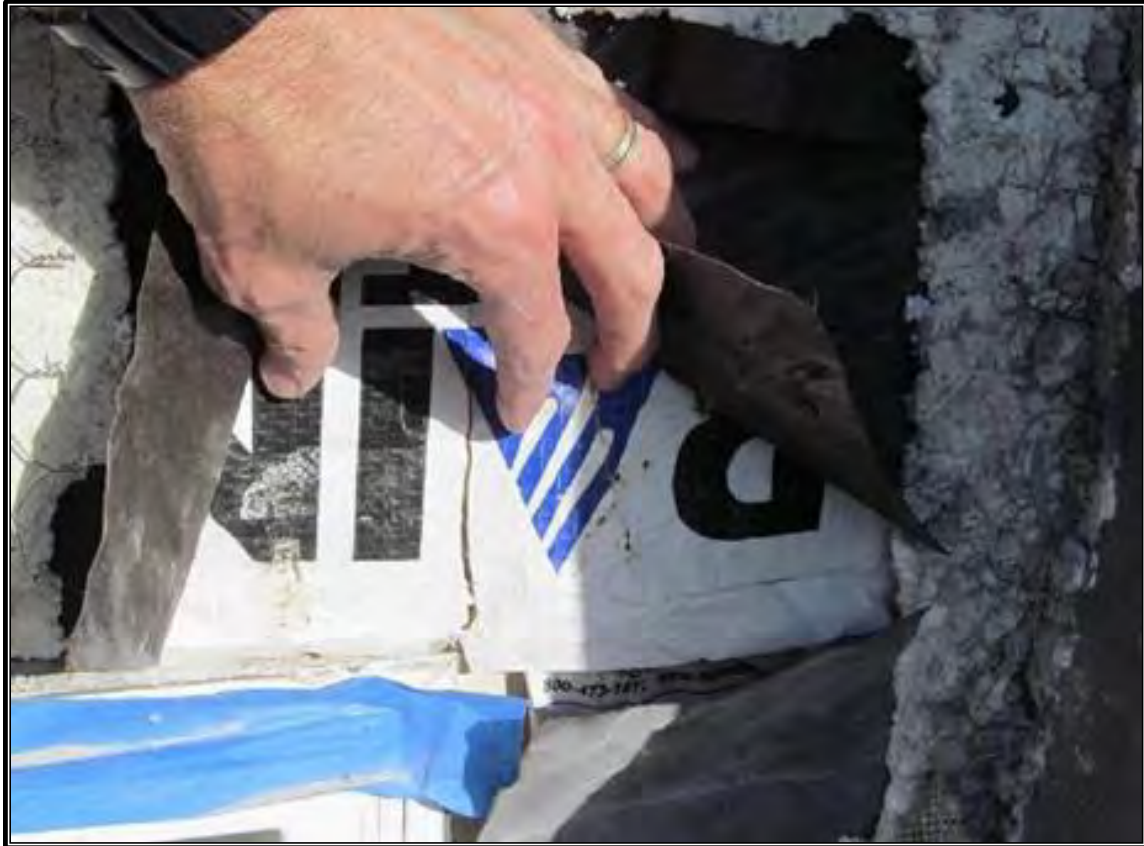
Photo #3 (Pltff Photo Disc ITS Photo 178): One layer of WRB over sheathing.

SBSA has asserted that the weather resistive barrier (“WRB”) does not meet the applicable codes and the ESR-3529 for the Amerimix Fiber Base Coat Stucco system utilized on the project.

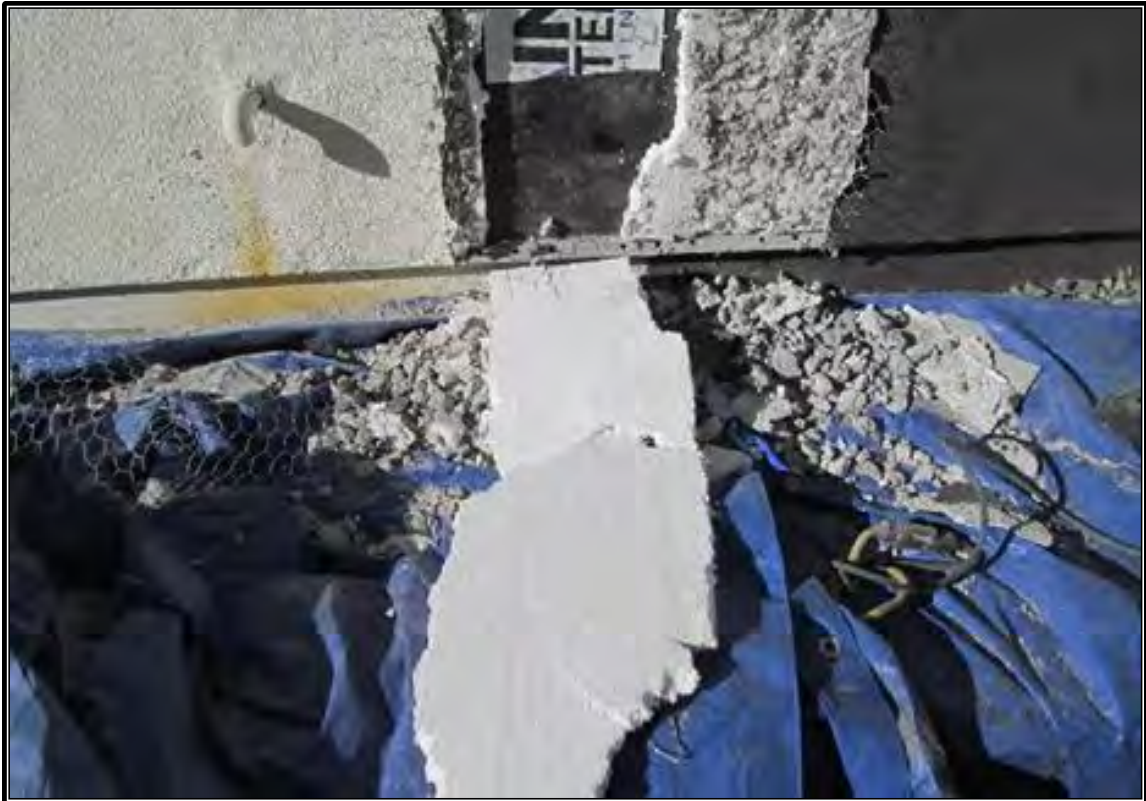
HCCI observed instances of non-compliant EPS foam board during our extensive review of the available plaintiff and developer photographs (**Photo #4**).

Photo #4 (Pltff Photo Disc IT7 Photo 279): EPS foam board exposed during DT.

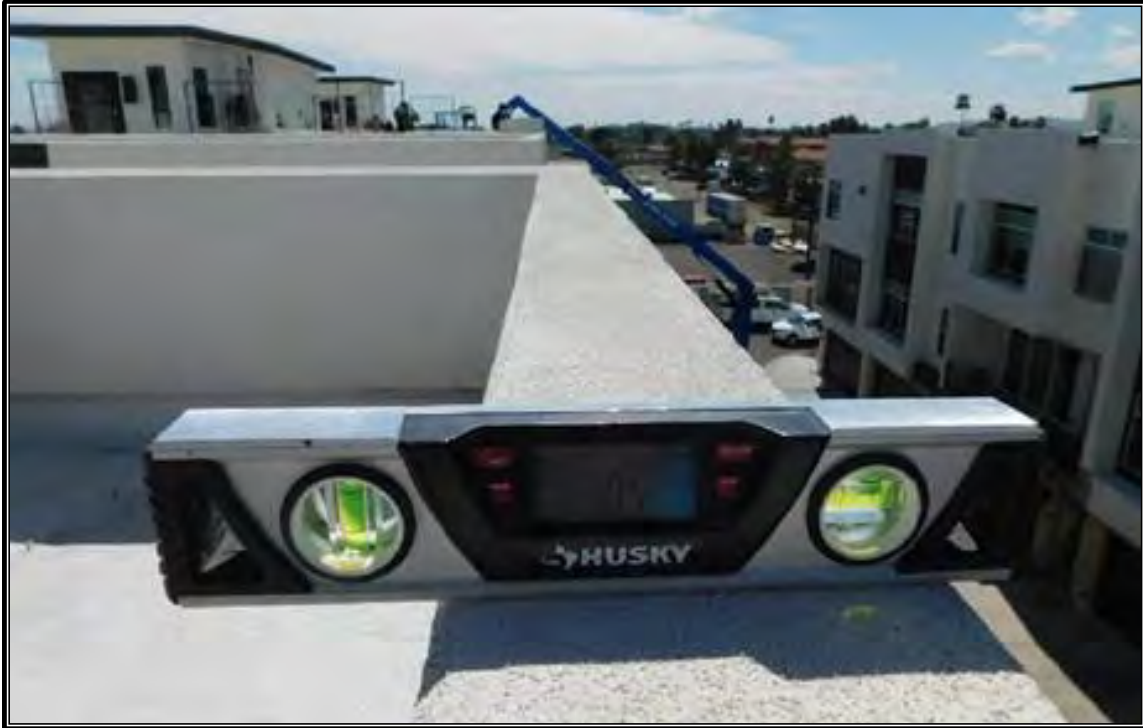
Photo #5 (Pltff Photo Disc OBS7 Photo 350): Roof parapet wall 0.5% slope.

SBSA asserts that the parapets and pot shelves are not properly sloped and that water is penetrating the stucco system.

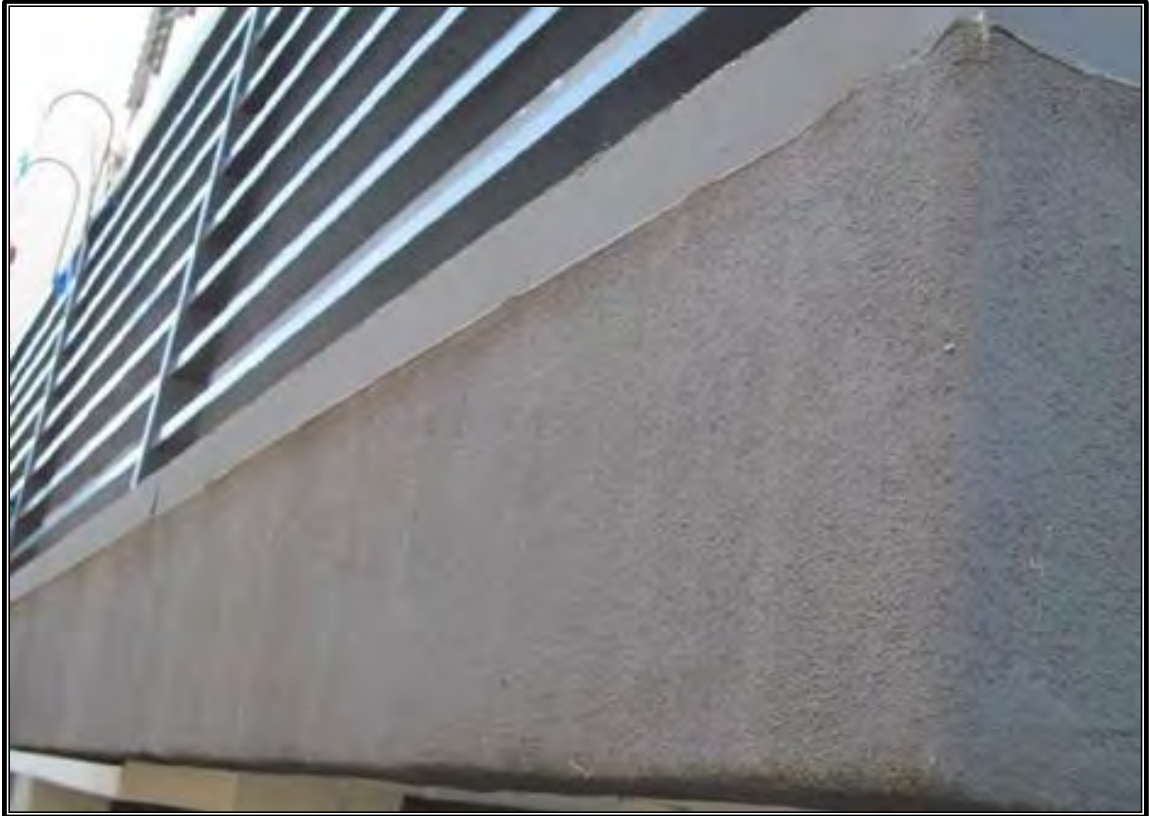
Photo #6 (Pltff Photo Disc IT7 Photo 182): Deck edge flashing at stucco.

SBSA asserts that the metal flashing at the deck perimeters is inset above the stucco in a non-weather board fashion, draining into the stucco system below.
