**PLAINTIFF’S RESPONSE TO
THIRD-PARTY DEFENDANTS
RENCO, LLC DBA RENCO
ROOFING AND DESERT VISTA,
INC.’S JOINT MOTIONS IN
LIMINE NOS. 1 AND 2**

Project Number: 219061.00 (030)
Project Name: Gallery
Location: 3104-3127 North 71st Street
Scottsdale, Arizona 85251

Subject: Construction and Design Compliance Report

c. Non-Compliant EPS Foam Board for Stucco System

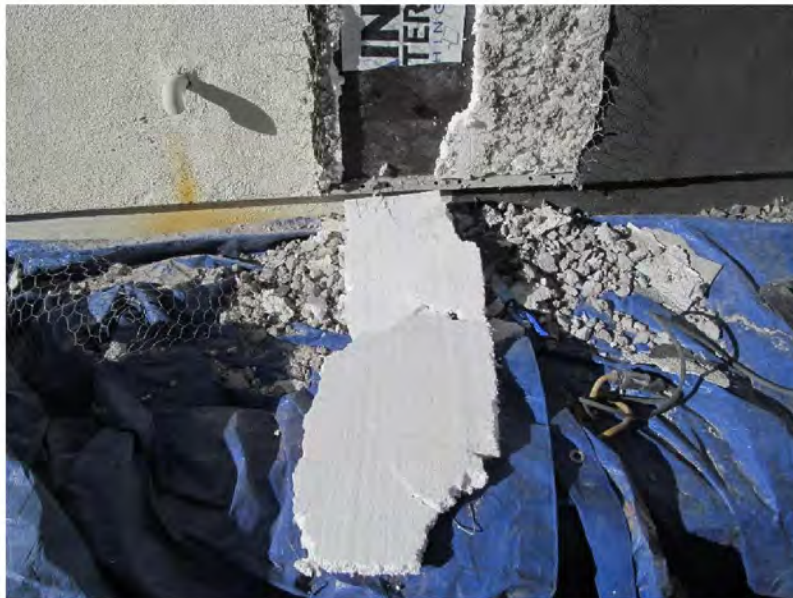
March 10, 2021, Disc IT7, Photograph 279, JJF, Building C, EPS foam board installed over WRB with vertical grooves generally missing at the back face.

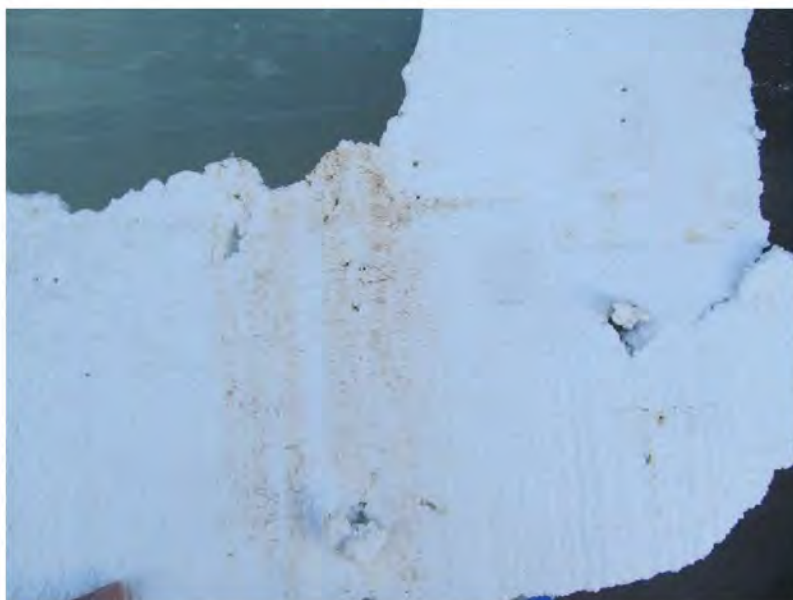
March 10, 2021, Disc IT7, Photograph 210, JJF, Building C, EPS foam board installed tight to WRB and vertical grooves generally missing at the back face.
