## The Village at Rio Paseo Condominium *Goodyear, AZ*

Report #: 40816-0  
Beginning: January 1, 2022  
Expires: December 31, 2022

# RESERVE STUDY Update "With-Site-Visit"

August 19, 2021

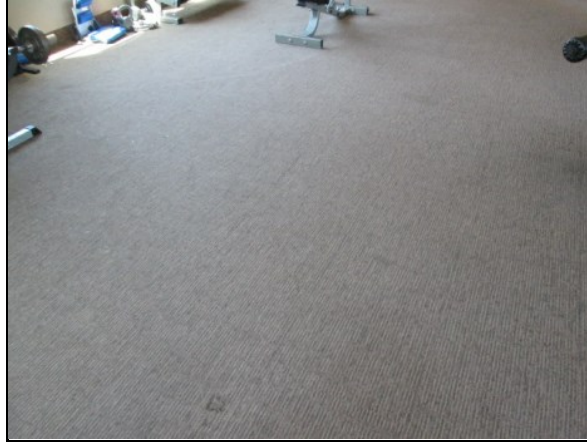
### Comp #: 900 Carpet Floor - Replace

Comments: The carpet floor is reportedly original. Observed to be older with wear and staining evident. Based on age, replacement should be expected soon.

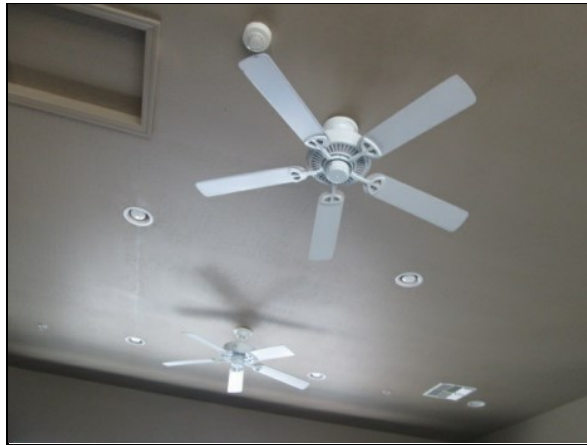
### Comp #: 910 Interior Lights - Replace

Comments: Fixtures include (19) recessed can lights and (3) ceiling fans. Treat repairs and individual replacements as a maintenance expense. Expect to eventually replace all of the fixtures to update and modernize the lighting while also restoring the appearance.

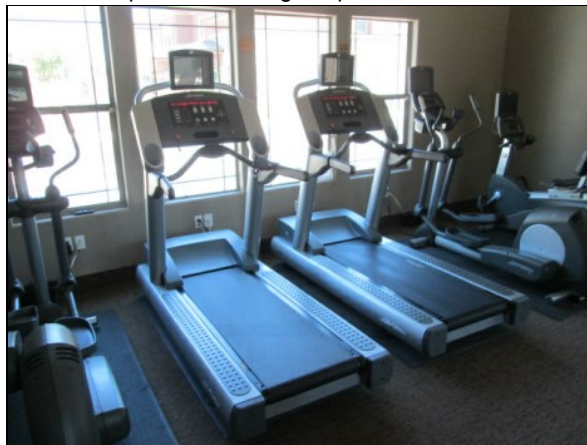
**Comp #: 930 Cardio Equip - Replace**

Comments: Pieces include (2) 93T treadmills, (2) 91X ellipticals and (2) 90R recumbent bikes. Manufactured by Life Fitness. Appear to be functional and in decent shape. Based on age, replacement should be anticipated in the near future.

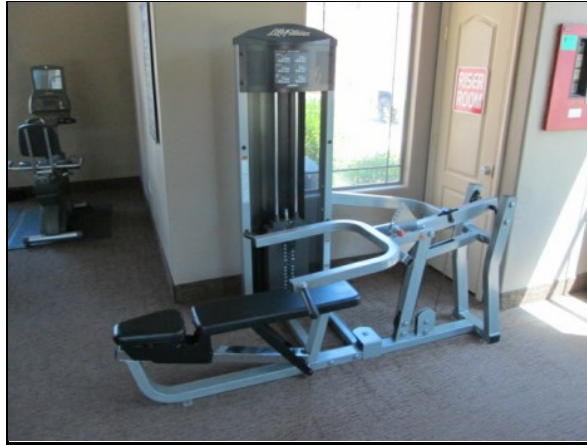
**Comp #: 935 Strength Equip - Replace**

Comments: Pieces include (1) leg press/calf raise, (1) lat/row, (1) pec fly/rear deltoid, (1) multi-press, (1) leg curl/extension, (1) abdominal/back, (1) Weider 200 workout power tower, (2) benches and a dumbbell set + rack. Manufactured by Life Fitness. Observed to be functional and in decent shape. Based on age, replacement should be anticipated in the near future.

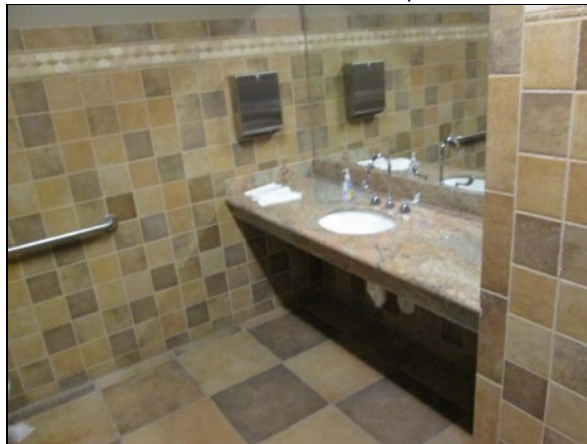
Comments: Observed to be intact and in fair shape. This component funds to remodel the pool building restrooms, which includes replacement of the lighting, mirrors, sinks, counters, toilets, tile surfaces, paint, etc.

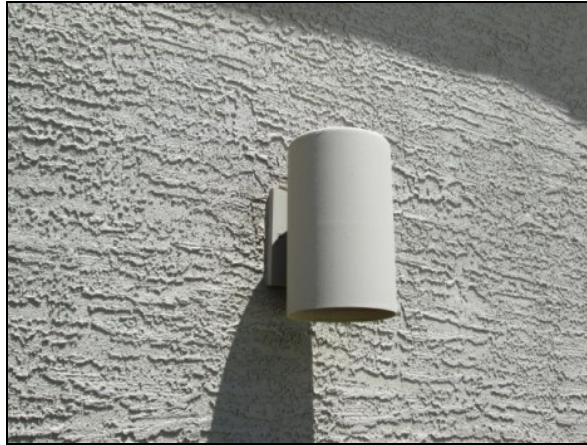
**Comp #: 1010 Exterior Lights - Replace**

Comments: Fixtures include (7) recessed can lights and (6) wall lights. Treat repairs and individual replacements as a maintenance expense. Expect to eventually replace all of the fixtures to update and modernize the lighting while also restoring the appearance.

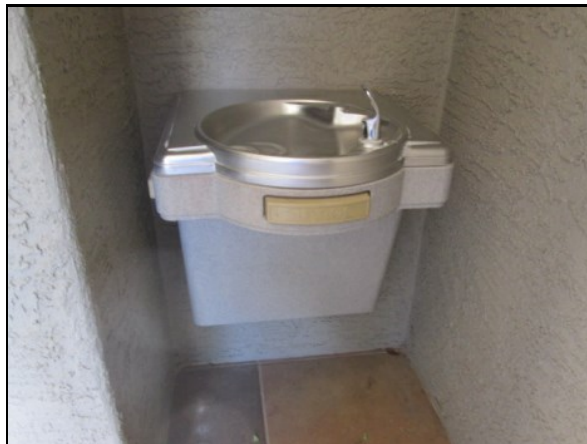
**Comp #: 1020 Drinking Fountain - Replace**

Comments: Appears to be older, worn and weathered. Based on age, replacement should be expected soon.

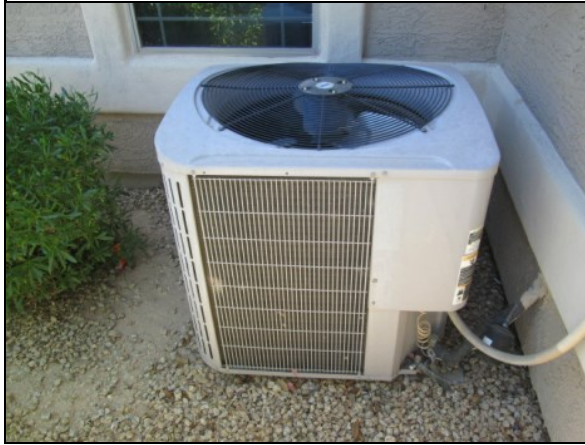
**Comp #: 1070 HVAC Unit - Replace**

Comments: Appears to be older and weathered. Based on age, replacement should be expected soon. This component funds to replace the condenser and air handler together.

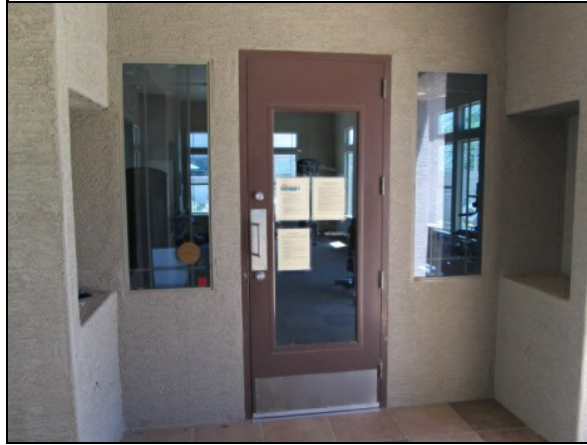
**Comp #: 1085 Doors & Windows - Replace**

Comments: There are (3) exterior doors and (1) interior door. There are also (28) windows totalling approximately 290 Sq Ft. Long life expectancy, but replacement should be planned eventually.

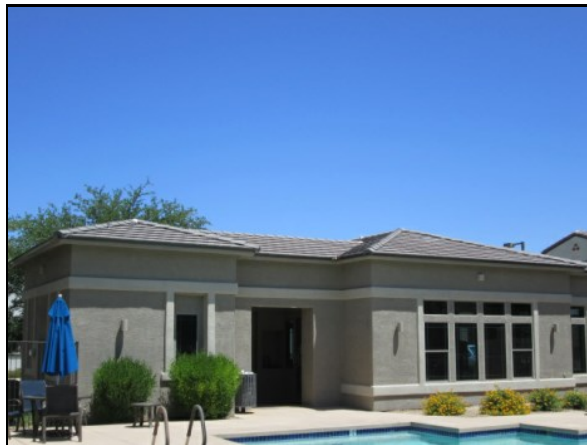
**Comp #: 1090 Tile Roof - Replace**

Comments: This is a concrete tile roof system. Underlayment is the true waterproofing component of this roof. Although it is not visible to inspect, replacement will be needed eventually. Tiles have a longer life span than the underlayment, but roofers recommend replacing them anyway with the underlayment. There are multiple reasons supporting complete replacement, and the cost differential is not that high. Life span will vary depending on the quality of underlayment installed as well as regular roof maintenance.

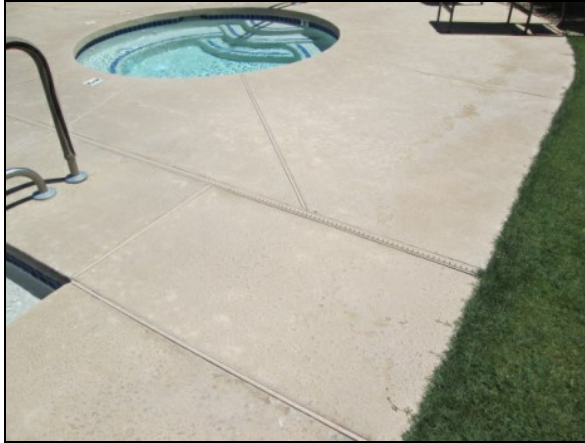
Comments: Surface appears to be worn with cracking throughout. This component funds to periodically grind off the existing deck coating and re-apply a new surface. Combined cost with the seal/repair component accounts for the total estimated resurface budget.

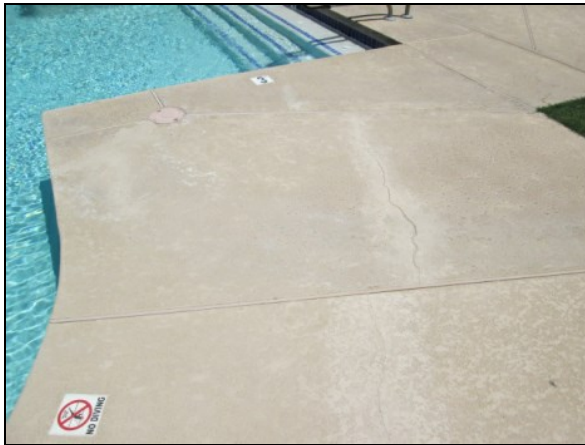
### Comp #: 1201 Pool Deck - Seal/Repair

Comments: This component funds to periodically patch cracks and seal/paint the deck to cover stains and restore the appearance.

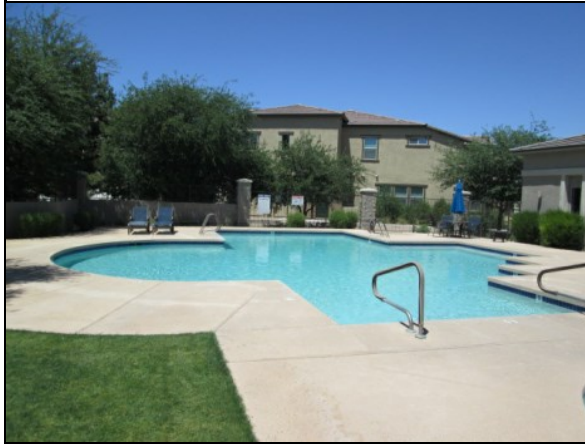
Comments: The 2020 cost appears to be quite low, so the budgeted cost reflects a more typical price for this scope of work. Pool surface was observed to be intact and in good shape.

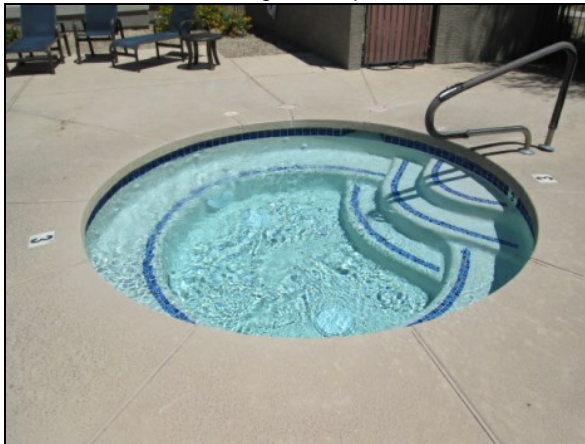
Comments: Pool surface was observed to be intact and in good shape.

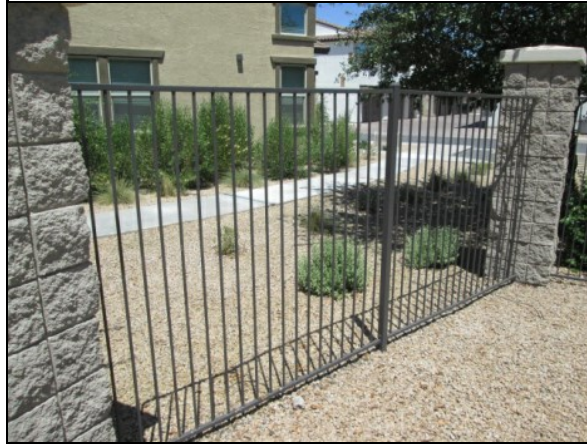
**Comp #: 1215 Pool Fence - Replace**

Comments: There is approximately 135 LF of 2.5' tall fence and 55 LF of 6' fence. There are also (3) pedestrian gates, including the pool/spa equipment gate. Observed to be intact, secure and in fair shape.

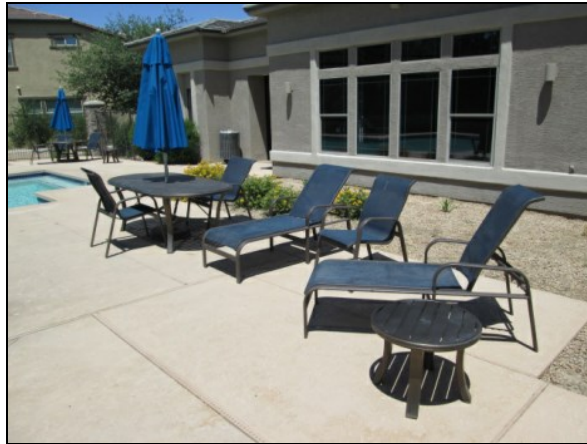
**Comp #: 1220 Pool Furniture - Replace (A)**

Comments: Quantity includes (8) lounges, (10) chairs, (2) dining tables, (5) side tables and (2) umbrellas. Overall, the pool furniture appears to be intact, functional and in decent shape. Wear and weathering was noted, especially on the slings.

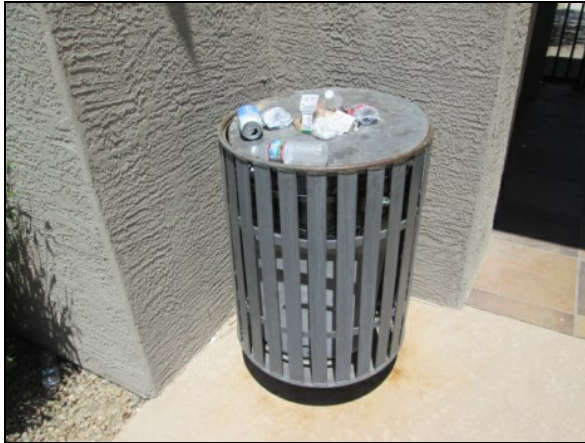
**Comp #: 1220 Pool Furniture - Replace (B)**

Comments: Appears to be older with wear and weathering evident.

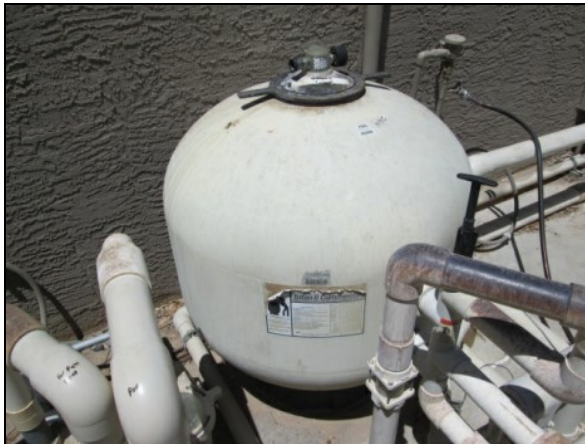
**Comp #: 1240 Pool Filter - Replace**

Comments: Appears to be older, worn and weathered. Based on age, replacement should be expected soon.

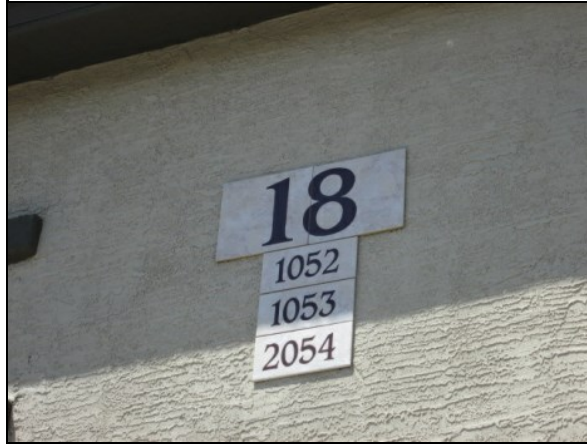
**Comp #: 2800 Building Signs - Replace**

Comments: There are (7) tile signs per building. (1) sign is the building number, while the remaining (6) are the unit numbers. Appear to be intact and in fair shape. Some weathering noted.

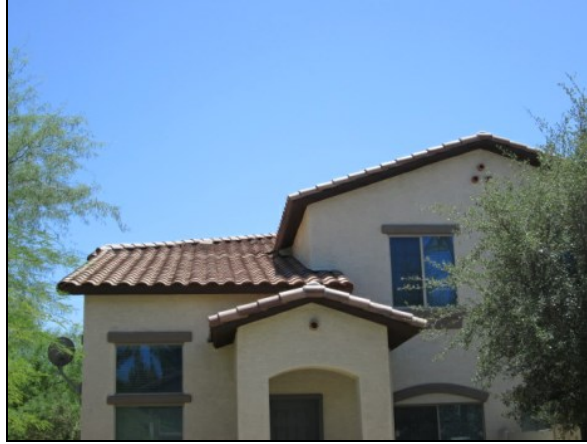
**Comp #: 2900 Tile Roofs - Replace**

Comments: This is a concrete tile roof system. Underlayment is the true waterproofing component of this roof. Although it is not visible to inspect, replacement will be needed eventually. Tiles have a longer life span than the underlayment, but roofers recommend replacing them anyway with the underlayment. There are multiple reasons supporting complete replacement, and the cost differential is not that high. Life span will vary depending on the quality of underlayment installed as well as regular roof maintenance.

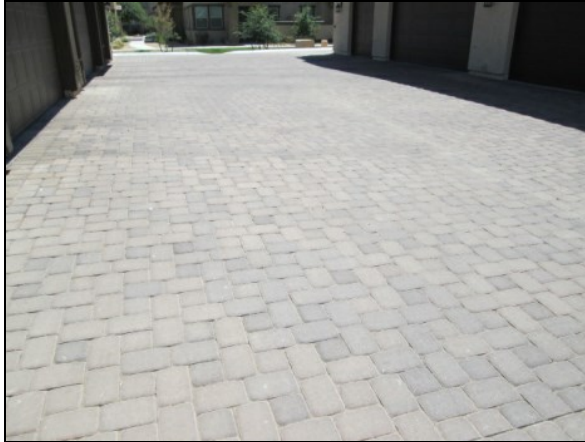
Comments: Complete replacement of the pavers is not anticipated. This component funds to remove pavers and rehab or re-level the sand base, then re-install existing pavers.

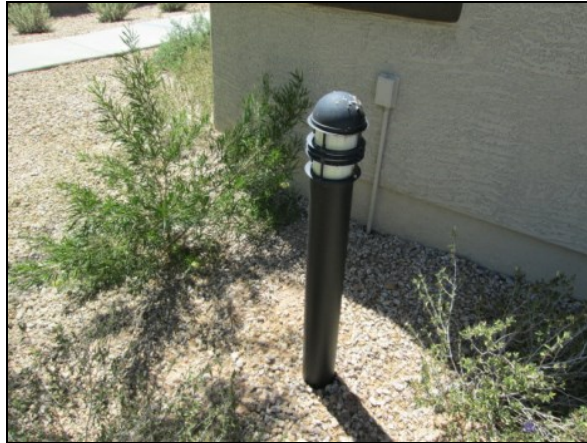
Comments: Surfaces were observed to be heavily worn, faded and oxidized.

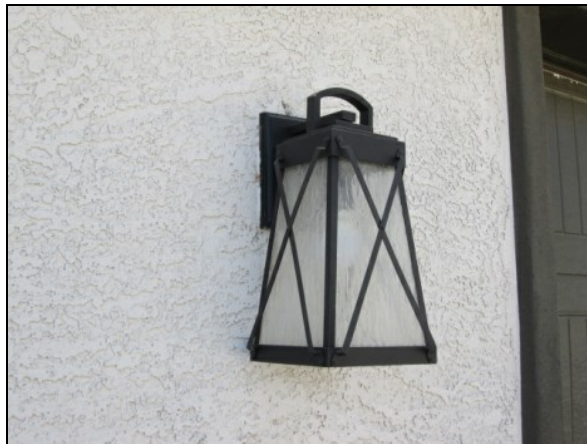
**Comp #: 2200 Exterior Lights - Replace**

Comments: Fixtures include (117) recessed can lights and (117) coach lights. Treat repairs and individual replacements as a maintenance expense. Expect to eventually replace all of the fixtures to update and modernize the lighting while also restoring the appearance.

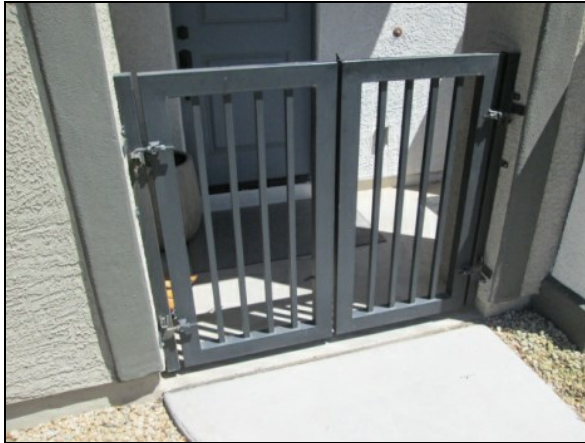
**Comp #: 2300 Pedestrian Gates - Replace**

Comments: Appear to be intact, functional and in good shape. Future replacement should be anticipated.

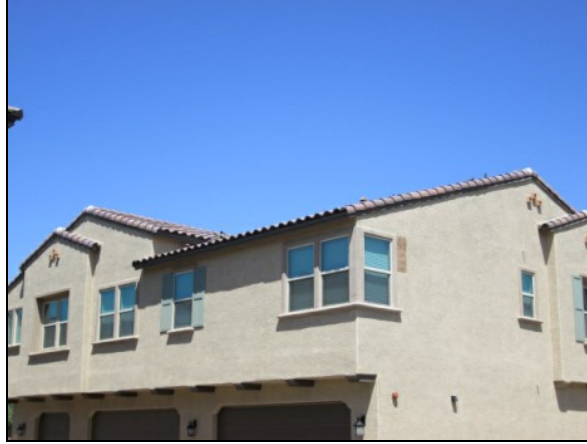
**Comp #: 2900 Tile Roofs - Replace**

Comments: This is a concrete tile roof system. Underlayment is the true waterproofing component of this roof. Although it is not visible to inspect, replacement will be needed eventually. Tiles have a longer life span than the underlayment, but roofers recommend replacing them anyway with the underlayment. There are multiple reasons supporting complete replacement, and the cost differential is not that high. Life span will vary depending on the quality of underlayment installed as well as regular roof maintenance.
