Title of Action: Gallery Condominium Association vs. K. Hovnanian at Gallery, LLC

We represent the Gallery Condominium Association ("Association") regarding the defective original construction of The Gallery condominium project located in Scottsdale, Arizona. The purpose of this letter is to provide you with formal notice of the defective work and the Association's claim pursuant to the Homeowners' Association Dwelling Actions (A.R.S. § 33-2002, et seq.), the Purchaser Dwelling Act (A.R.S. § 12-1361, et seq.), and the Association's governing documents.

The Association has retained a forensic expert, SBSA, Inc. ("SBSA") to investigate the defective construction of the common elements at The Gallery. The following defects and deficiencies in the common elements at The Gallery have been identified by SBSA:

These defective conditions are described in detail in the attached Notice of Claim Summary report dated July 2, 2019¹. The SBSA report includes photographs of the defective conditions, which were observed project-wide. The defects impair the structural integrity, functionality or appearance of the dwelling and will continue to do so in the future if not repaired or replaced.

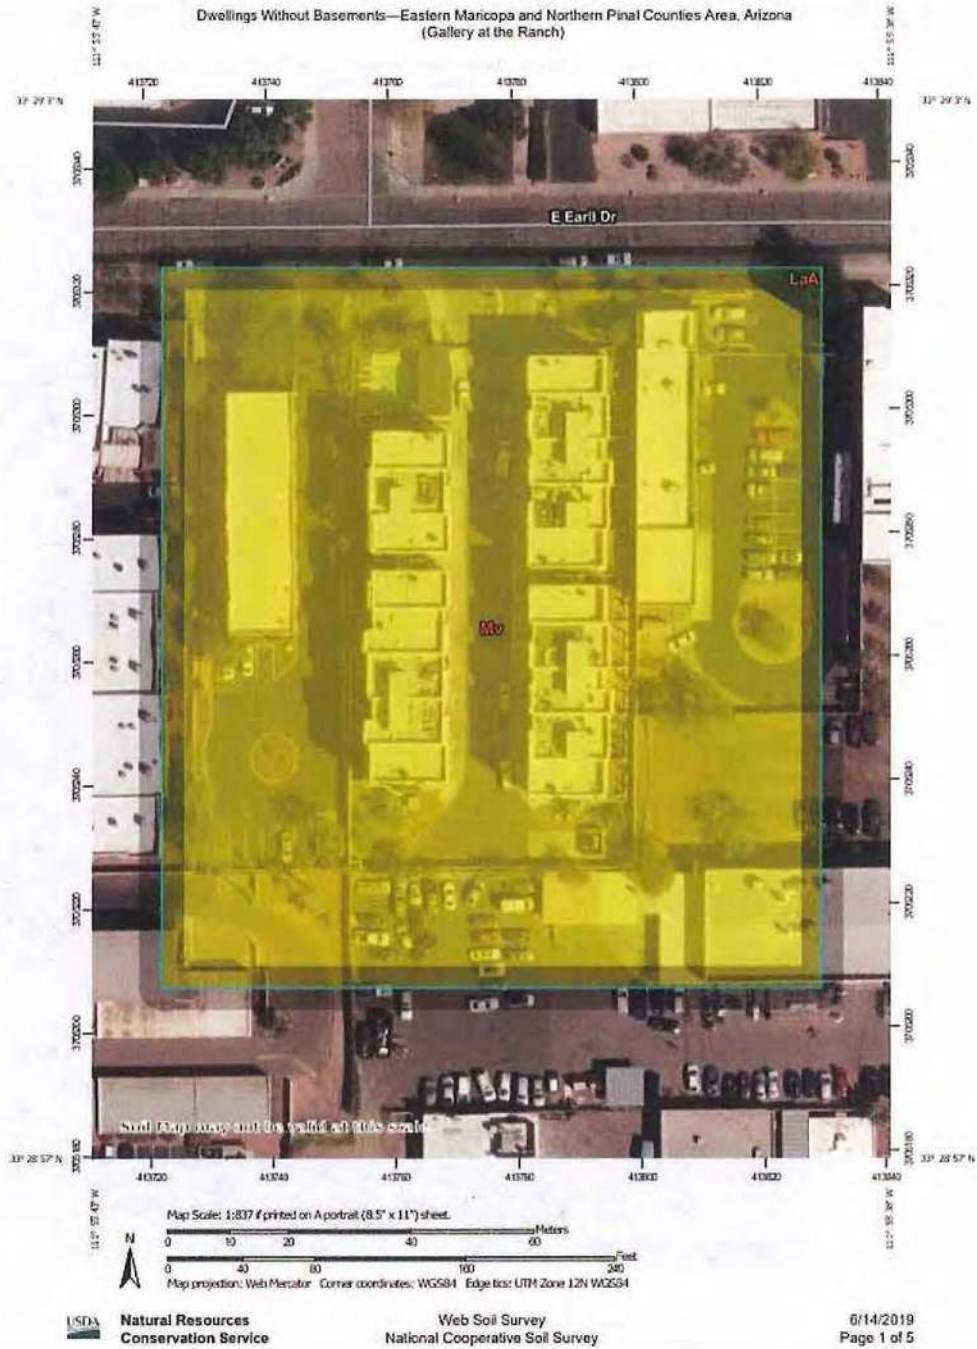
No geotechnical report has been provided for review. A complete review of the soils report is required prior to final engineering conclusions. According the United States Department of Agriculture, Natural Resources Conservation Service, Web Soil Survey, the site is approximately 3-acres in size, and primarily Mohall loam (MLRA 40) underlies it. The soils are considered somewhat limited for shallow foundation systems, due to minor shrink swell issues (rated at 0.05), that would be moderately favorable for shallow foundation system use.

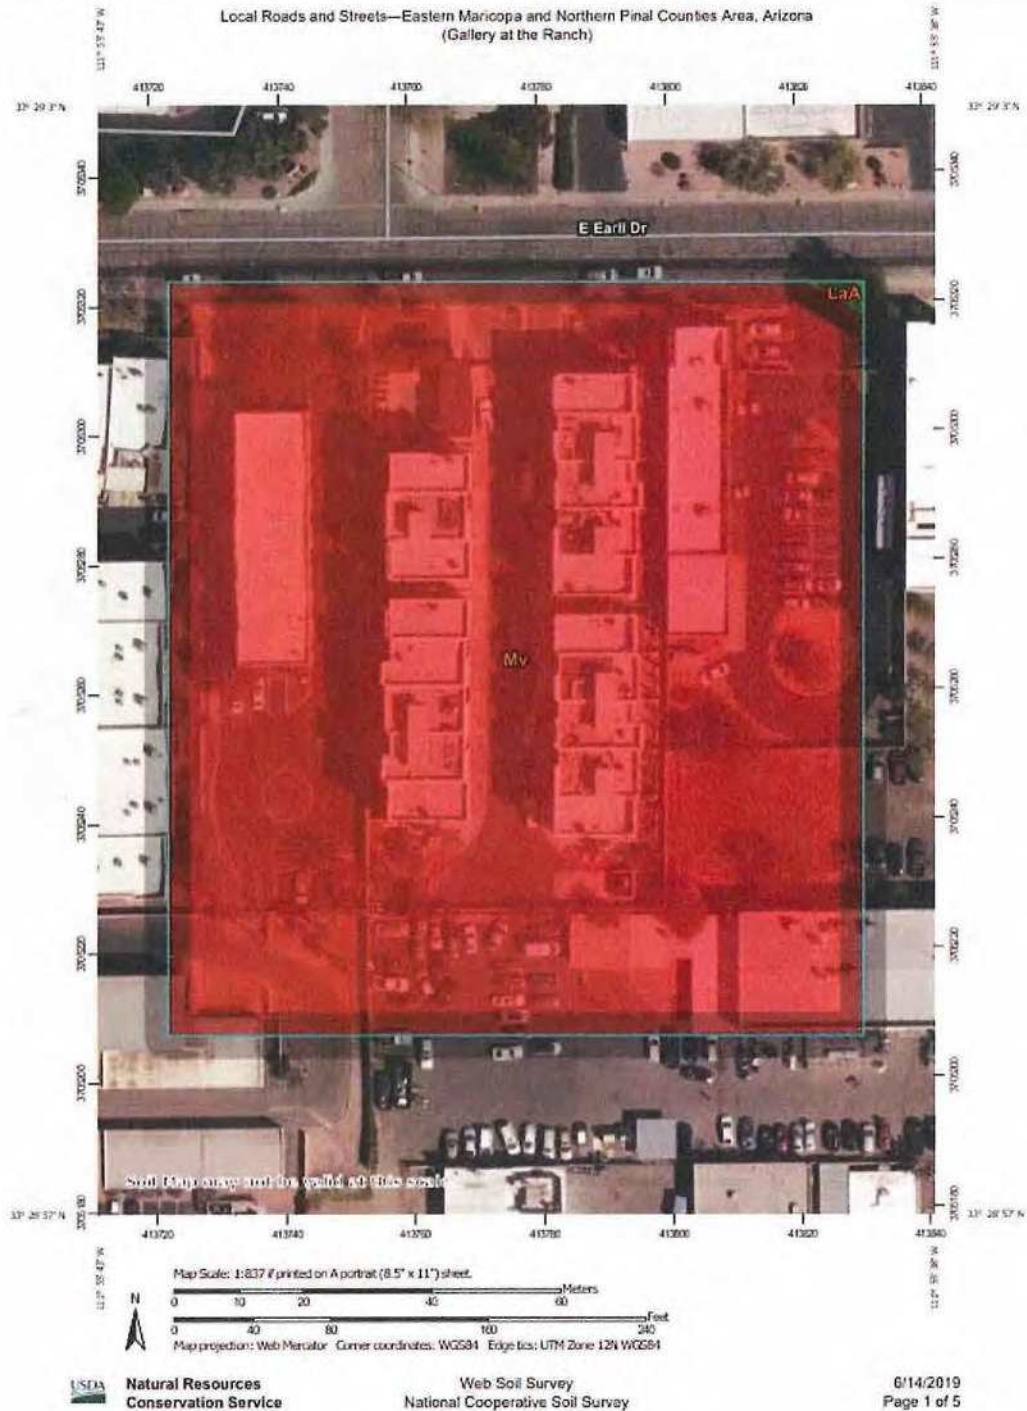
For roadway and streets, the site is considered limited due to the low strength of the on-site soils (rated at 1.00) and, to a lesser degree, the shrink swell associated with the loam.

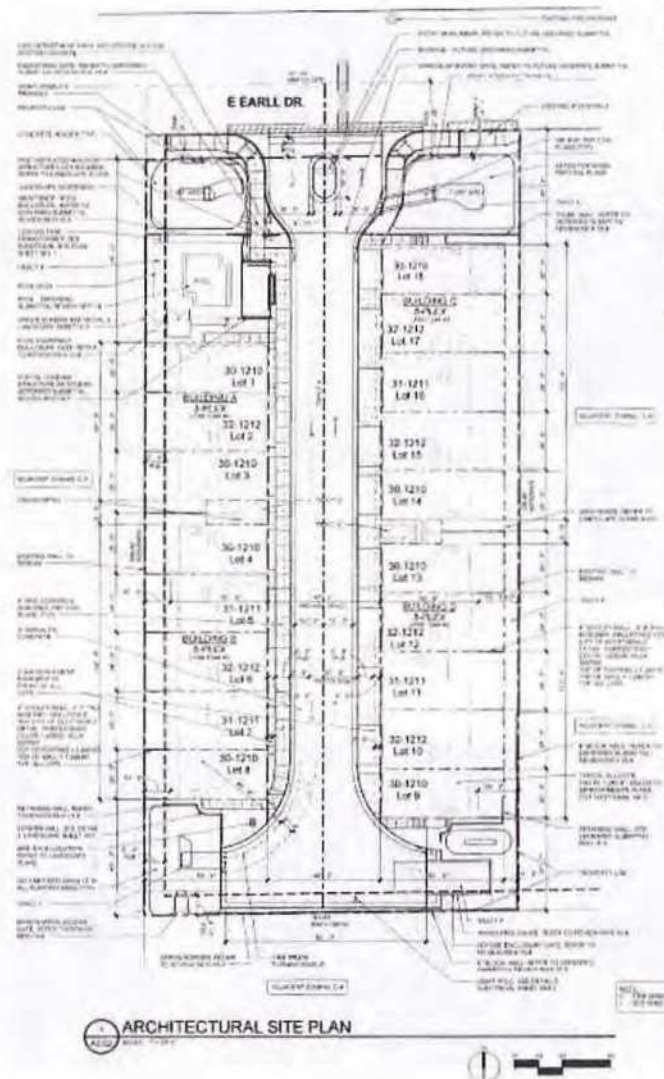
It is unclear from the site how the rear lots are graded to provide defined swales to either the north or south ponds. The CMU fencing and tight constraints limit the available surface area to construct defined channels.

The road slopes from a high point in the center roadway to the east and west. The overall site generally slopes from the north toward the south.
