Exhibit A

Project Number: 219061.00 (030)
Project Name: Gallery
Location: 3104-3127 North 71st Street
Scottsdale, Arizona 85251

Subject: Construction and Design Compliance Report

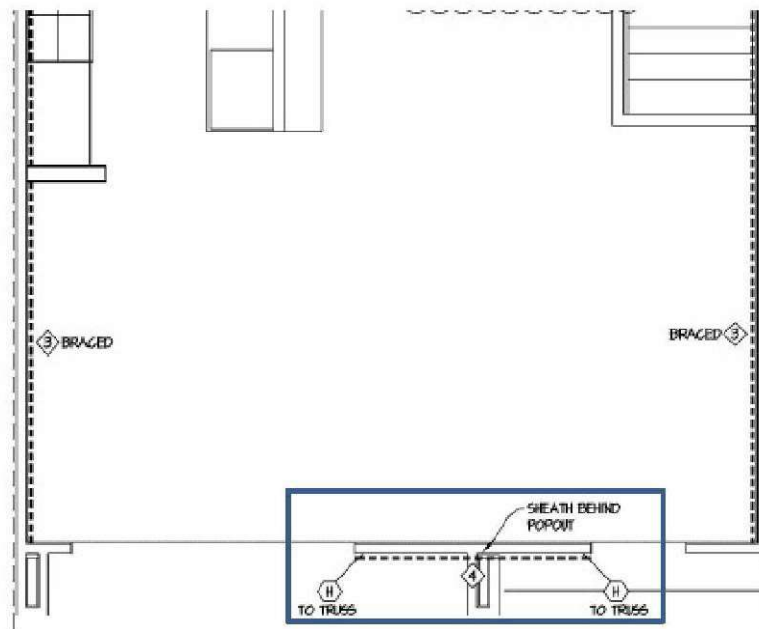
- "31-1211, 2nd Floor, Braced/ Shear Wall Plan"

As constructed, the cladding was installed over open stud framing without the required exterior sheathing at the second floor level between the triple panel slider window in the great room and the pop-out wall. Fasteners in the CS16 strap connecting the exterior sheathing below the triple panel window were missing and the steel strap had buckled. The buckled steel strap and the missing exterior wood sheathing failed to comply with the braced/shear wall plan specified on the structural drawings. The non-compliant condition more likely than not reduces the structural integrity of the LFRS, as intended by the Structural Engineer of Record (EOR) and requires repairs.
