RE: JSH File No: **17412-00067**  
File Type: Residential  
Property: Gallery Condominiums Subdivision  
Address: 7107 East Earll Drive  
Scottsdale, AZ 85251  
BSC File No: 220080S

Per Jones, Skelton & Hochuli, P.L.C.'s (JSH) request, Evan J. Marshall, SE of BSC Forensic Services, LLC (BSC), formerly of Envista Forensics, LLC (Envista), performed on-site inspections at the referenced property on March 9-11, 2021. Reportedly, subsequent to construction completion, water infiltration through various locations of the roof and exterior wall cladding caused water damage to interior finish surfaces of several units of the buildings.

- Whether the wood framing construction work performed by LeBlanc Construction was the cause of the reported water penetration.
- Whether there was missing wood construction at the balcony edges as reported on pages 8-9 of the MCC Defect Issue Report dated January 31, 2022.
- Whether missing shear wall components can be extrapolated to entire project.

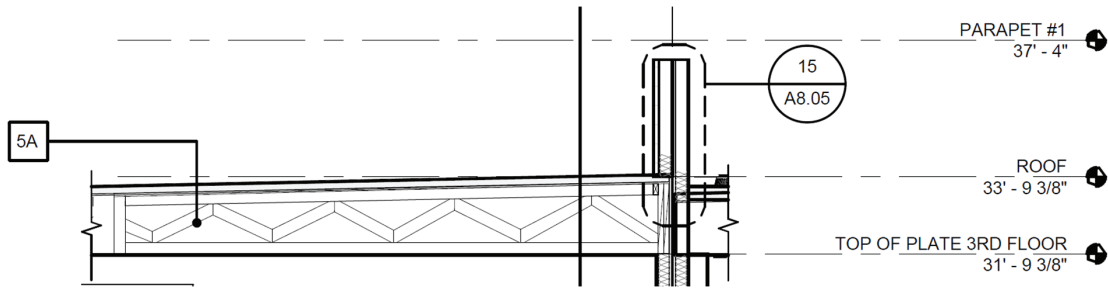
Figure 8. Taken from Section 4 on Sheet A5.02 depicting visible slope in roof surface.

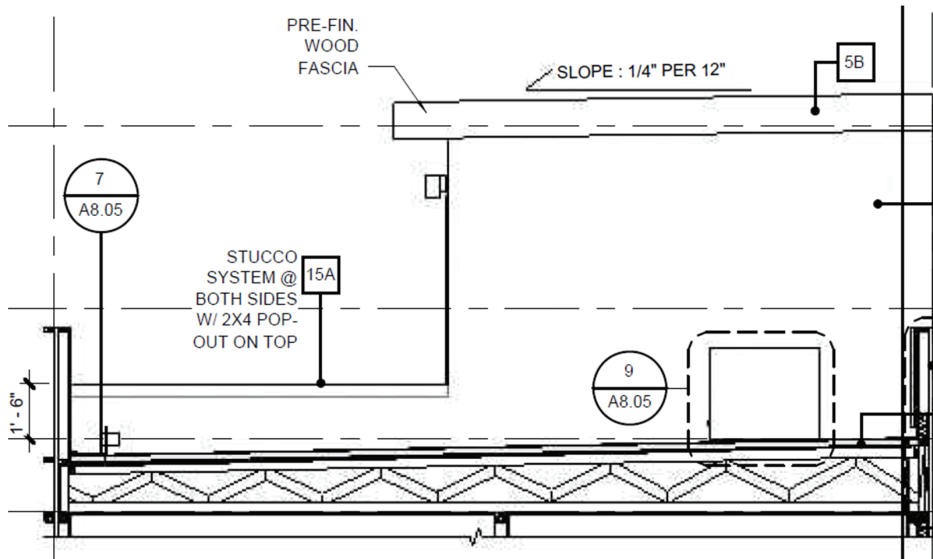
Figure 9. Taken from Section 4 on Sheet A5.16.2 depicting visible slope in roof surfaces and callout for 1/4-inch vertical per 12 inches horizontal slope on stairwell roof.

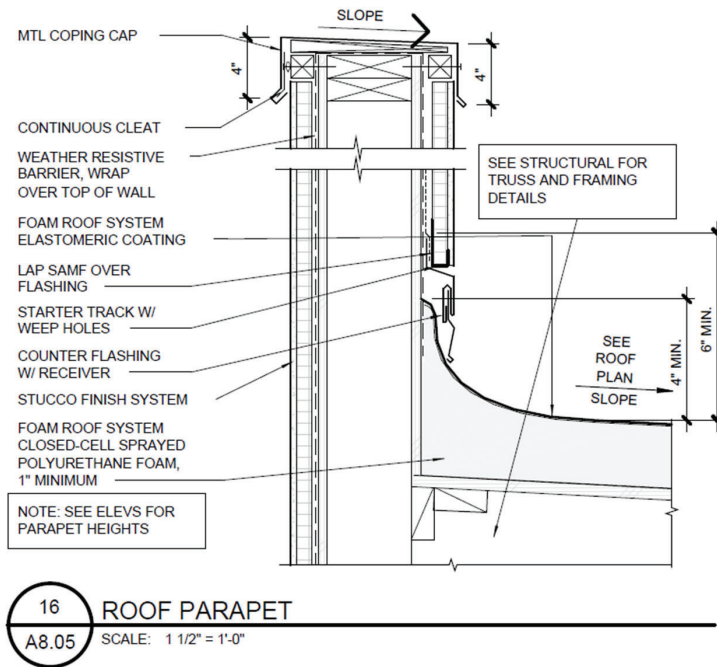
Figure 10. Taken from Section 16 on Sheet A8.05 depicting visible slope in roof surface, and callout for foam roof insulation with elastomeric coating and roof slope.

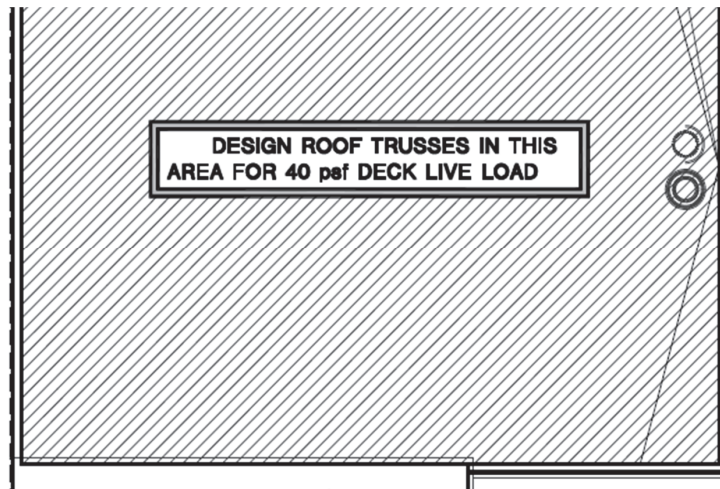
Figure 11. Taken from Sheet S2.6 of the structural drawings depicting design live load (40 psf) for roof trusses' design.

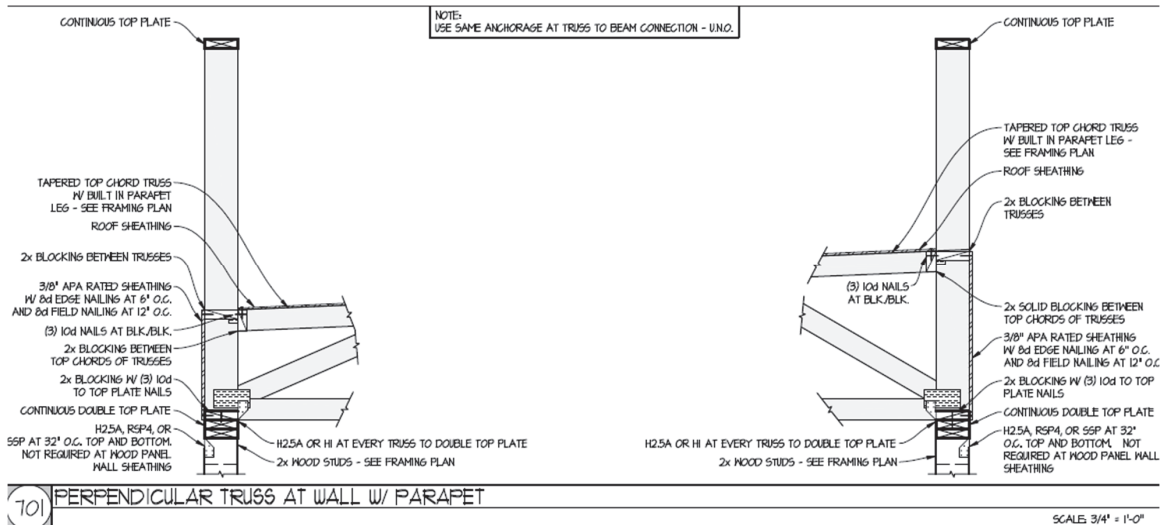
Figure 12. Taken from Sheet SD of the structural drawings depicting visible slope in roof surface and calling out tapered (i.e. sloped) roof trusses.

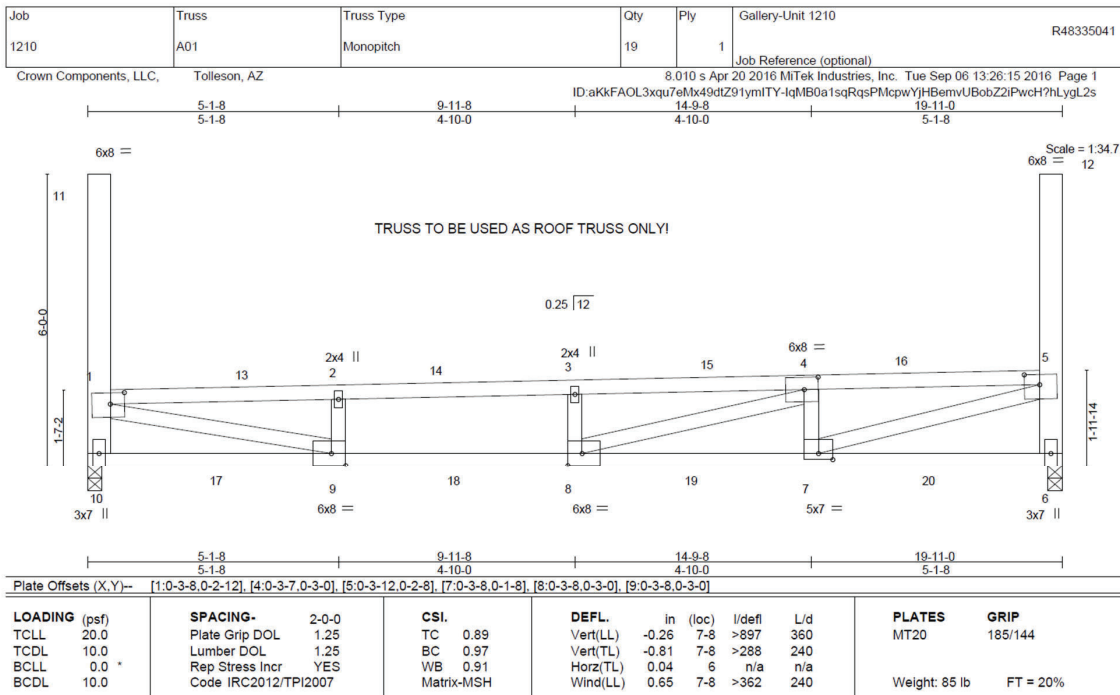
Figure 13. Taken from Miltek roof truss design calculations and drawings depicting a monopitch (i.e. sloped) top surface.

The preceding excerpt drawings indicated that the wood roof sheathing (e.g. plywood) should be installed directly onto the tops of the roof trusses. These drawings further indicated that the roof trusses and roof covering should slope at 1/4" per 12" (i.e. 1/4" of vertical rise for 12" of horizontal run), and that trusses were designed (i.e. engineered, presumably by Crown Components, LLC). Based on this information, BSC would expect that the roof slopes and installation configurations
