Project Number: 219061.00 (030)
Project Name: Gallery
Location: 3104-3127 North 71st Street
Scottsdale, Arizona 85251

Subject: Supplemental Construction and Design Compliance Report

Per your request, SBSA, LLC, A Charles Taylor Company (SBSA), provided a Construction and Design Compliance Report (SBSA CDC Report) dated June 23, 2021 to document findings based on observations of the buildings at the Gallery Townhomes site (Gallery) in Scottsdale, Arizona. This supplemental report provides additional findings based on a visual observation on August 23, 2021 and disclosed photographs.

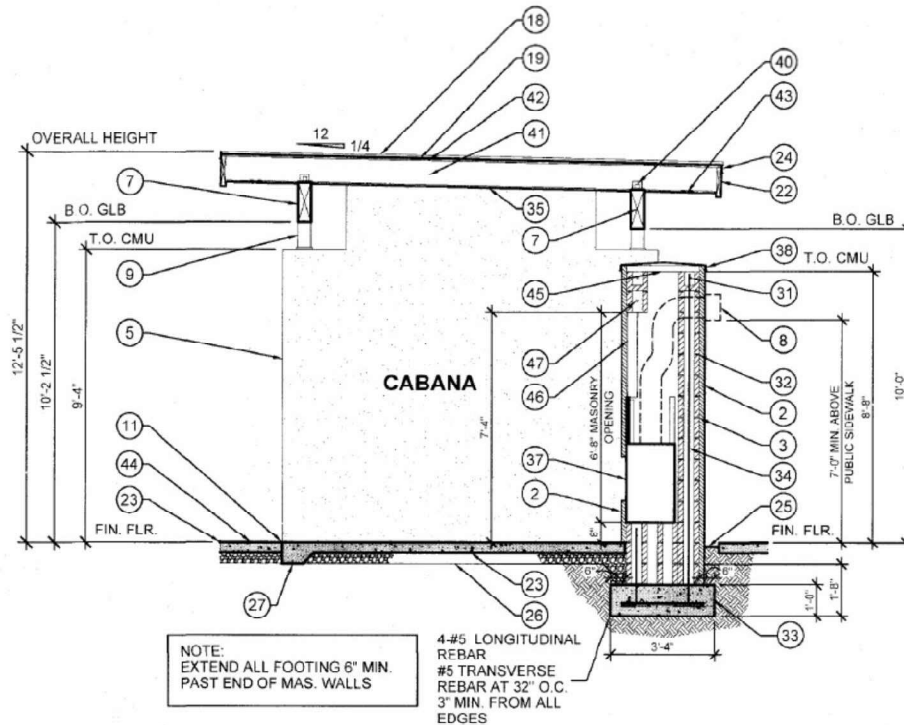
**BUILDING SECTION A**

Felten Group, "Exterior Elevations and Building Sections," stamped April 6, 2016, Sheet A2.1 "Gallery Pool Cabana," Bates Number Gallery_000089, illustrates the following:
